Continuing Airworthiness Notice – 27-018

Diamond DA 42 Rudder Steering Bracket P/N D60-5710-20-00-NPC

10 November 2020

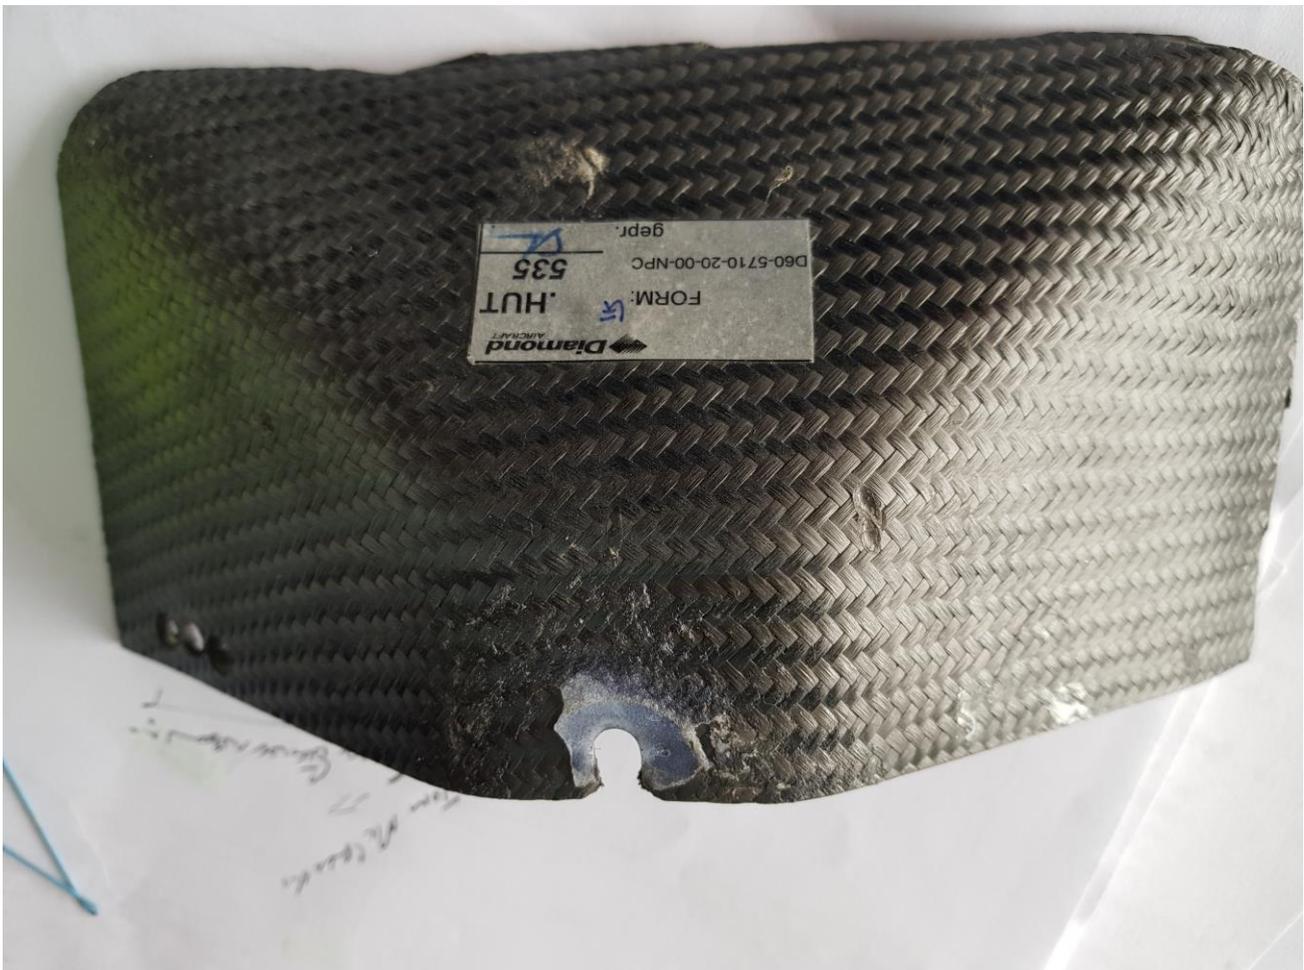
An engineering investigation determined that the rudder T-yoke had separated from the rudder steering bracket P/N D60-5710-20-00-NPC and the oblong washer had disbonded from the rudder steering bracket.

The aft side of the elongated hole in the rudder steering bracket was found sheared through the edge of the bracket, which resulted in detachment of the T-yoke axle. Refer to the photo of the rudder steering bracket included in this CAN.

Rudder Steering Bracket P/N D60-5710-20-00-NPC: The aft side of the oblong hole in the rudder steering bracket was found sheared through the edge of the bracket, which resulted in detachment of the T-yoke axle.

The CAA strongly recommends a detailed visual inspection of the rudder steering bracket P/N D60-5710-20-00-NPC for the following:

2. Determine whether the hole in the rudder steering bracket P/N D60-5710-20-00-NPC has sufficient edge margin.
Note: The distance from the edge of the bracket to the hole centre must not be less than 18mm. Report the edge margin distance to the CAA by completing a CA005D form. If the distance from the edge of the bracket to the hole centre is less than 18mm, then accomplish corrective action before further flight.

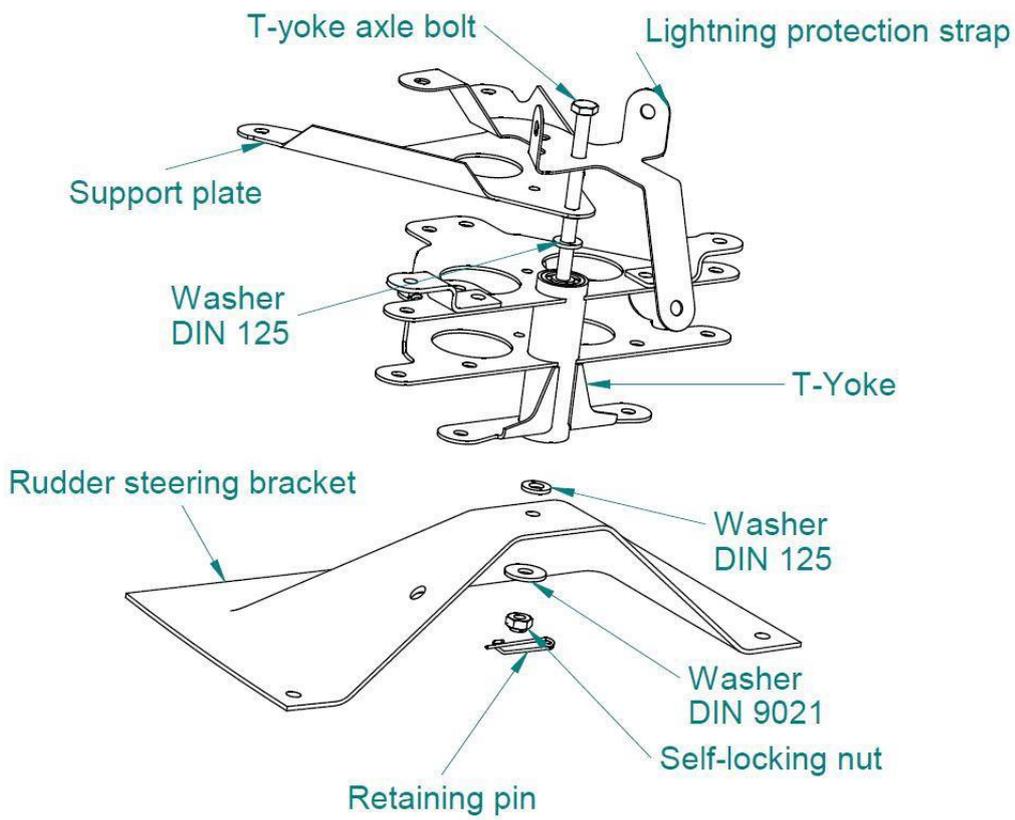
Rudder steering assembly: T-yoke and rudder steering bracket.
