# **CIVIL AVIATION AUTHORITY OF NEW ZEALAND**

## **AIRWORTHINESS DIRECTIVES**

**Amendment Nr 25-08**

**Effective date 28 August 2025**

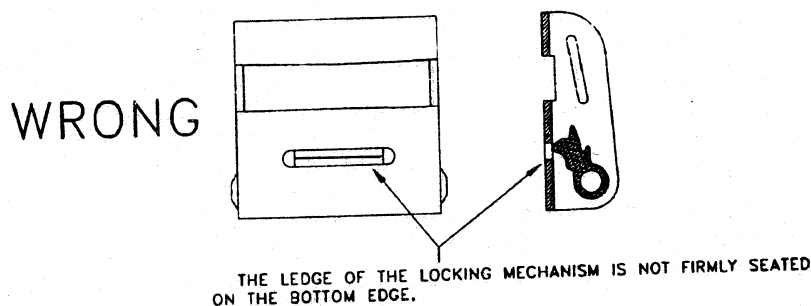
**Requirement:** To prevent failure of the seat restraint system due to the buckle assembly locking mechanism not engaging properly, which could result in the restraint system failing to properly secure the occupant during turbulence or landing, accomplish the following:

After the lever is completely closed, examine the slot in the bottom of the buckle. The locking mechanism should be firmly seated against the edge of the slot as shown in Figure 1.

If the locking mechanism does not seat properly, replace the buckle with an airworthy buckle.

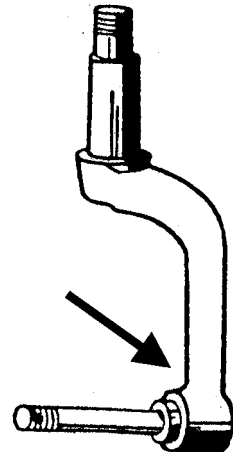
**Requirement:** To prevent fatigue failure of the tailwheel fork, remove the wheel from the axle and perform a dye-penetrant inspection of the fork for cracks. Particular attention is required in the area indicated. Replace any forks found cracked before further flight.
