# **CIVIL AVIATION AUTHORITY OF NEW ZEALAND**

## **AIRWORTHINESS DIRECTIVES**

**Amendment Nr 26-08**

**Effective date 3 September 2026**

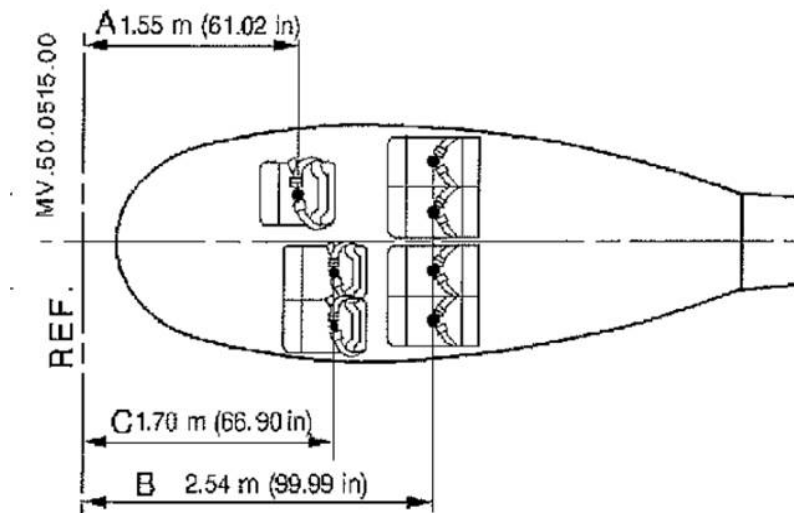
**Figure: Airbus Helicopters recommended CG position of forward two-place seat**

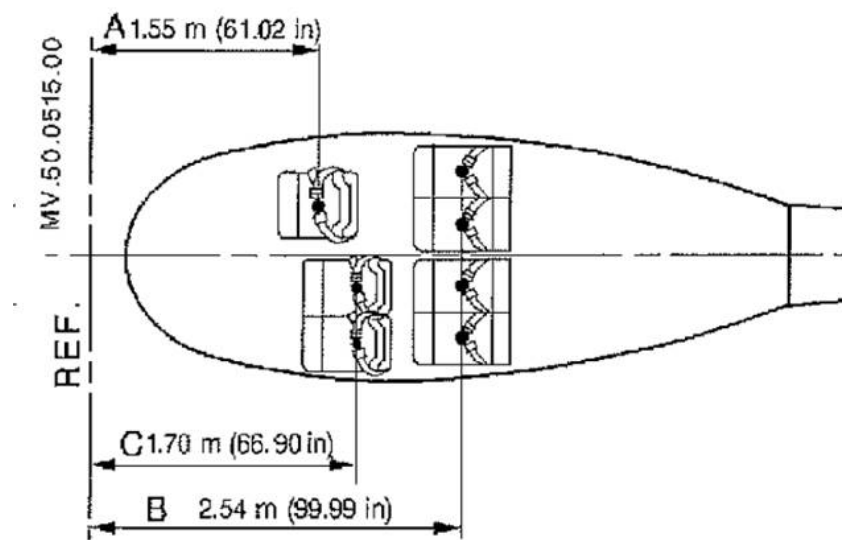
**Figure: Airbus Helicopters recommended CG position of forward two-place seat.**

Annotate the CAA2173 to include the value of the longitudinal moment arm of the forward two-place seat used.

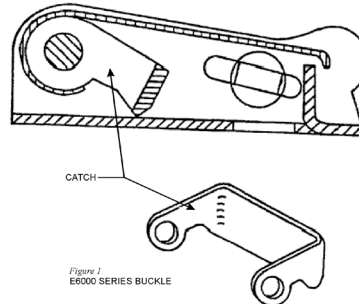
**Note:** Buckle assembly concerned has a front cover plate which is pivoted at one end and is pulled through an arc at the other end to release the latch from the buckle. The E6000 buckle can be identified by the type of catch used. Figure 1 (following) shows the catch configuration and its location within the buckle assembly.

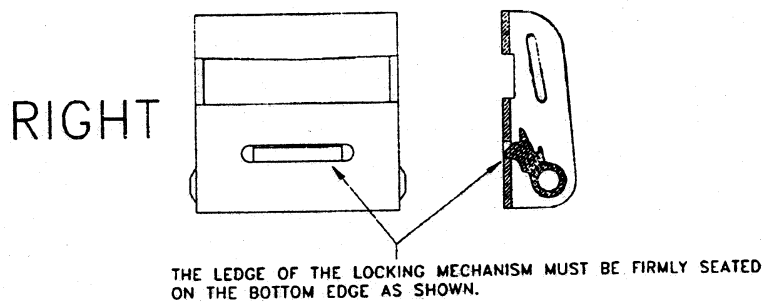
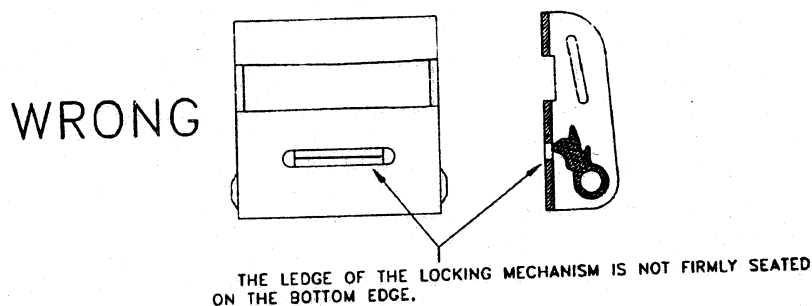
After the lever is completely closed, examine the slot in the bottom of the buckle. The locking mechanism should be firmly seated against the edge of the slot as shown in Figure 1.

If the locking mechanism does not seat properly, replace the buckle with an airworthy buckle.

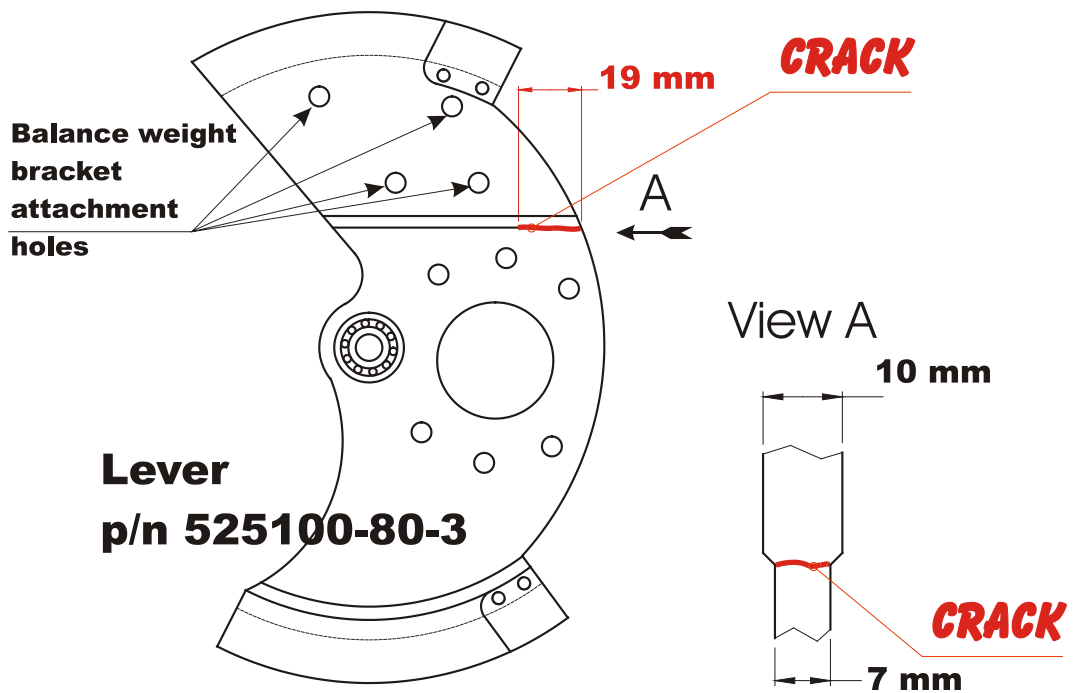
If the lever is found cracked, replace affected parts before further flight.

Inspect the primary stops of the lever for damage and wear. If any defects are found, or if the rubber pads are excessively worn, replace affected parts before further flight.
