# **CIVIL AVIATION AUTHORITY OF NEW ZEALAND**

## **AIRWORTHINESS DIRECTIVES**

**Amendment Nr 26-09**

**Effective date 24 September 2026**

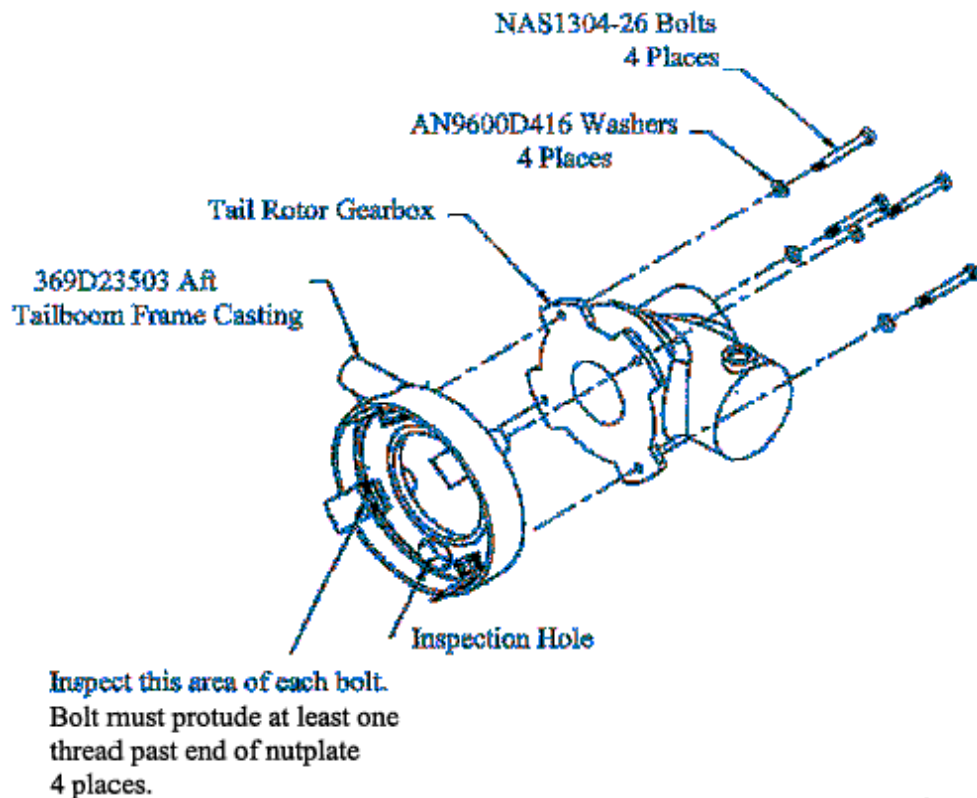
**Figure 1 - Inspection Location**

**Requirement:** To prevent loss of the tail rotor gearbox due to attaching bolts of inadequate grip length and subsequent loss of helicopter control, accomplish the following:

1. Determine the P/N of each tail rotor gearbox attaching bolt. If the P/N cannot be determined or if the bolt is not P/N NAS1304-26, replace with bolt, P/N NAS1304-26, before further flight. Torque the bolt to 100-110 in-lbs and apply a slippage mark.
2. Remove the tailboom control rod and determine the number of bolt threads protruding from each nutplate on the internal surface of the aft tailboom frame casting, P/N 369D23503, as shown in Figure 1 of this AD. At least one thread must protrude. If more than four threads protrude, add an additional washer, P/N AN960D416, under the bolt head. Torque the bolt to 100-110 in-lbs, and reapply a slippage mark.

3. Between 2 and 10 hours TIS after accomplishing the requirements of paragraph 2 of this AD, inspect the torque on each bolt by applying 100 in-lbs. If any bolt movement occurs, retorque the bolt to 100 -110 in-lbs. Reapply a slippage mark after torque check and reinspect the torque between 2 and 10 hours TIS thereafter until no bolt movement occurs.
