# **CIVIL AVIATION AUTHORITY OF NEW ZEALAND**

## **AIRWORTHINESS DIRECTIVES**

**Amendment Nr 25-11**

**Effective date 27 November 2025**

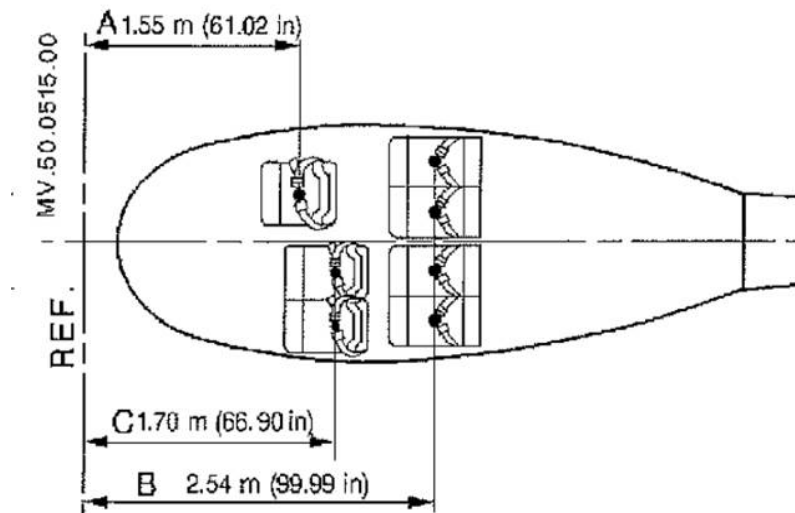
1. Determine the longitudinal moment arm of the forward two-place seat using the center of the seat pan cushion as a measurement reference point.  
Complete and issue a new form CAA 2173 Weight and Balance Data.  
The weight of the seat components must be included in the CG calculations. If a seat adaptor plate is fitted the moment (position and weight) of the plate must also be considered for the CG calculation.  
The lateral CG arm of the helicopter must not be assumed to be zero. The lateral CG must be recorded and be within the limits specified in the AFM.  
Annotate the CAA2173 to include the value of the longitudinal moment arm of the forward two-place seat used.
2. Remove CAA Limitations Section, (1 page), dated 14 December 2015 and insert 1 page dated 30 June 2016.

**Figure: Airbus Helicopters recommended CG position of forward two-place seat**
