CIVIL AVIATION AUTHORITY OF NEW ZEALAND

AIRWORTHINESS DIRECTIVES

Amendment Nr 25-07

Effective date 31 July 2025

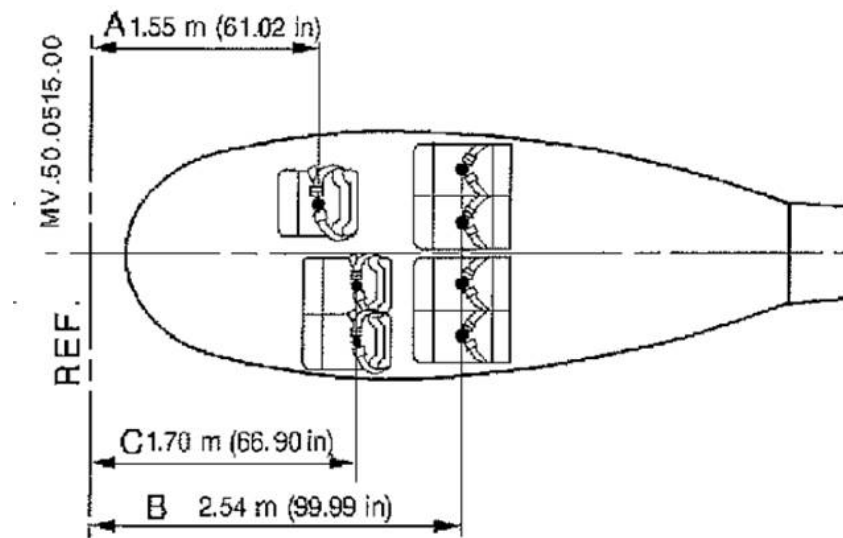
Figure: Airbus Helicopters recommended CG position of forward two-place seat.

Annotate the CAA2173 to include the value of the longitudinal moment arm of the forward two-place seat used.

2. Remove CAA Limitations Section, (1 page), dated 14 December 2015 and insert 1 page dated 30 June 2016.
