CIVIL AVIATION AUTHORITY OF NEW ZEALAND

AIRWORTHINESS DIRECTIVES

Amendment Nr 25-06

Effective date 19 June 2025

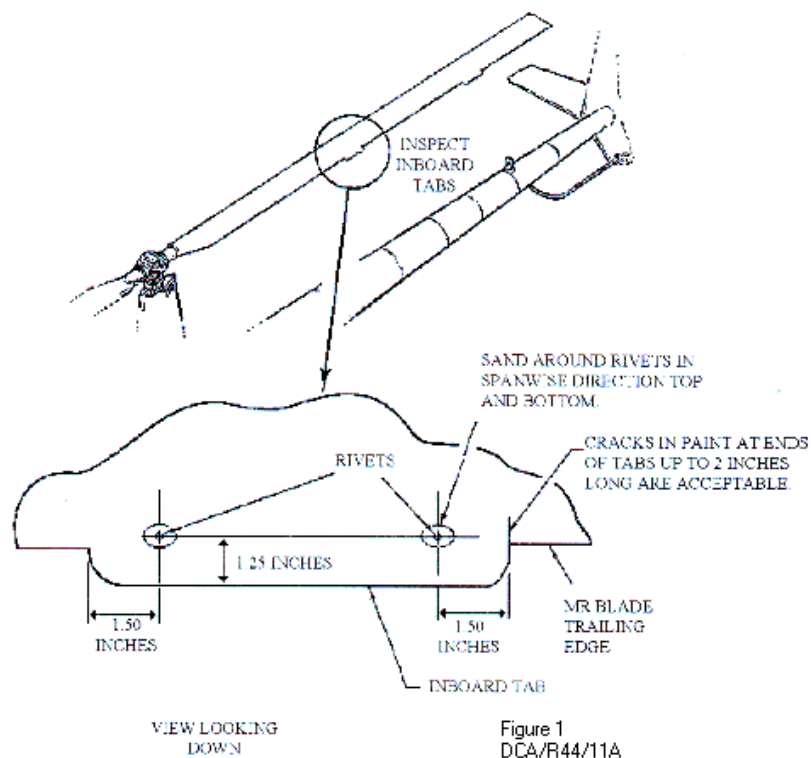
2. Using a 5-power or higher magnifying glass, visually inspect both upper and lower main rotor blade skin surfaces around the inboard trim tab rivets (4 locations) for cracks. If a crack is found, replace the main rotor blade with an airworthy main rotor blade before further flight.

3. Install a set of main rotor blades, P/N C016-2. This constitutes terminating action for the inspections required by this AD.

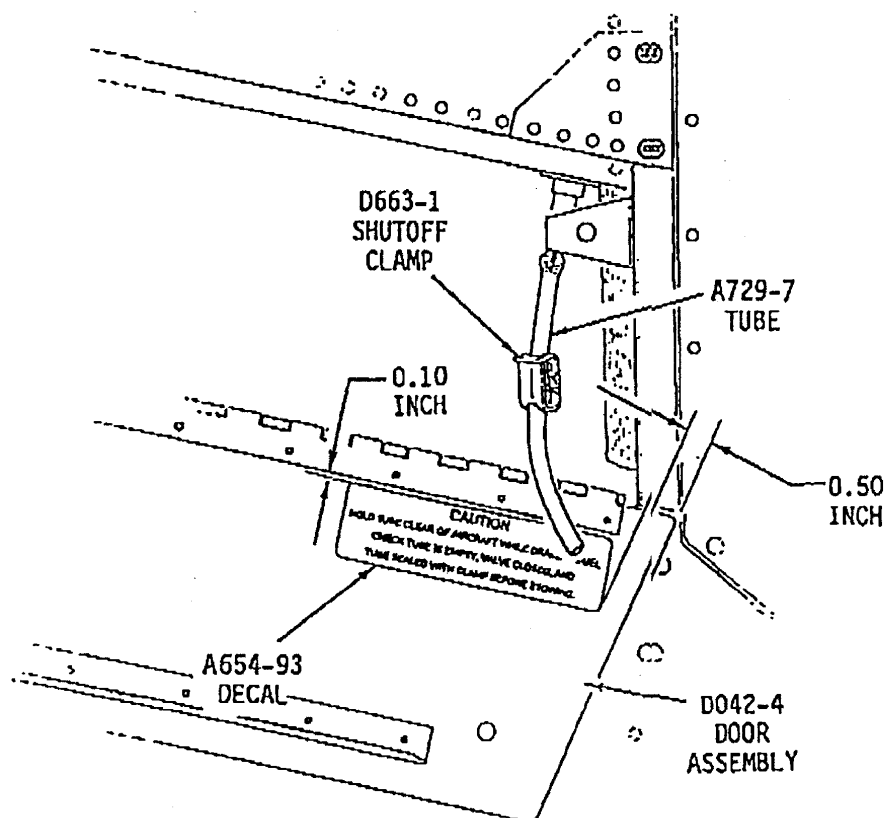
FIGURE 1
AD 99-13-11

Requirement: To prevent fuel leaks from the auxiliary fuel tank sump drain, which could cause a fire and subsequent loss of the helicopter, accomplish the following:-

Install placard decal, P/N A654-93, as shown.
