MODEL NO: 150 (and others)

REPORT NO: S-150-ATA25/01RD

REPAIR DEFINITION

STEEL SEAT FOOT / ROLLER HOUSING REPAIR

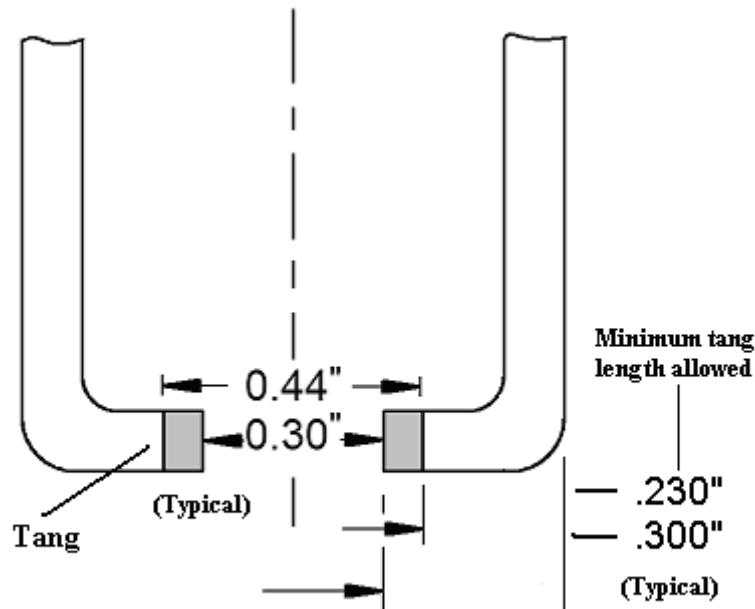
### FIGURE 2.0-1 ROLLER HOUSING TANG GEOMETRY REQUIREMENTS PER AD 2011-10-09

(6) Due to wear or deformation of the tangs, inspect the tang length from the inner edge of the tang to the outer edge (the bend area) of the roller housing (see figure 4).

(i) The minimum measurement allowed for the remaining tang length is 0.230 inches remaining on either of the tangs, from the inner edge of the tang to the outer edge (the bend area) of the roller housing. If the measurement is less than 0.230 inches on either of the tangs, before further flight, replace the roller housing.

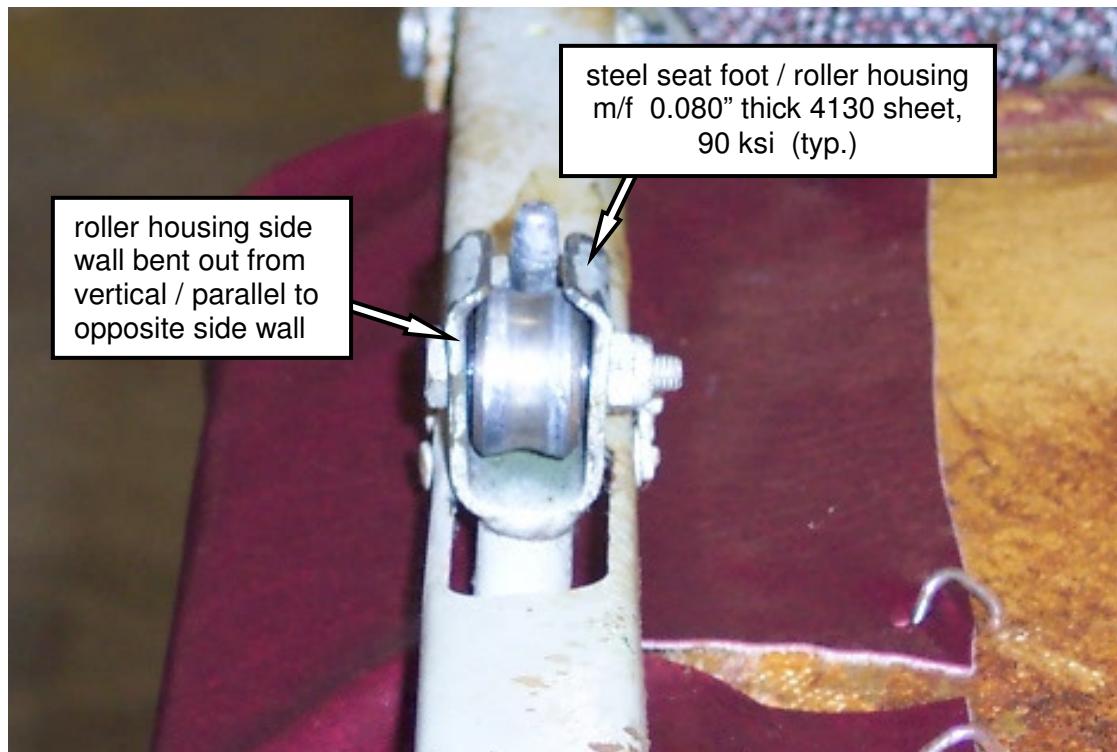
In the case of seats which use steel roller housings (e.g. as defined by Cessna drawings 0311310 "Roller, Pilot Seat", and 0514016 "Housing Assy – Seat Roller"), the tangs may not meet the dimensional requirements set forth in the AD due to primarily to deformation or bending of the seat feet, rather than being caused by actual wear / loss of material. Ref. Figures 2.0-2 and 2.0-3 for examples of this type of deformation / bending of roller housing geometry.

FIGURE 2.0-2 DETAIL OF BENDING / DEFORMATION OF SEAT ROLLER  
HOUSING SIDE WALL

Read the entire service document prior to beginning the repair; contact Cessna Customer Service if the repair cannot be performed as described below. Steel seat roller housings may be gently formed (or "bent") back to a configuration conforming to specifications as shown in Figure 3.2-1 below and AD 2011-10-09, followed by an NDI inspection (as identified in paragraph 3.2.4) for any cracking. Note that this is a cold forming operation. No heating is to be done for this operation.

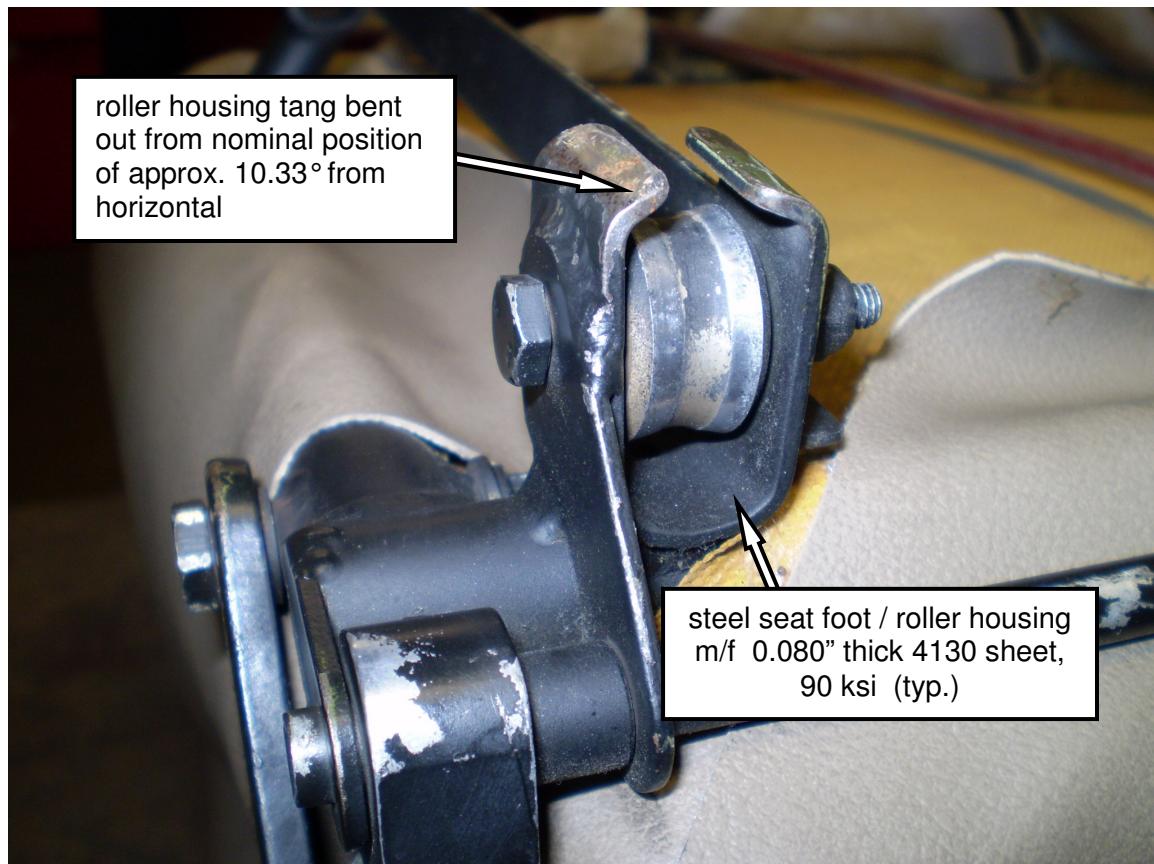
FIGURE 2.0-3 DETAIL OF DEFORMED / BENT SEAT ROLLER HOUSING TANGS
