Airworthiness Directive Schedule

Aeroplanes

Embraer EMB-820C, S/N 820127

25 March 2010

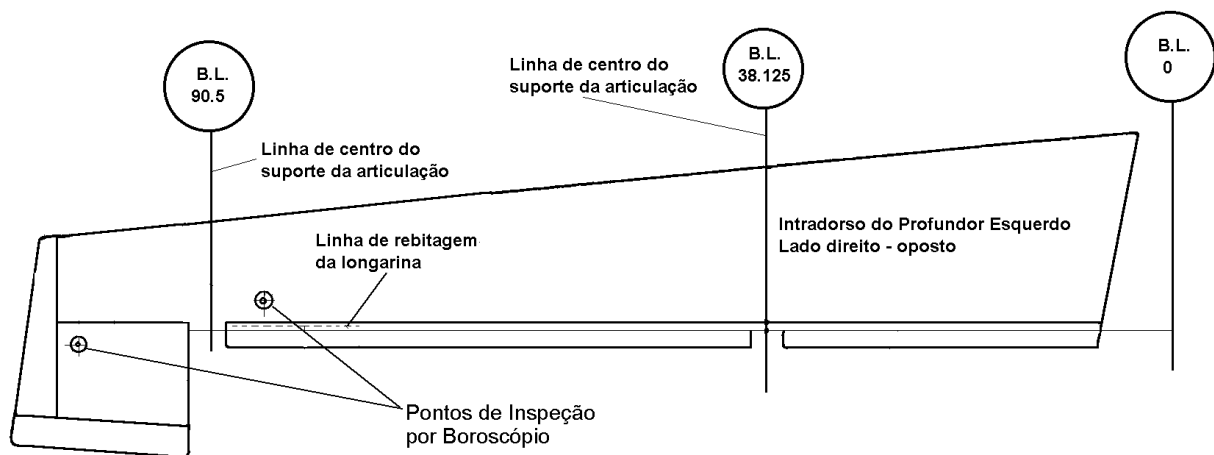
Figure 1: Borecope Probe Access Points

Requirement: To prevent failure of the elevator spar due to possible insufficient rivet edge margins, accomplish the following:

With the aid of a boroscope inspect the elevator spar for defects and rivet spacing through the access points per figure 1.

If any cracks or defects are found contact the aircraft manufacturer for further advice and accomplish a manufacturer approved repair, or replace the elevators before further flight.

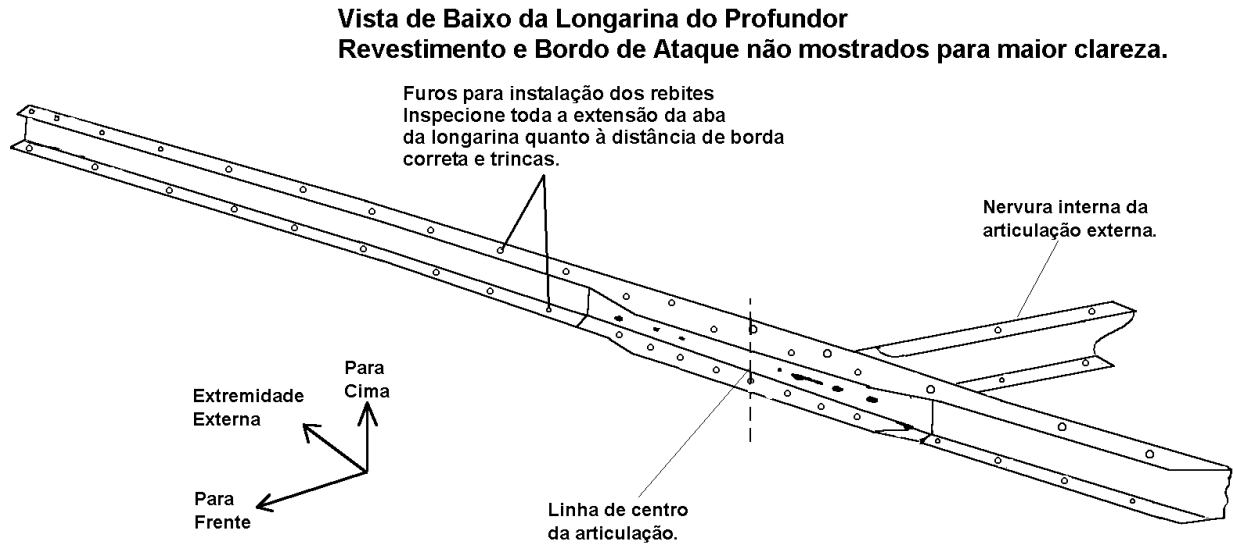
Figure 2: Inspection Area

Inspect the elevator spar per figure 2 for any defects and determine that the rivet edge margins are within the limits specified by the aircraft manufacturer.

If no defects are found and the rivet edge distances are found to be within the limits specified by the aircraft manufacturer, no further AD action is required.

If the rivet edge margins are not within the limits specified by the aircraft manufacturer, inspect thereafter per the requirements of this AD at intervals not to exceed 100 hours TIS.

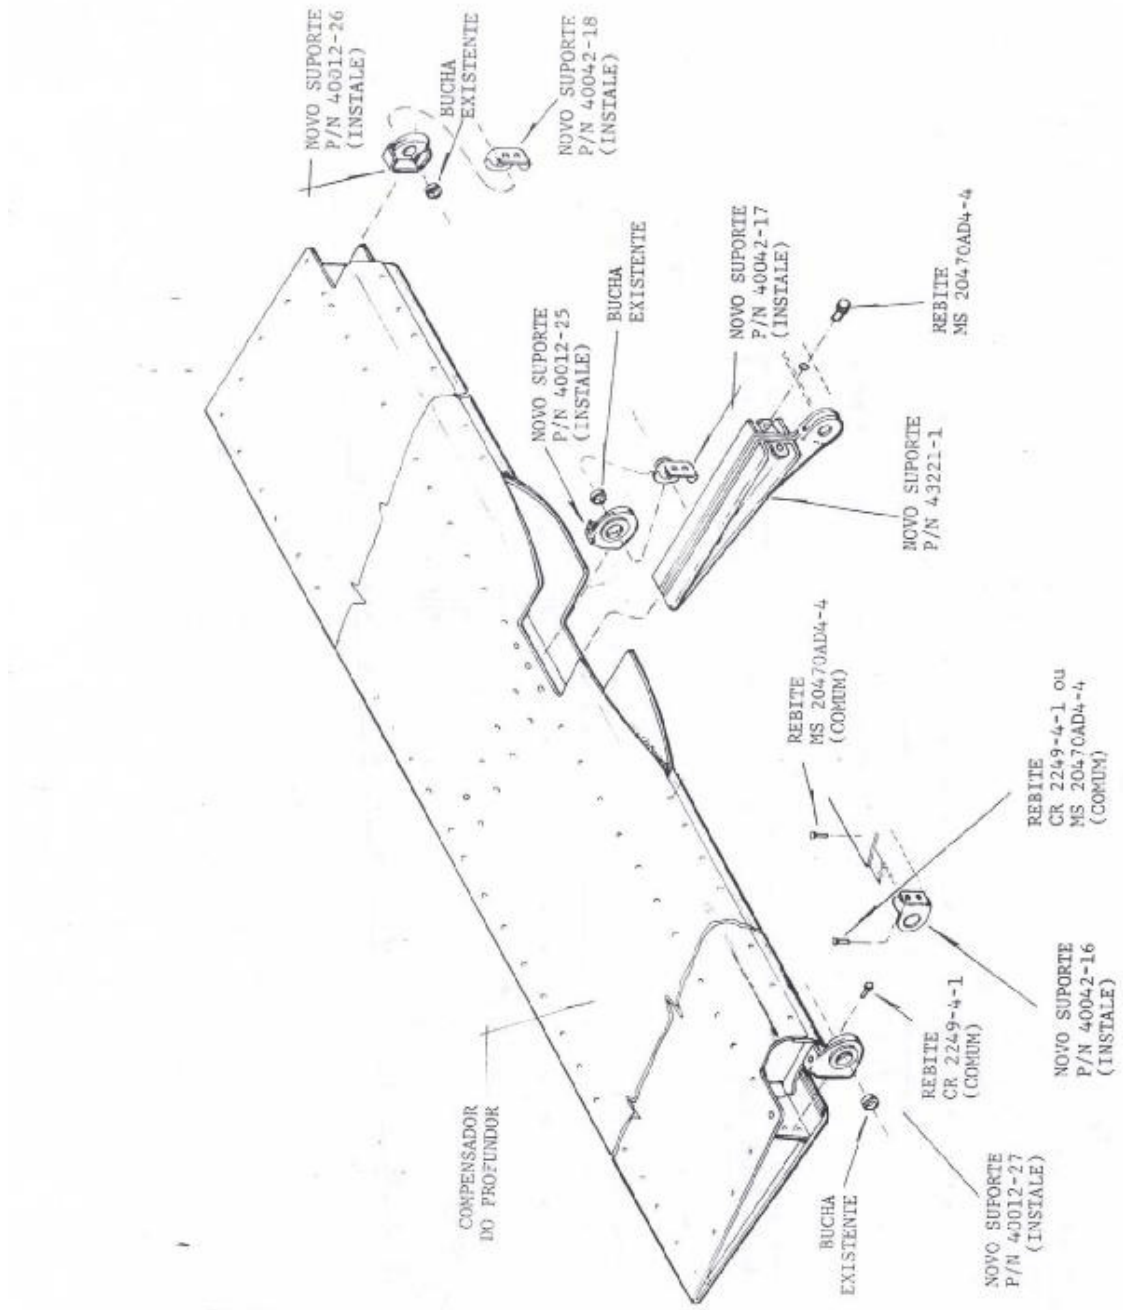
Figure 1: Aileron Balance Cable End Fitting and Bellcrank Inspection.

Requirement: To prevent failure of the elevator trim tab brackets, accomplish the following:
 Remove the elevator trim tab per the instructions in the aircraft maintenance manual and take care not to lose the trim tab pivot bushes. Remove the existing brackets P/N 40042-08, 40042-09 and 40042-10 and discard them. Install new steel brackets P/N 40042-16, 40042-17 and 40042-18 using the existing screws. Refer to figure 1 for the positions of the hinge brackets of the elevator trim tab.

Remove supports P/N 40012-12, 40012-13 and 40012-22 and install new steel supports P/N 40012-25, 40012-26 and 40012-27 on the elevator trim tab.

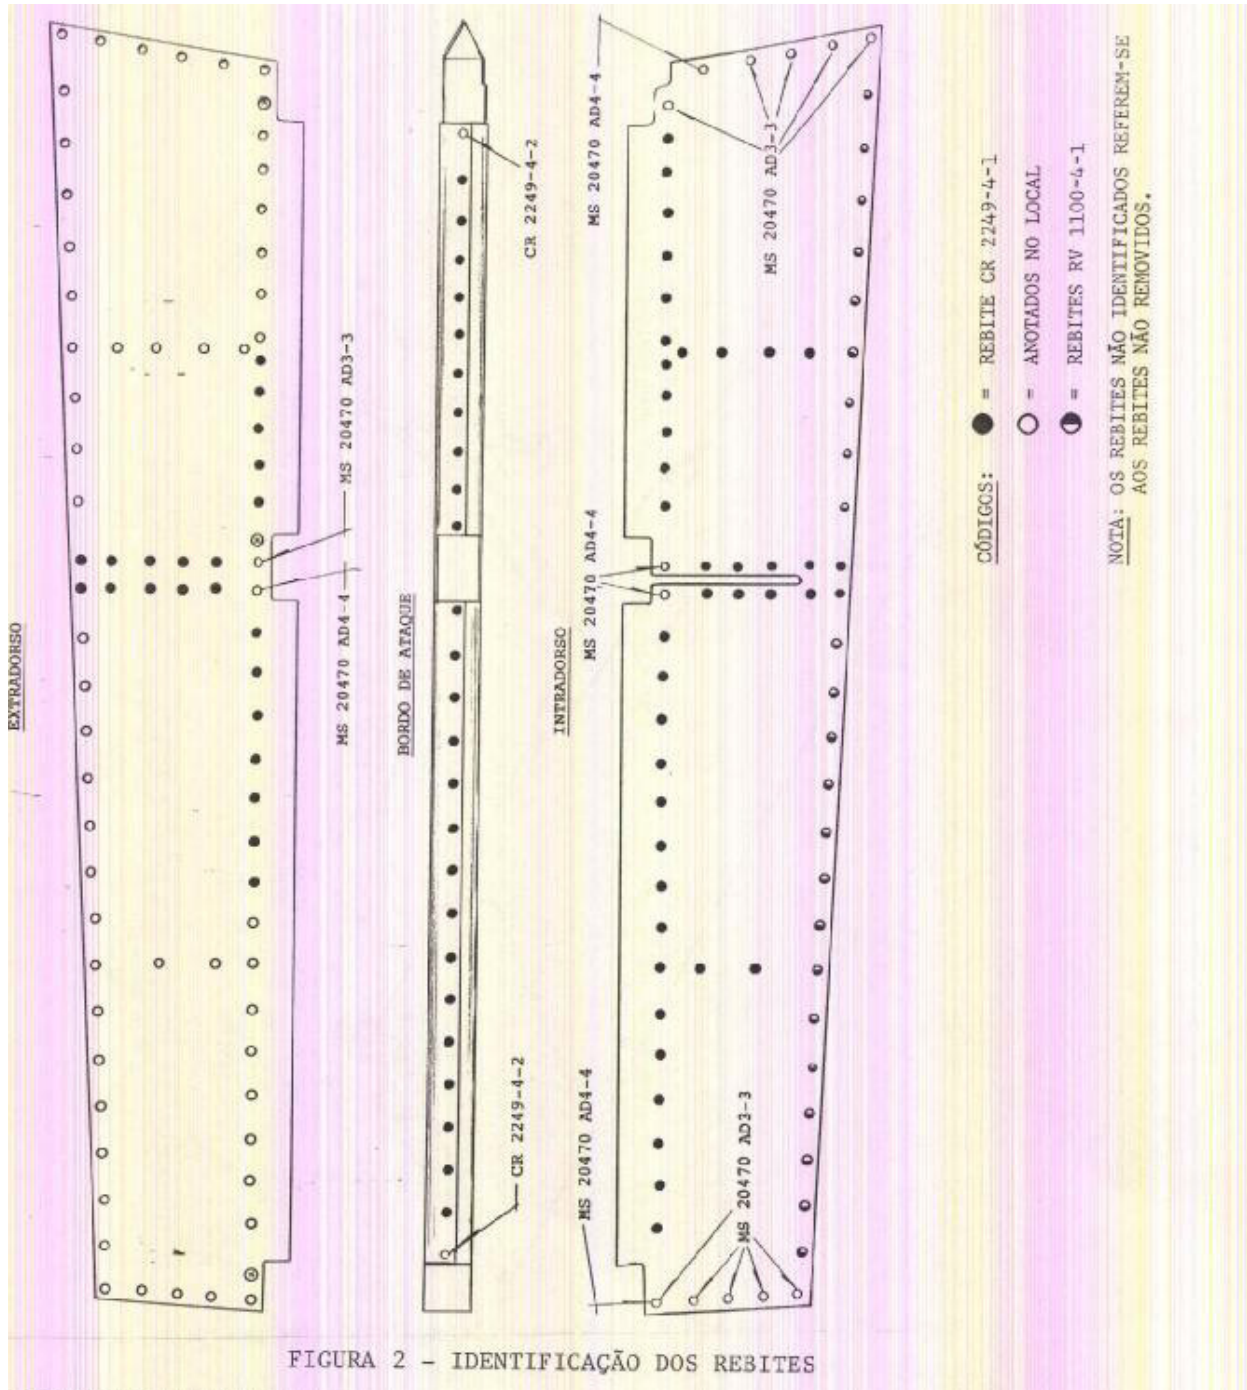
Figure 2: Position of the rivets.

Remove trim control rod bracket P/N 43221 and replace with bracket P/N 43221-1. Touch up any exposed metal parts with paint as required. Accomplish these corrective actions per manufacturer approved procedures. Refer to figure 2 for the position of the rivets which hold the new elevator trim brackets and trim control rod bracket P/N 43221-1 in position.

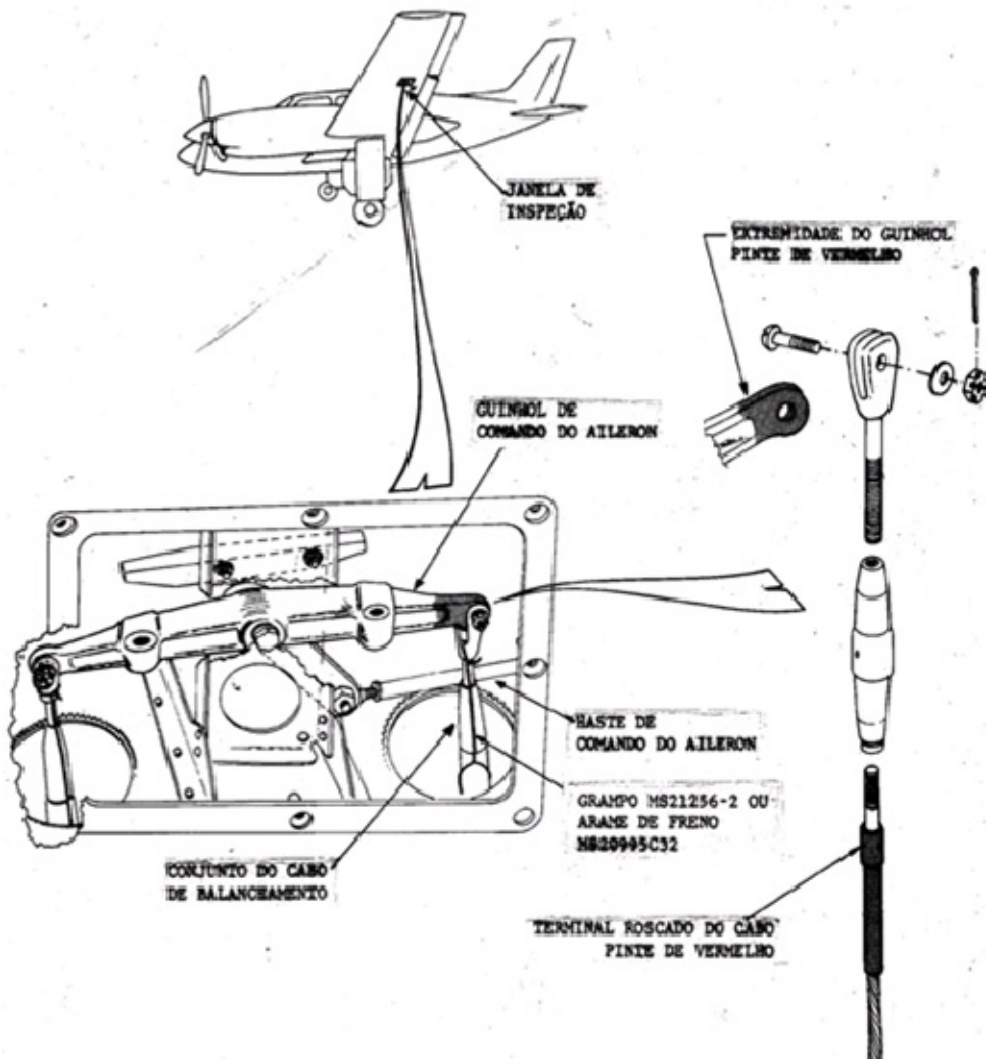
Figure 1: Aileron Balance Cable End Fitting and Bellcrank Inspection.

Requirement: To prevent failure of the aileron control system bellcrank and/or balance cable, accomplish the following:

Clean the aileron balance cable end fitting and the attach end of the bellcrank in both wings of the aircraft and determine if both are marked with red paint per figure 1 of this AD. No further action is required if both fittings are marked with red paint in both wings.

If no red paint markings are found on the aileron balance cable end fitting or the bellcrank end, move the aileron control system through the full travel and inspect for any defects. Determine whether the bellcranks are fitted in the correct orientation and determine that the aileron balance cable end fittings are fitted to the bellcrank in the correct orientation. Replace any defective parts as required before further flight. Ensure the aileron bellcranks and the aileron balance cable end fittings are marked with red paint and fitted correctly per the manufacturer instructions.
