# Airworthiness Directive Schedule

### Piper PA-31 Series (Navajo, Chieftain, Mojave, Cheyenne and T1040)

27 February 2020

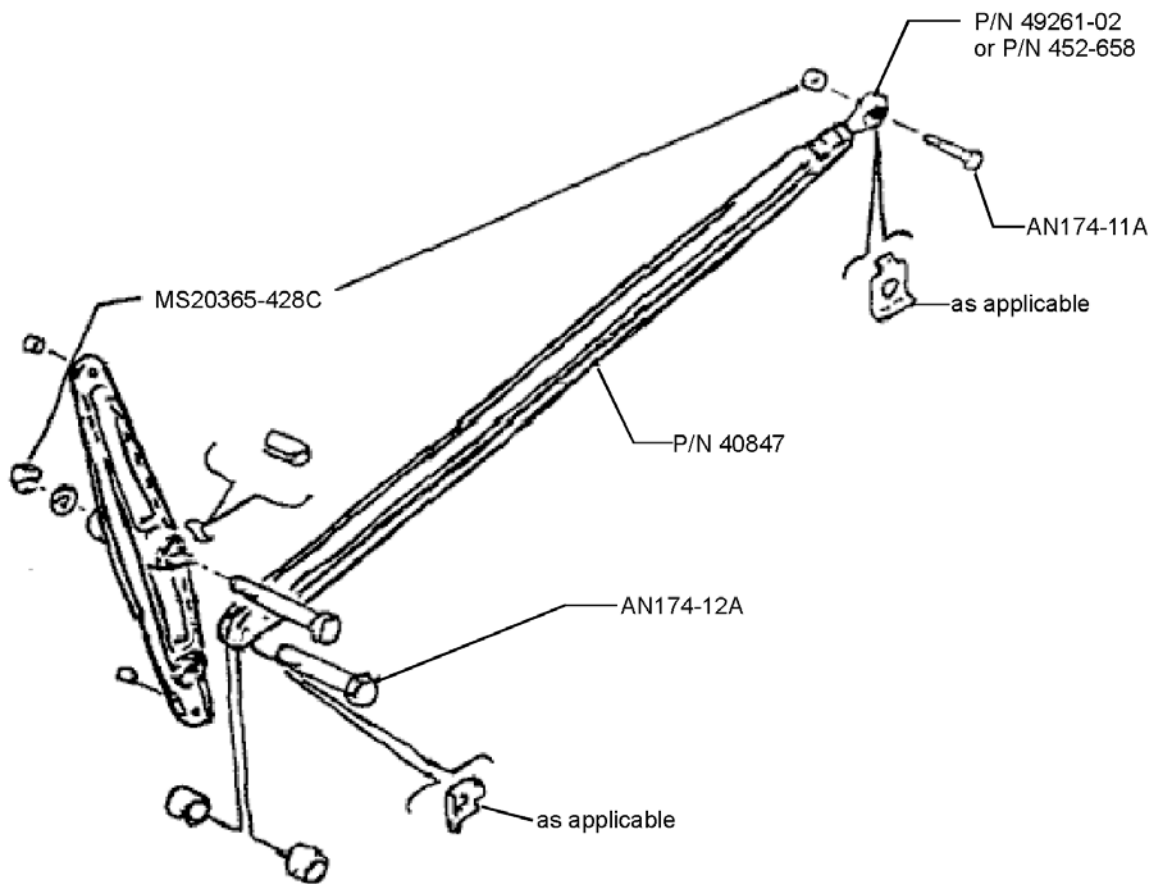
Ensure that the elevator control tube assembly area is not damaged by accomplishing the following inspections and procedures:

3. Secure the aft end of the bungee link to the elevator horn with safety wire for removal and installation of the bungee attach bolt.
4. Inspect, using FAA-approved magnetic procedures, the rod end shank and threads for cracks. If found cracked, prior to further flight, replace the rod end with part number (P/N) 49261-02 or P/N 452-658.

5. Visually inspect the bearing in the rod end for wear and free movement. IF wear is found or the bearing will not move, prior to further flight, replace the rod end with P/N 49261-02 or P/N 452-658.

6. Inspect, using a 10X magnifying glass, the forward attach holes in the pushrod for cracks, corrosion, or elongation. If cracks, corrosion, or elongation is found, prior to further flight, replace the pushrod with P/N 40847-00, 40847-04, or 40847-07, as applicable.

7. Visually inspect the forward and aft attach area to ensure that both a forward bolt, P/N 402 311 (AN 174-12A), and an aft bolt, P/N 402 317 (AN 174-11A), are installed. If either one of these bolts is not installed, prior to further flight, install the applicable bolt or replace the existing bolt with one of the applicable part number.

*Note 1: Figure 1 of this AD illustrates the elevator assembly and the specific areas that are to be inspected.*

8. Remove the safety wire, reinstall the pushrod, check to ensure that the elevator rigging is correct, and reinstall the bottom half of the tailcone and the fuselage side panels.
