# Airworthiness Directive Schedule

### Yakovlev/Aerostar 3, 18, 50, 52 and 55 Series

3 September 2026

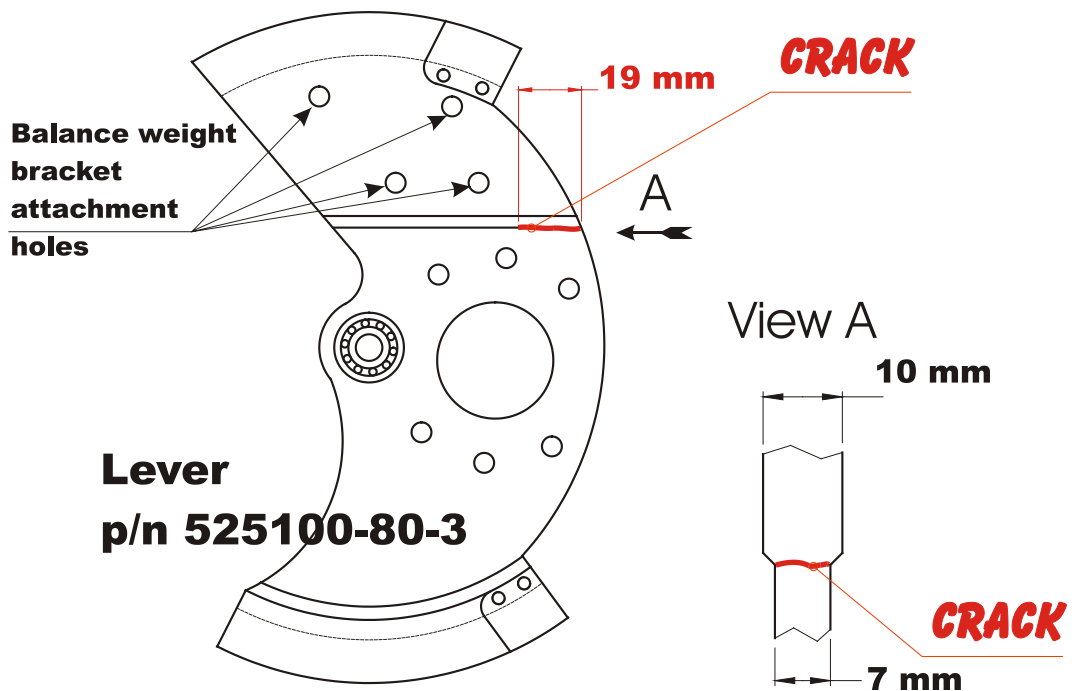
**Note:** This AD is prompted by a report of finding a 19 mm crack in the elevator control pulley P/N 525100-80-3 (referred to in the Romanian parts catalogue as a “lever”). The failure of this component could result in loss of elevator control.

Inspect lever P/N 525100-80-3 for cracks using a dye penetrant method. Inspect in the area below the attachment of the balance weight bracket at the point where the section reduces from 10 mm to 7 mm.

If the lever is found cracked, replace affected parts before further flight.

Inspect the primary stops of the lever for damage and wear. If any defects are found, or if the rubber pads are excessively worn, replace affected parts before further flight.
