# Airworthiness Directive Schedule

### Beechcraft 33, 35 and 36 Series (Bonanza and Debonair)

19 December 2019

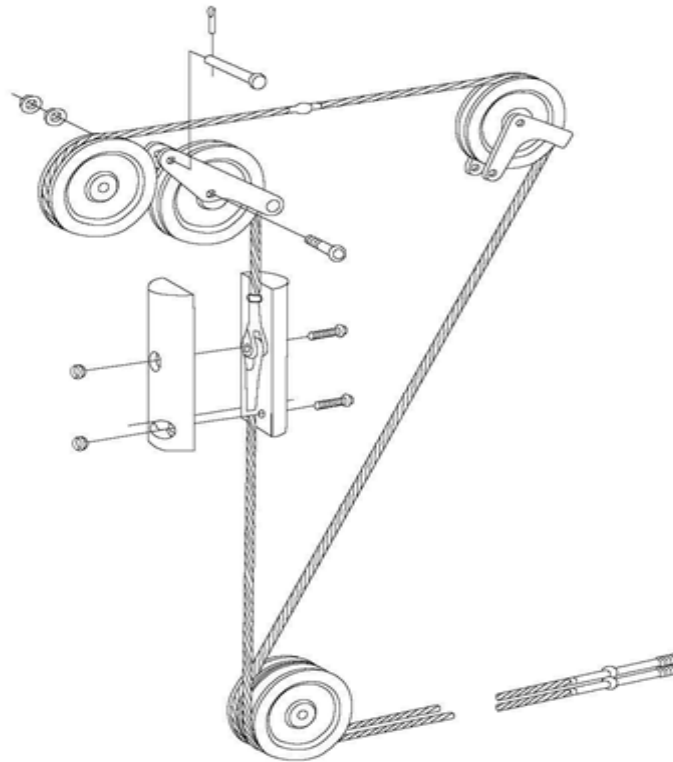
Figure 1 - Forward Elevator Control Cable - Adapted from the Beechcraft IPC.

Inspect the forward elevator control cable assembly for wear, broken wires and corrosion. If any defects are found, replace the forward elevator control cable assembly before further flight.

1. Replace the forward elevator cable assembly, or
