# Airworthiness Directive Schedule

## Aeroplanes

### Hawker Beechcraft 58 and 95 Series (Baron)

29 August 2013

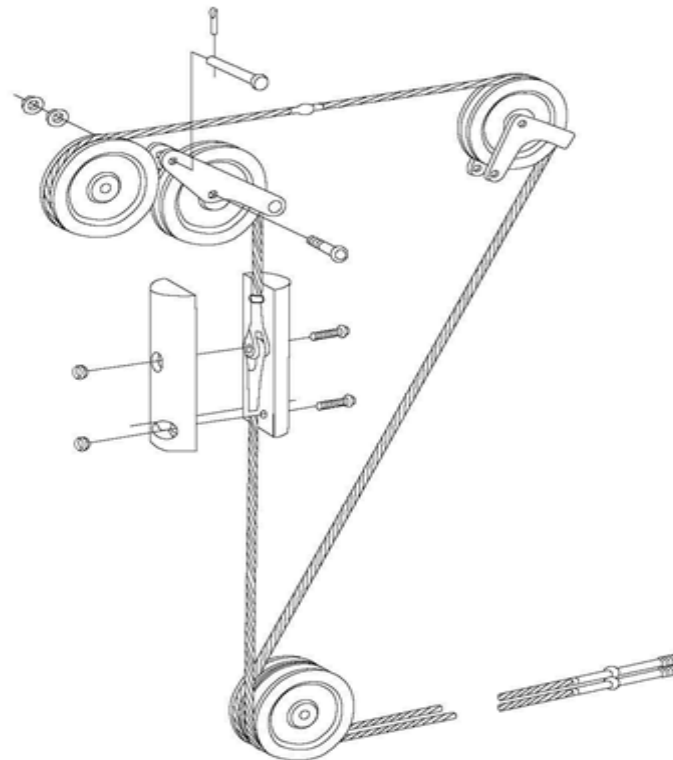
Figure 1 - Forward Elevator Control Cable - Adapted from the Beechcraft IPC.

Inspect the forward elevator control cable assembly for wear, broken wires and corrosion. If any defects are found, replace the forward elevator control cable assembly before further flight.

1. Replace the forward elevator cable assembly, or
