Airworthiness Directive Schedule

Cessna 210 Series

29 October 2020

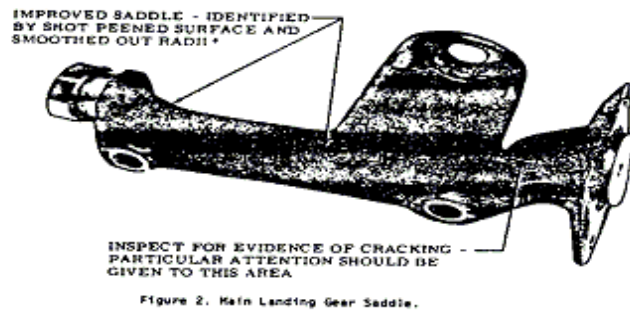
Inspect P/N 1241423-1 and 1241423-2 main landing gear saddles for cracks using dye penetrant method in accordance with either procedure 1 or 2 as specified in note 4 and 5 of this AD. Pay particular attention to the critical areas shown in Figure 2 of this AD.

If any cracks are found, replace saddles before further flight.
