Airworthiness Directive Schedule

Aeroplanes

Piper PA-34 Series (Seneca I, II, III, IV and V)

30 May 2024

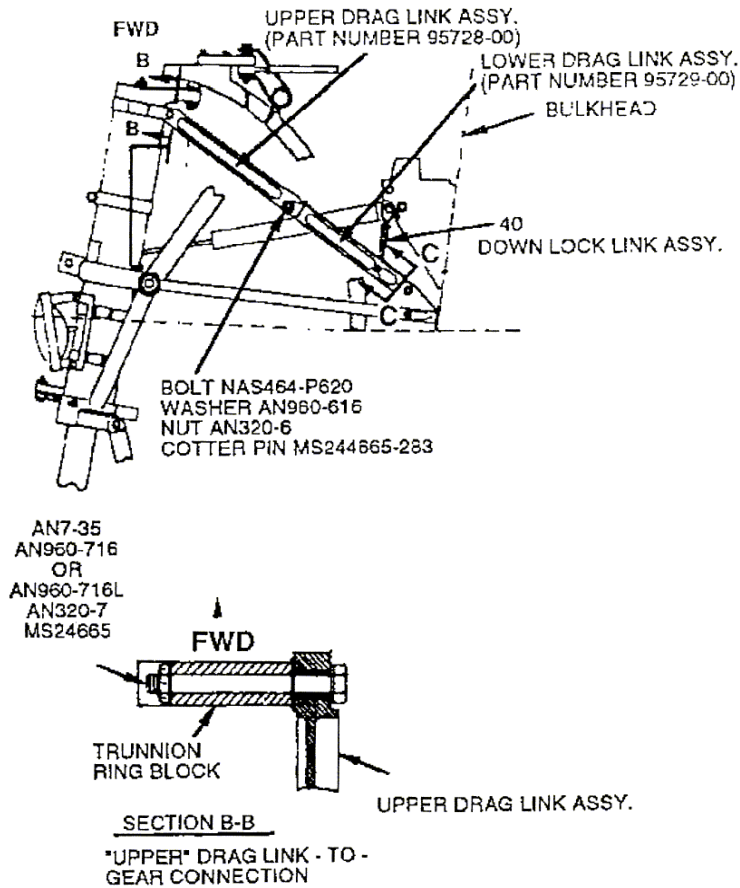
Requirement: To prevent prevent failure of components of the NLG which could result in the NLG collapsing, accomplish the following:

1. Replace the bolt and stack up that connects the upper drag link to the nose gear trunnion with new Piper parts (or approved equivalent parts) per the figure in this AD:

If any defects are found accomplish all the required corrective actions in table 1 of SB No. 1123B before further flight.
