# Continuing Airworthiness Notice – 62-001

## MDHI Torque Event Inspections

14 December 2005

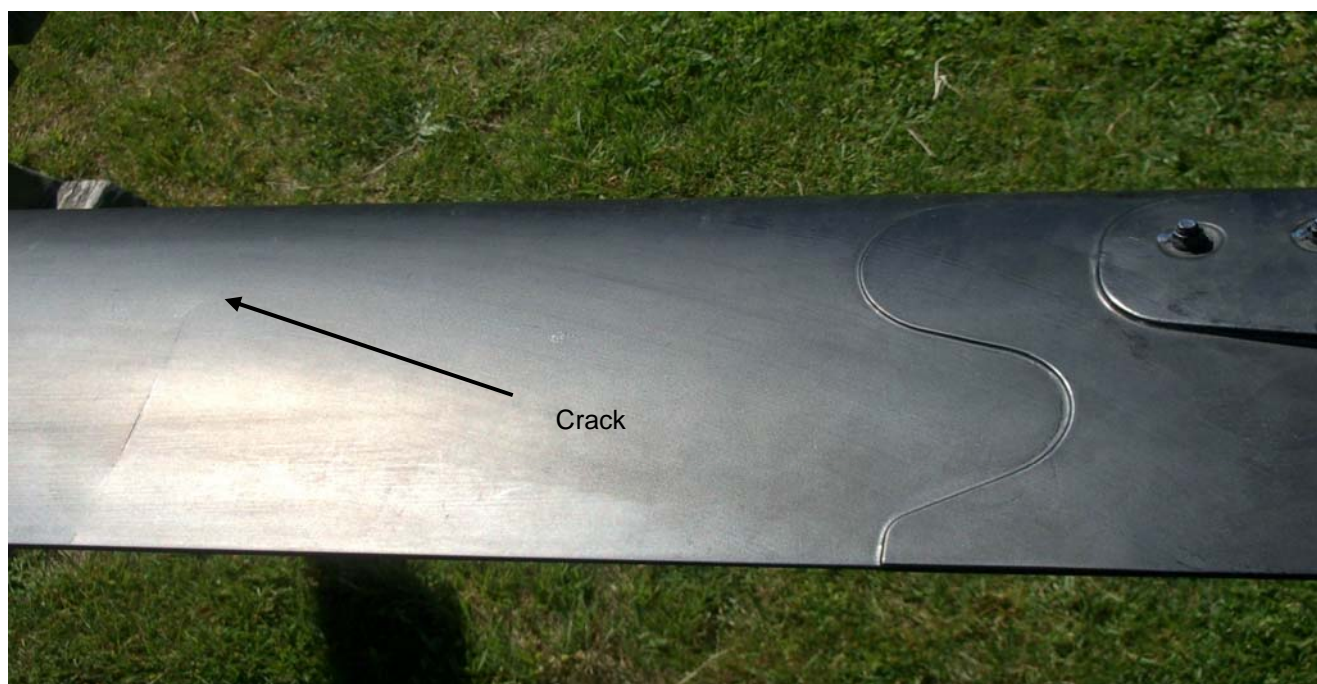
Recently, the CAA received a defect notification from a pilot that had identified a large crack during a TE inspection on a Hughes 369E helicopter main rotor blade (see below).

Underside of 369E Main Rotor Blade P/N 500P2100-101, S/N C670, TTIS 1398 hrs, 9,800 TEs

It is recommended that pilots required to perform TE inspections familiarise themselves with this notice and the applicable technical data, to ensure that they are appropriately qualified and knowledgeable to perform the inspections thoroughly and diligently.

If there is any doubt as to the requirements of the inspection or if the inspection indicates a potential crack, then an appropriately rated LAME should be consulted.
