Airworthiness Directive Schedule

Components & Equipment

Aircraft Seats and Harnesses

25 September 2025

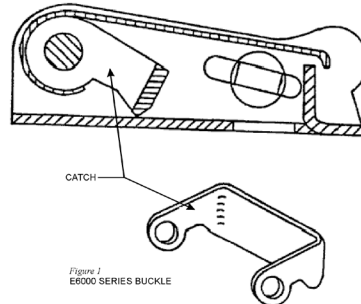
Applicability: All Eon Corporation TSO C22 safety belt assemblies incorporating E6000 buckles.

Requirement: To prevent inadvertent opening of safety belt assemblies accomplish the following:

Note: Buckle assembly concerned has a front cover plate which is pivoted at one end and is pulled through an arc at the other end to release the latch from the buckle. The E6000 buckle can be identified by the type of catch used. Figure 1 (following) shows the catch configuration and its location within the buckle assembly.

1. Inspect all Eon Corporation TSO C22 safety belt assemblies for incorporation of E6000 buckles.
2. Remove from service all safety belt assemblies with E6000 buckles and replace with approved safety belt assemblies. Removed belts, if not destroyed, must have the TSO approval markings either permanently obliterated or removed.

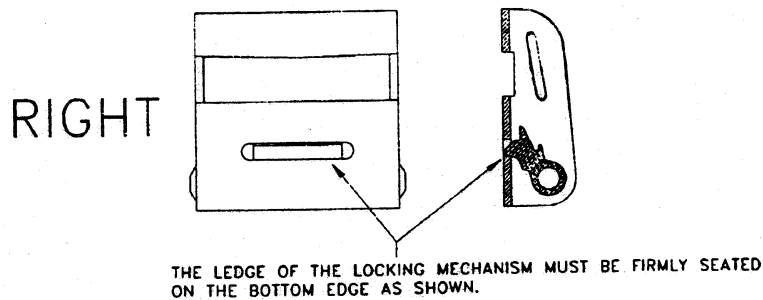
Requirement: To prevent failure of the seat restraint system due to the buckle assembly locking mechanism not engaging properly, which could result in the restraint system failing to properly secure the occupant during turbulence or landing, accomplish the following:

After the lever is completely closed, examine the slot in the bottom of the buckle. The locking mechanism should be firmly seated against the edge of the slot as shown in Figure 1.

If the locking mechanism does not seat properly, replace the buckle with an airworthy buckle.
