Airworthiness Directive Schedule

Components & Equipment

Carburettors and Injection Systems

26 November 2015

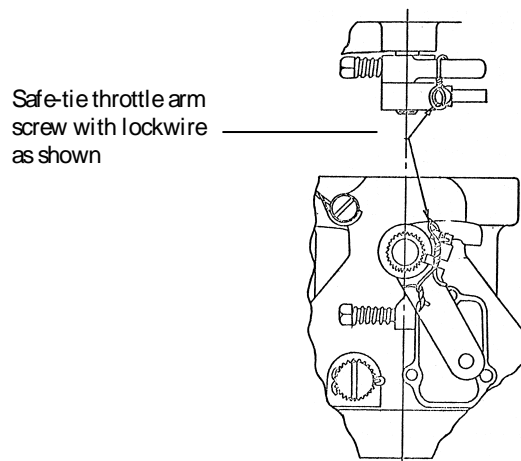
Requirement: To prevent throttle arm becoming loose and separating from the throttle shaft accomplish the following:-

View of Carburetor Throttle Arm Showing Method of Tying Lockwire

1. Check for correct torque the clamp screw, or alternative bolt and self-locking nut securing the throttle arm to the throttle shaft. The correct torque values are 15 to 20 inch pounds for the number 10-24 screw on MA-3 series carburetors, 20 to 25 inch pounds for the number 10-24 screw on MA-4 series carburetors and 35 to 40 inch pounds for the number 10-32 bolt and nut.
2. Check that there is clearance between the clamp faces when the torque value is correct.
3. Lock screws with 0.032 inch lockwire as shown in the drawing below.
