# Continuing Airworthiness Notice 27-023

## Schweizer/Hughes 269C Helicopters – Main Rotor Longitudinal Pitch Mixer Bellcrank

22 June 2023

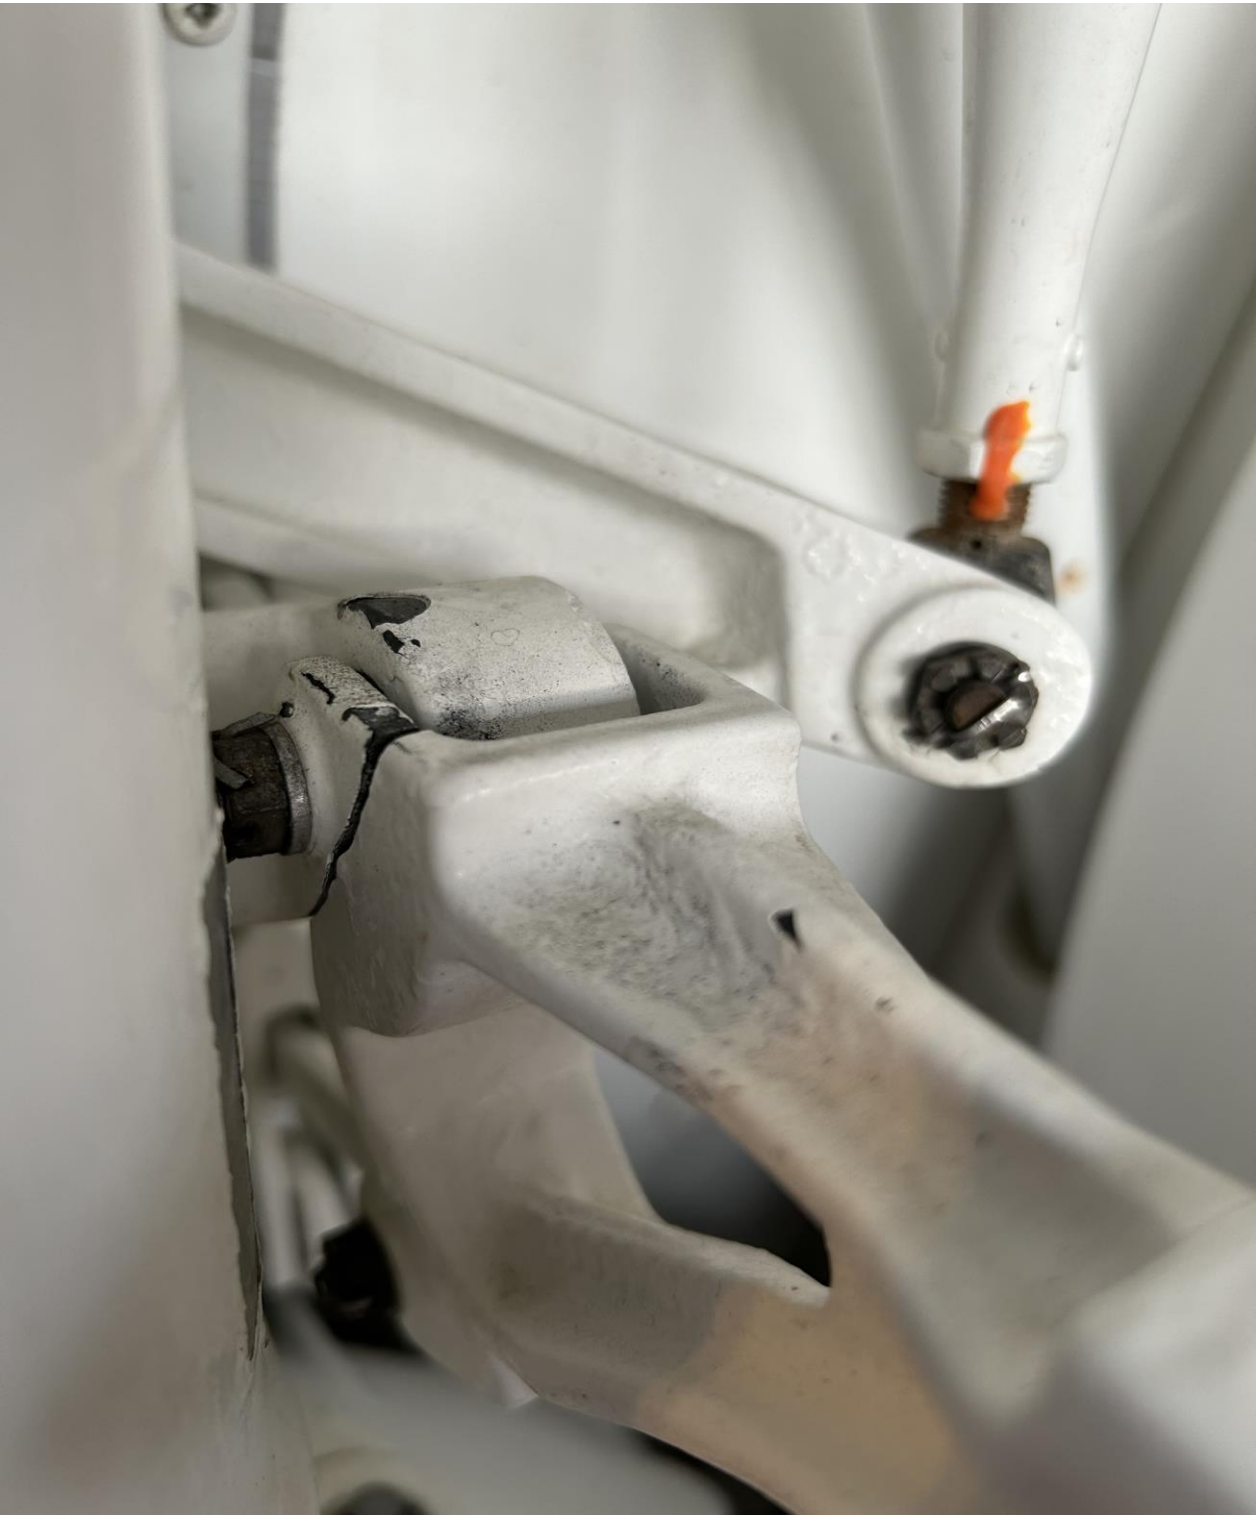
The CAA has received a report of an operator finding a cracked main rotor longitudinal pitch mixer bellcrank P/N 269A7519 on a Hughes 269C helicopter (For the location of the affected P/N refer to: IPC 4-16-18 and Figure 1 below in this CAN).

During a daily pre-flight inspection of the aircraft the pilot noticed a crack in the longitudinal pitch mixer bellcrank.

A subsequent inspection by an engineer could not identify any indication of damage, or corrosion which may have initiated the crack.

The affected aircraft had 18436 hours TTIS. However, it is not clear if the defective bellcrank had been installed since new.

Figure 1 - Cracked longitudinal pitch mixer bellcrank.

Operators are advised to pay particular attention to the flight control linkages when carrying out pre-flight inspections as required by the Pilot's Flight Manual.

Maintenance providers should thoroughly investigate any defects found during the scheduled inspection of helicopter flight control system/linkages.
