# Continuing Airworthiness Notice – 27-029 Revision 1

## MD 369D and 369E helicopters - Four Bladed Tail Rotor Hub Assembly, Hub Cracking

23 June 2025

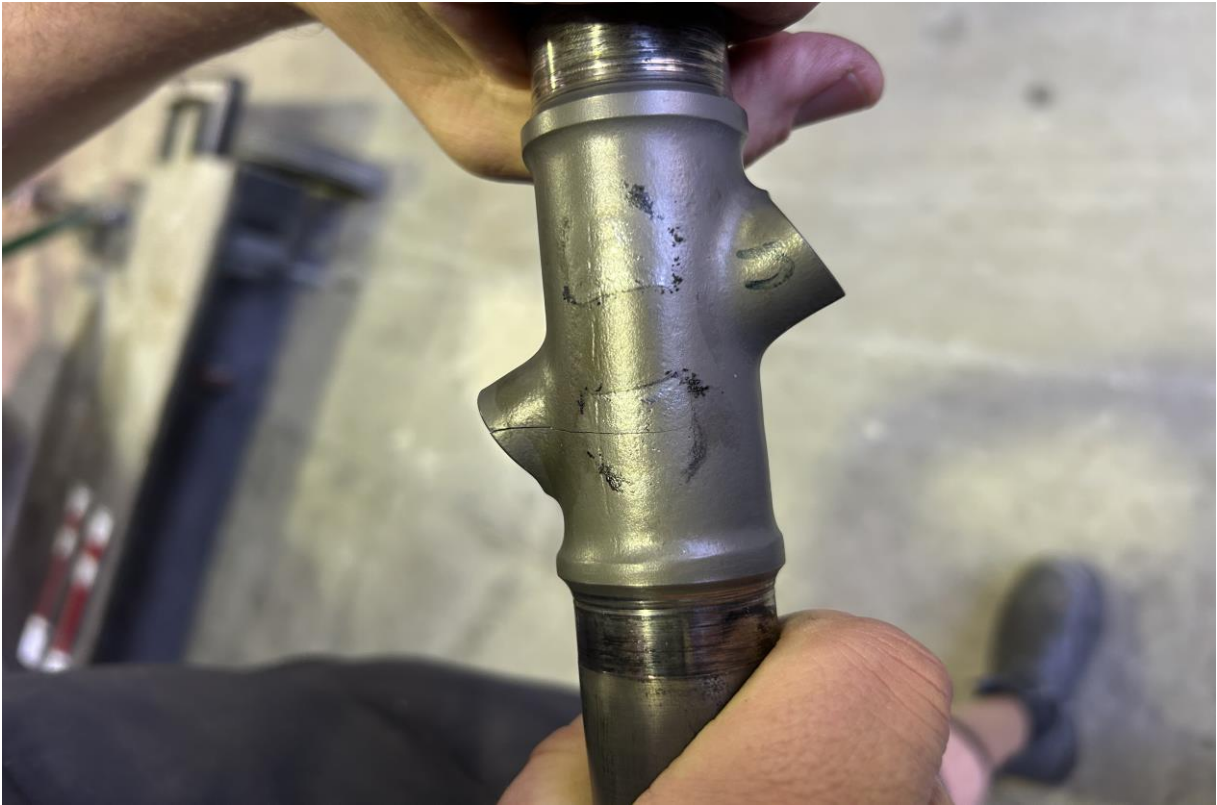
The subsequent inspection of the tail rotor pitch control assembly and blades identified significant cracks in the tail rotor hub (See Figures 1 and 2 below).

**Figure 1 – Hand force applied to exaggerate the crack opening**

CAA recommend that operators of MD 369D and 369E helicopters fitted with a 4 Bladed Tail Rotor pay particular attention to the tail rotor hub when carrying out daily pre-flight inspections.

Maintenance providers who are carrying out scheduled inspections of MD 369D and 369E helicopters fitted with 4 bladed tail rotor assemblies, should carefully inspect the hub, particularly in the areas adjacent to the teeter bolt holes, for potential indications of cracking.

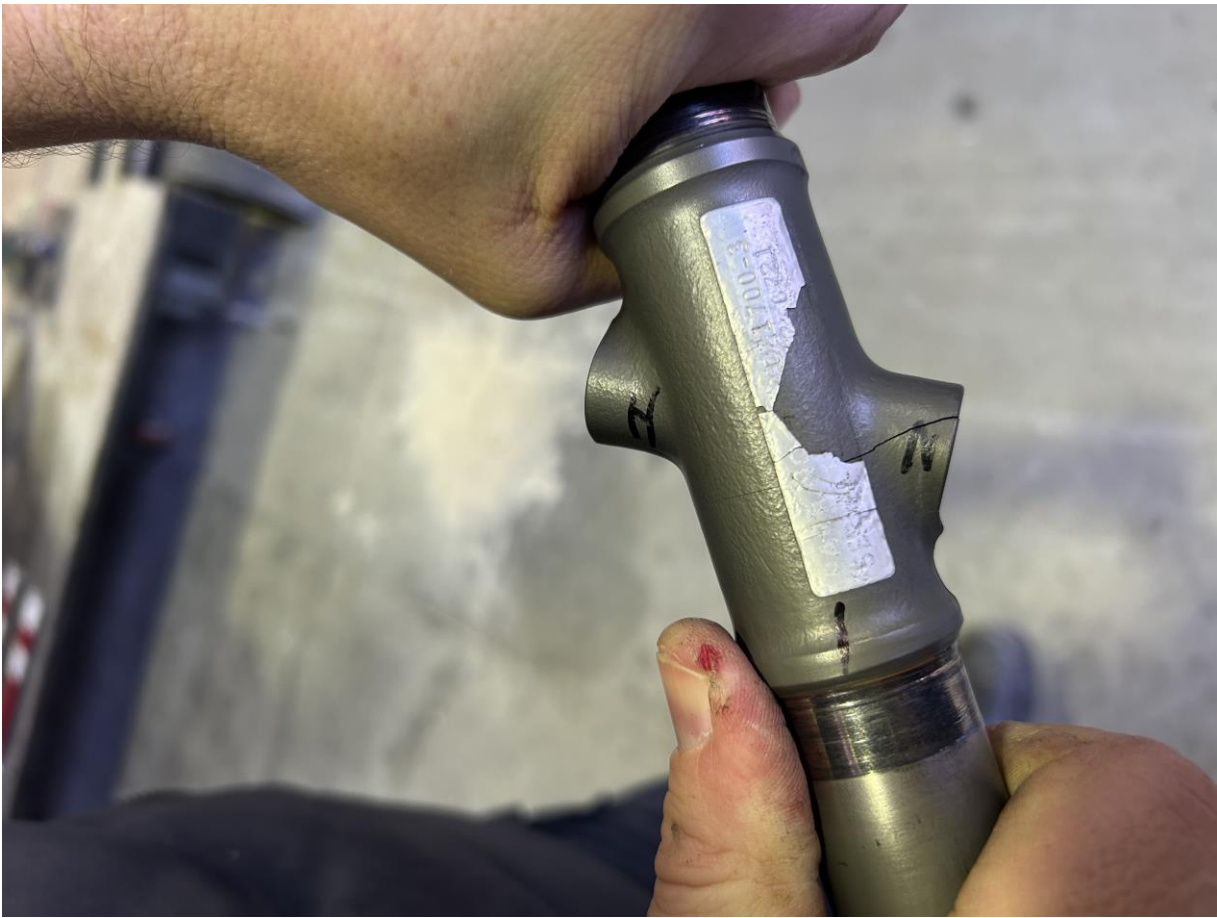
**Figure 2 - Hand force applied to exaggerate the crack opening**
