Continuing Airworthiness Notice – 27-031

Tecnam P2008 Stabilator Torque Tube – Cracks in Mass Balance Weight Attachment

26 February 2026

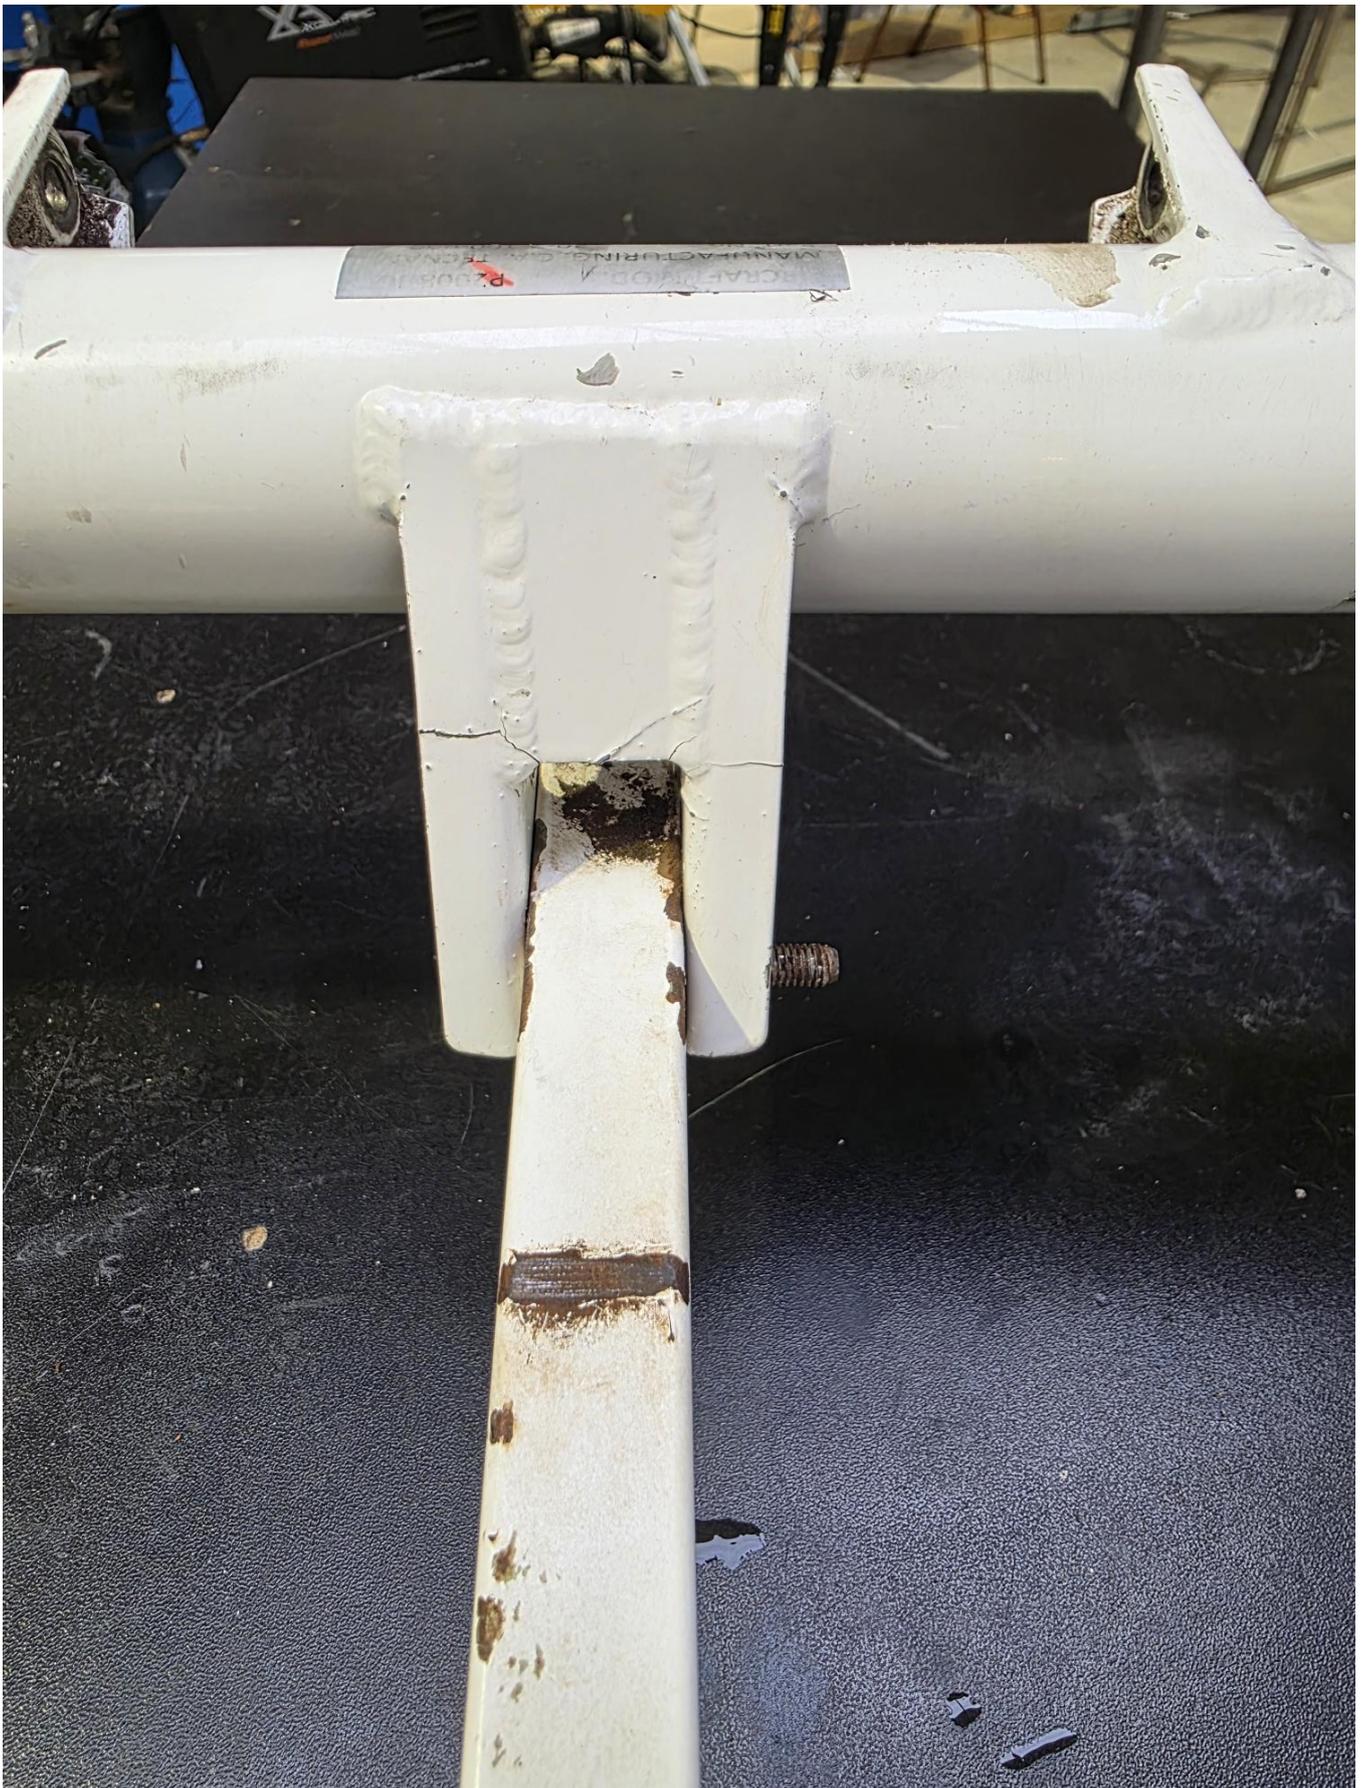
This CAN is prompted by a report received from an operator of finding cracks in the stabilator torque tube assembly P/N 20-7-100-000 on a P2008 JC aircraft in the area where the mass balance weight attaches to the stabilator torque tube.

This defect was found when the stabilator was removed from the aircraft for a different repair. A subsequent inspection of their fleet found 10 aircraft with similar cracks.

Photo 1 Stabilator Torque Tubes – Cracks in Mass Balance Weights Attachment
CAN Template: Rev 1 October 2021

The CAA strongly recommends that operators and maintainers of Tecnam P2008 aircraft inspect the stabilator torque tube assembly in the area where the mass balance weight attaches to the stabilator torque tube. If any cracks are found accomplish appropriate corrective actions before further flight.

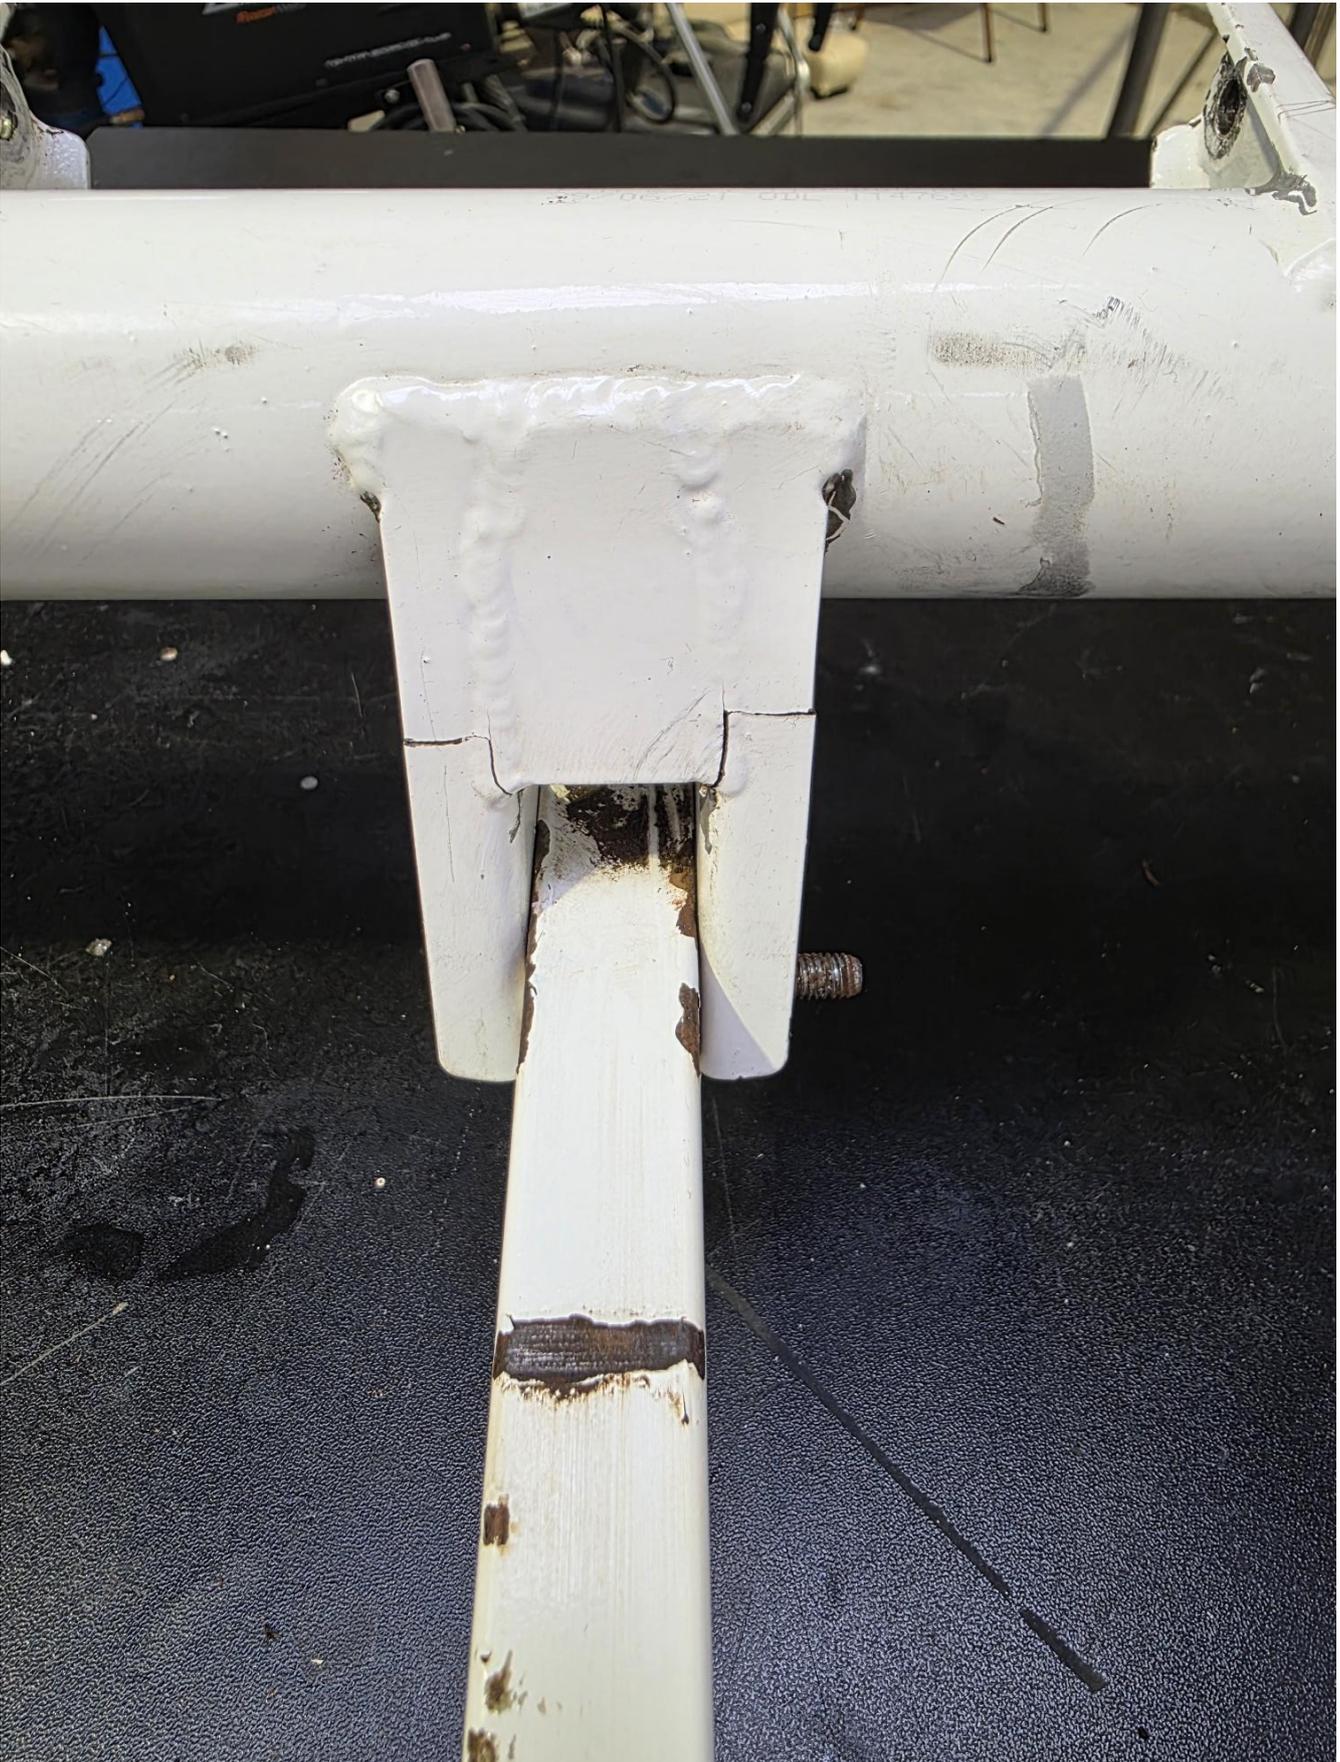
Photo 2 Stabilator Torque Tubes – Cracks in Mass Balance Weights Attachment
