# Continuing Airworthiness Notice - 27-032

## AS350 Helicopters Tail Rotor Pitch Control Rod – Damaged Ball Joint

14 May 2026

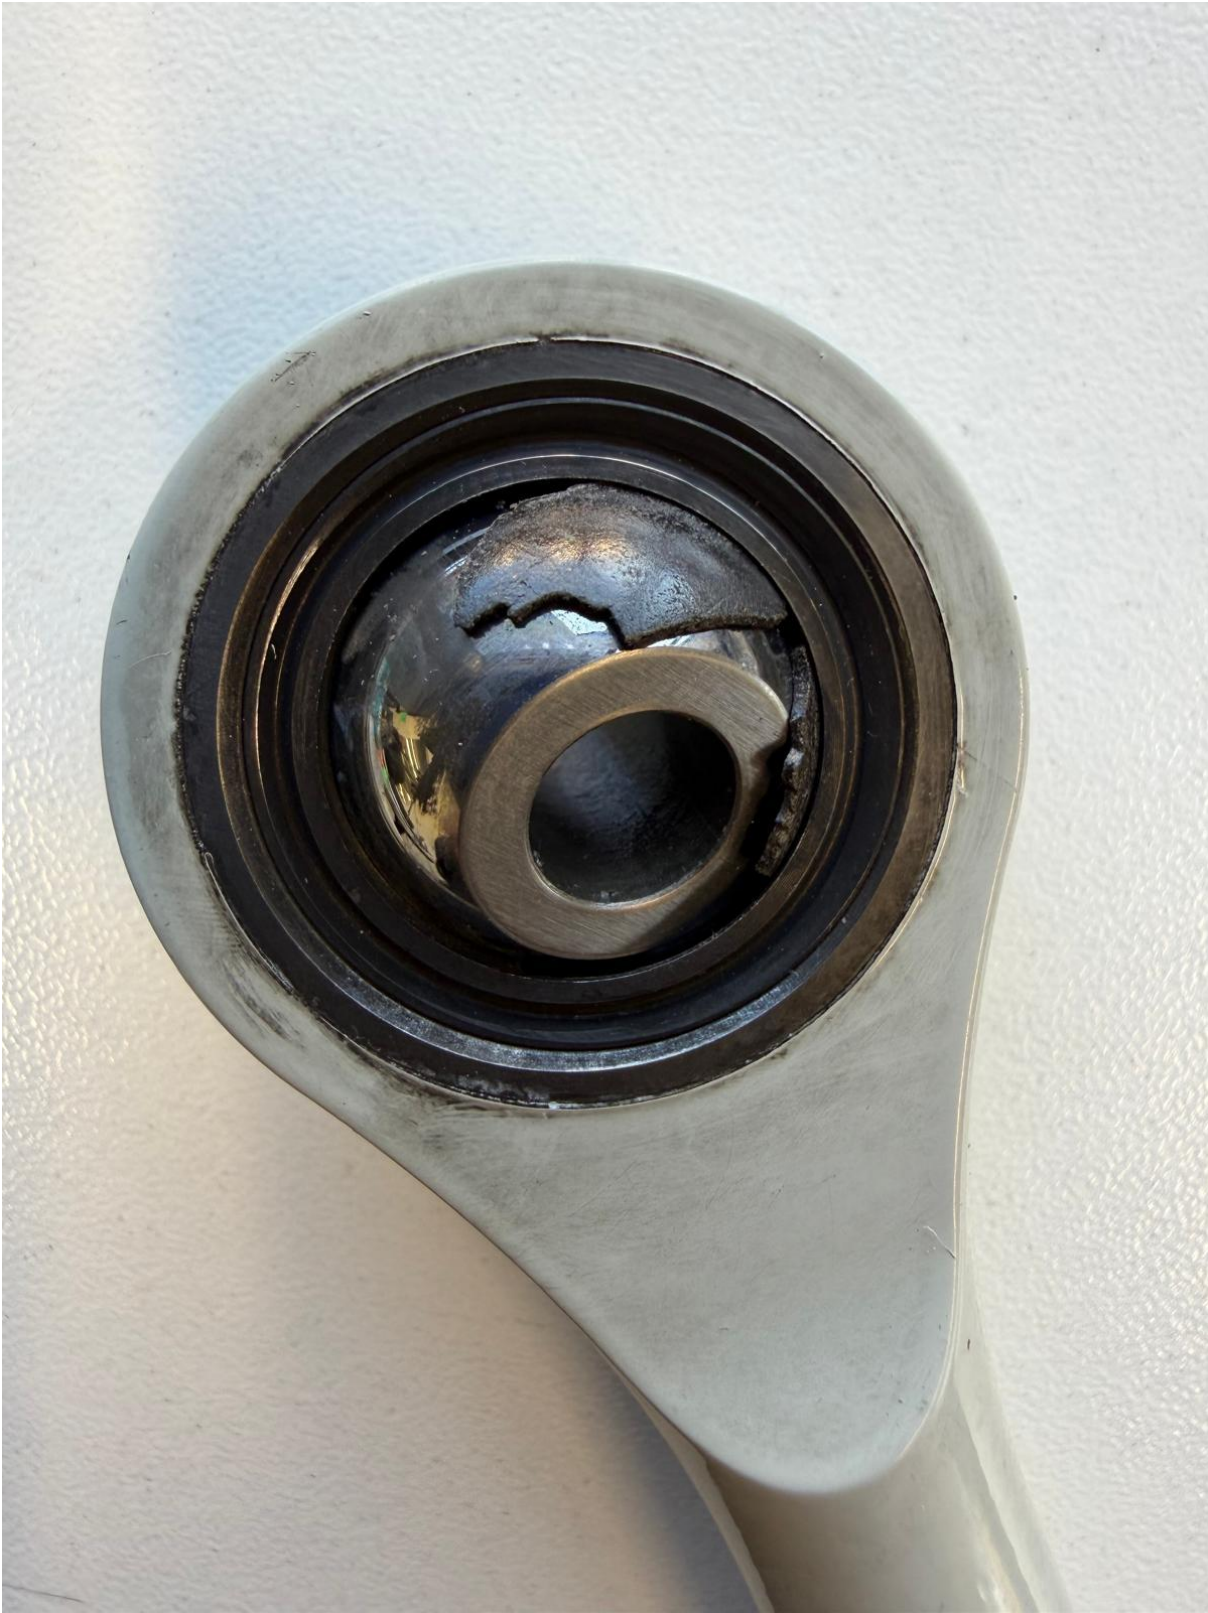
During pre-flight inspections excessive play was noted in the tail rotor pitch control rod ball joints. The extent of damage varied across the affected parts, but in each case the excess play seemed to be caused by a breakdown of the non-metallic liner material. Initial indications of failure appear to present as chips from the liner material, but in at least one case the liner material had completely failed causing excessive play and metal to metal contact in the bearing.

**Figure 1 – Extensive bearing liner material damage**

CAA recommend that operators of AS350 helicopters pay particular attention to the tail rotor pitch control rod bearings for play when carrying out daily pre-flight inspections. Maintenance providers who are carrying out scheduled inspections of AS350 tail rotor pitch control rod bearings should carefully inspect control rod bearings for degradation of the non-metallic lining materials. Worn bearings should be assessed against the appropriate inspection criteria and replaced as necessary.

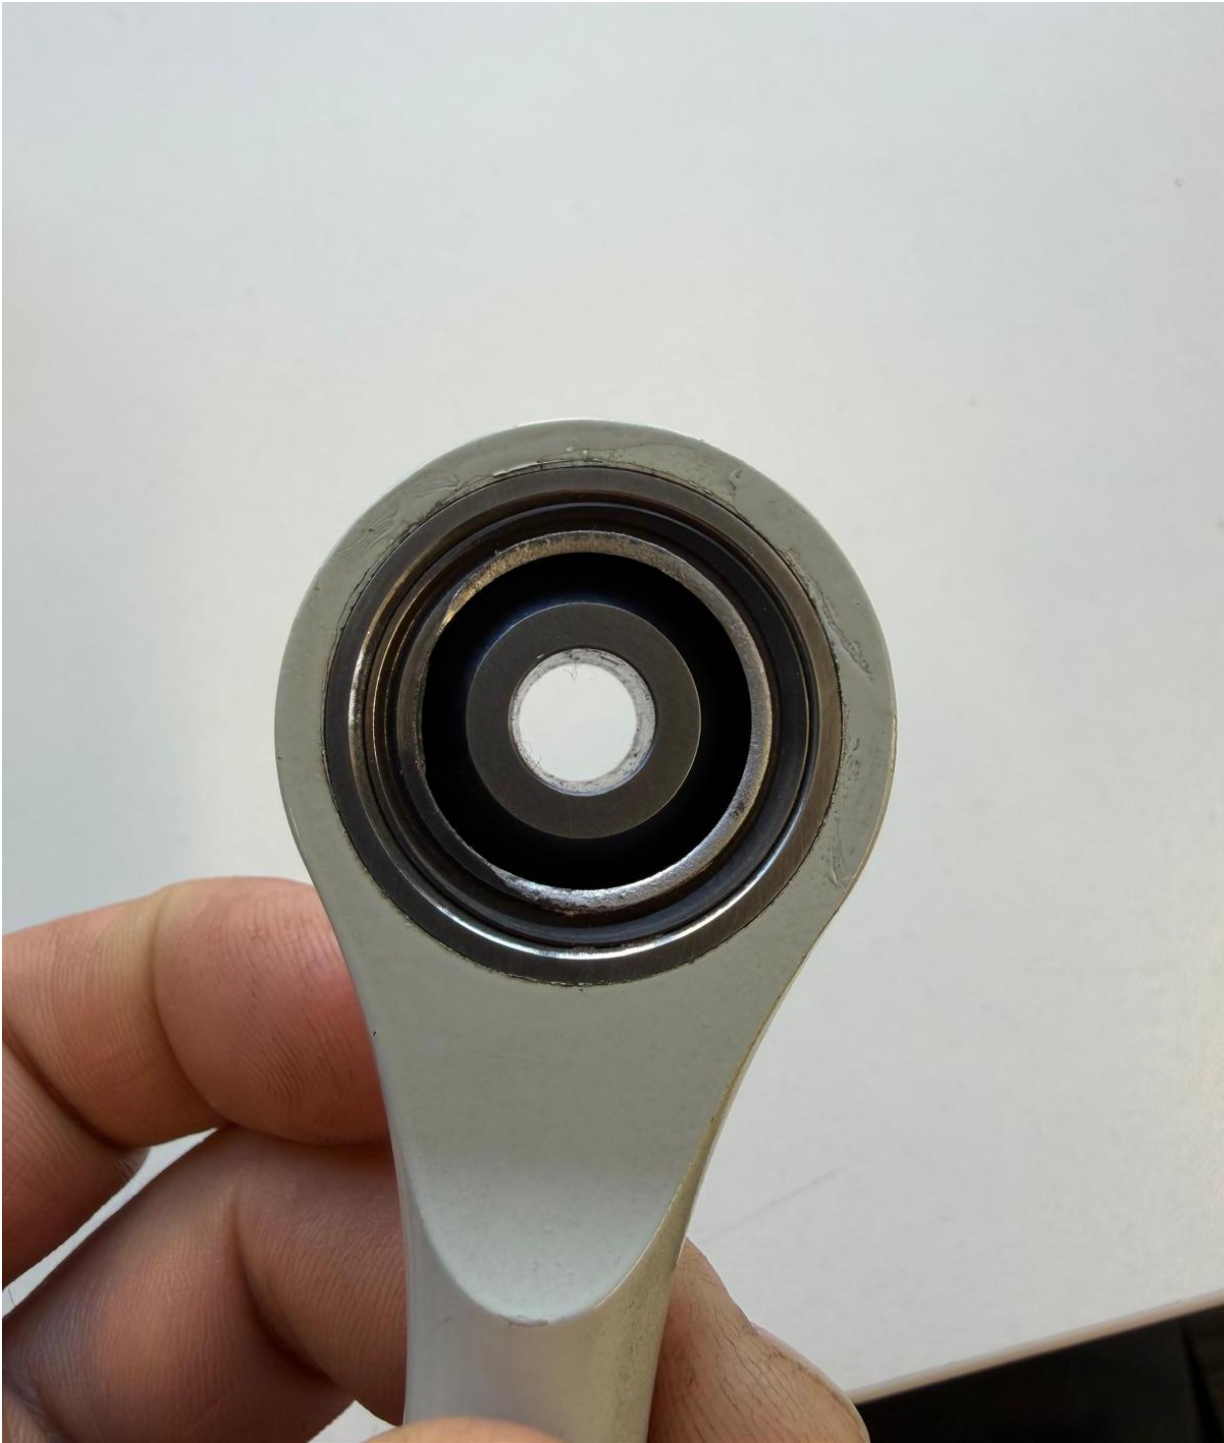
**Figure 2 – Complete loss of bearing lining material and resulting damage to surfaces.**
