# Continuing Airworthiness Notice – 27-033

## MD 369 Series Pilot Collective Stick - Corrosion and Cracking

29 October 2026

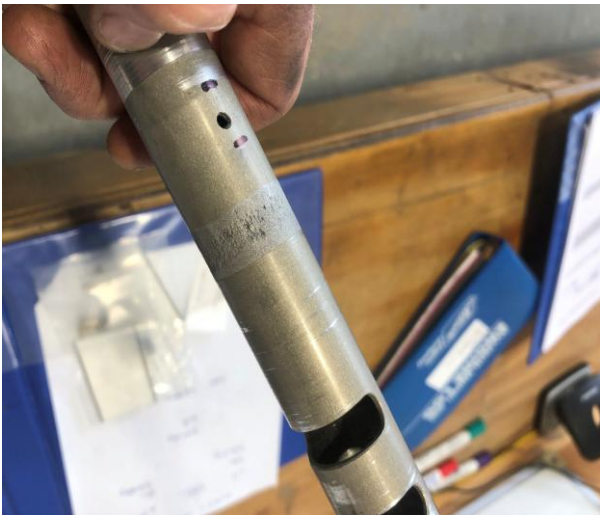
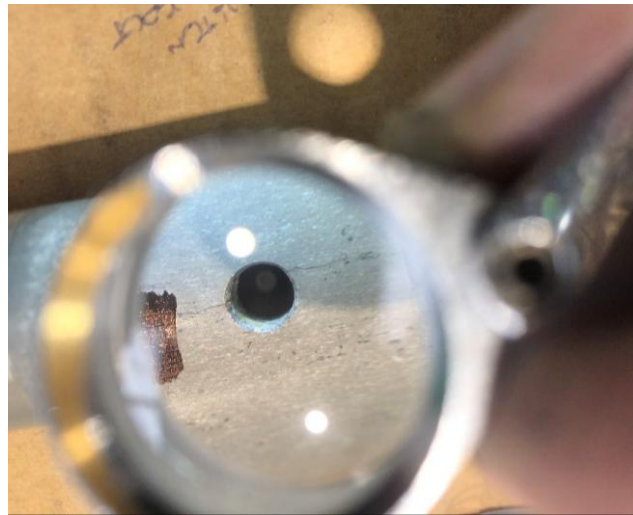
Detailed visual inspections of the disassembled collective tubes revealed cracks through the rivet holes on the collective tube as shown in Figure 1 below.

CAA are advised that the corrosion may be the result of aging aircraft which were previously operated in a door off configuration (likely during wet weather).

**Figure 1 – Collective tube with corrosion and cracking.**

Engineers are advised to accomplish a thorough investigation if they find signs of corrosion on the collective tube. It may be necessary to disassemble the collective control stick to perform a detailed inspection.

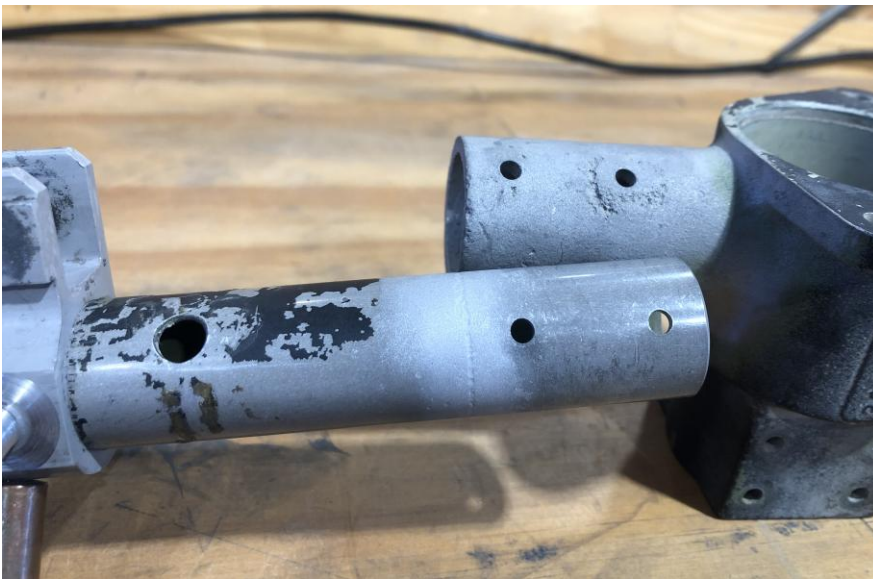
Initial indications of corrosion found during scheduled inspections tend to understate the severity of the damage. Further investigation and disassembly has revealed extensive corrosion requiring replacement of parts.

**Figure 2 – Collective tube and housing corrosion (paint removed and corrosion partially treated).**

At the next appropriate maintenance opportunity, operators are advised to request an inspection of the collective tube and housing socket in accordance with the helicopter maintenance instructions.

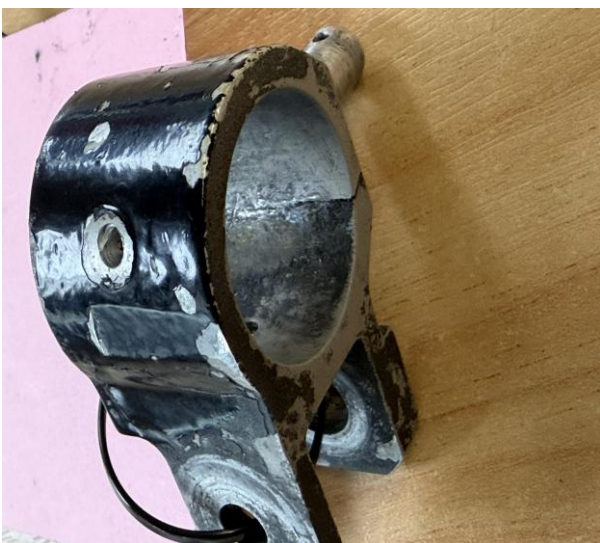
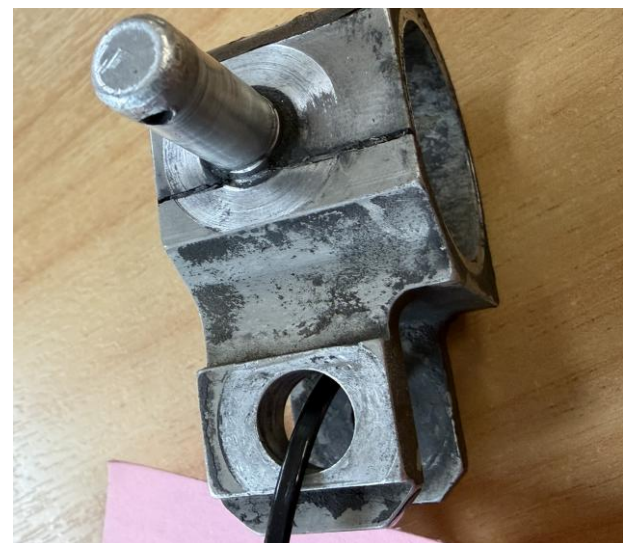
In one incident the pilot noted intermittent throttle friction and the investigation revealed the collective stick fitting cracked through. See Figure 3 below.

**Figure 3 - Collective stick fitting cracking.**
