# Continuing Airworthiness Notice – 32-005

## Cessna piston aircraft – Steering tube internal failure

13 August 2026

Cessna 150, 172 and 175 aircraft

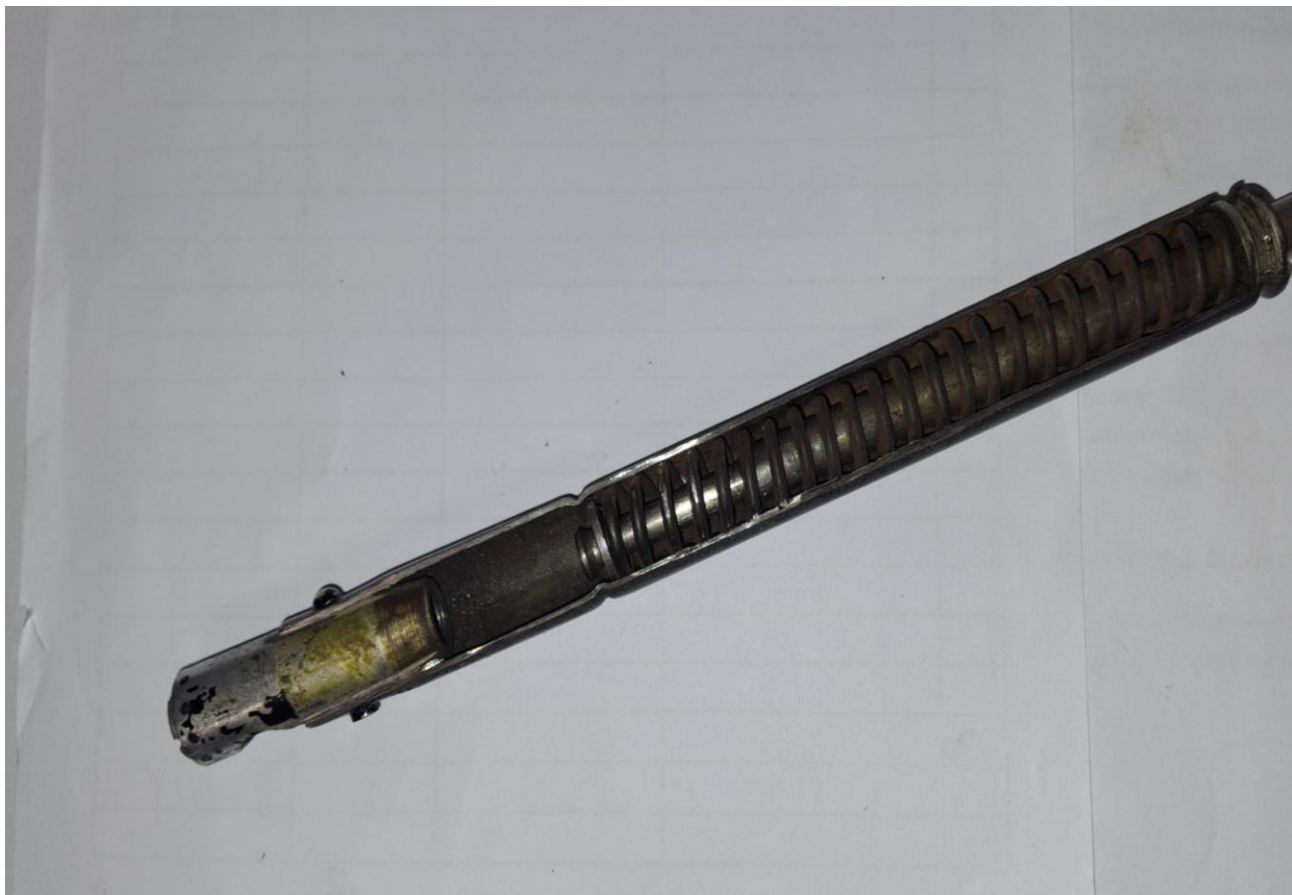
Subsequent inspection and destructive test of the steering tube P/N 0543022-4 revealed that it had suffered an internal failure. See figure 1 and 2 below for sectioned tube.

**Figure 1** – As intended - washer retained by the tube crimp

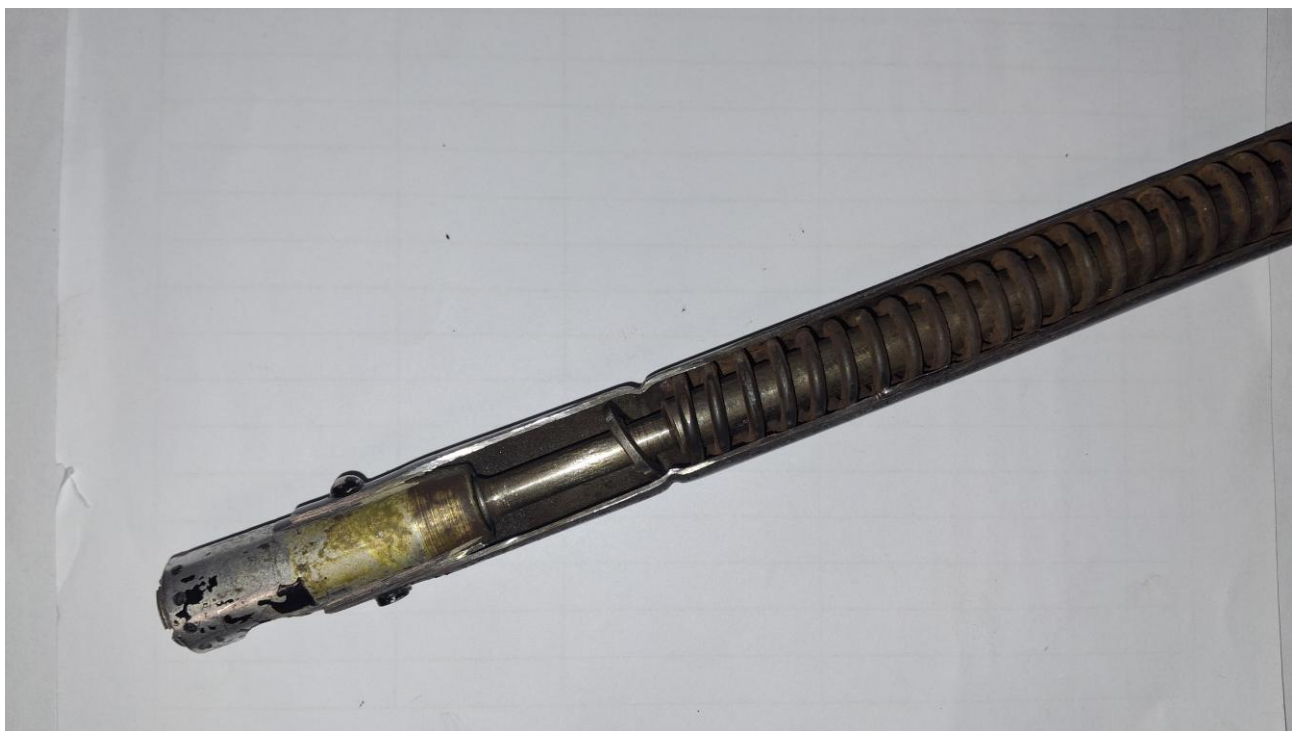
The tube is understood to have been fitted to the aircraft during production, with total time in service of 13330 Hours.

CAA are advised that the aircraft had recently experienced steering difficulty, which at the time was attributed to potential brake dragging. It is possible that this issue was symptomatic of the steering tube degrading.

**Figure 2** – Failed condition - Washer forced beyond the crimped section of the tube

Operators are advised to ascertain the current time in service of their steering tubes and consider proactive replacement of any steering tube which has been in service for the life of the aircraft.
