Continuing Airworthiness Notice 57-004

Pacific Aerospace Cresco 08-600 Aircraft - Excessive Wear found in Wing Rear Spar to Fuselage Attach Fittings

30 May 2023

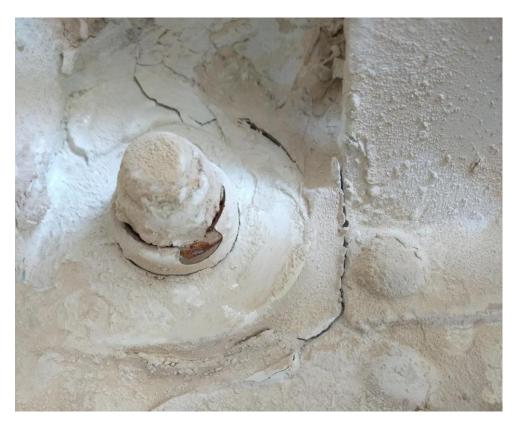
The defect report states that the bolt holes in the wing rear spar to fuselage fittings were found to be beyond maximum allowable oversize, which required a modification to correct. It was also found that the bolt heads had created 0.034" and 0.039" indentations in the spar attach fittings. The defect report stated that early detection of spar attachment wear and damage was prevented due to the application of a thick flexible sealant to the bolt heads and fittings.

Wing rear spar to fuselage attachment fitting with sealant applied.

Maintenance engineers are reminded of the importance of following the appropriate instructions for continuing airworthiness (ICA) when applying sealants and compounds to structural components, and when preparing any area for inspection.

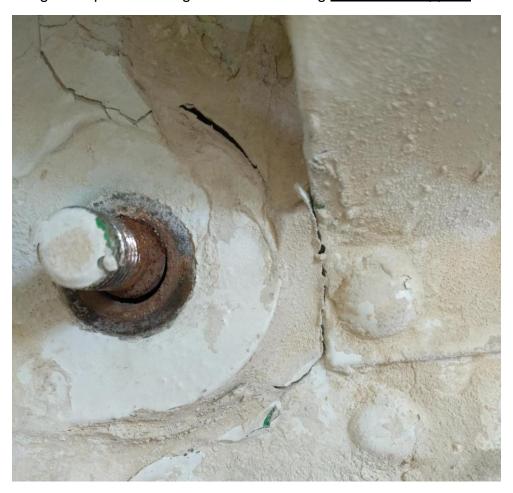
Wing rear spar to fuselage attachment fitting with sealant and nut removed.
