Continuing Airworthiness Notice – 57-005

Tecnam P2008 Fuselage Extrusion P/N 28-2-1095-1 Attachment Lugs - Corrosion

7 April 2026

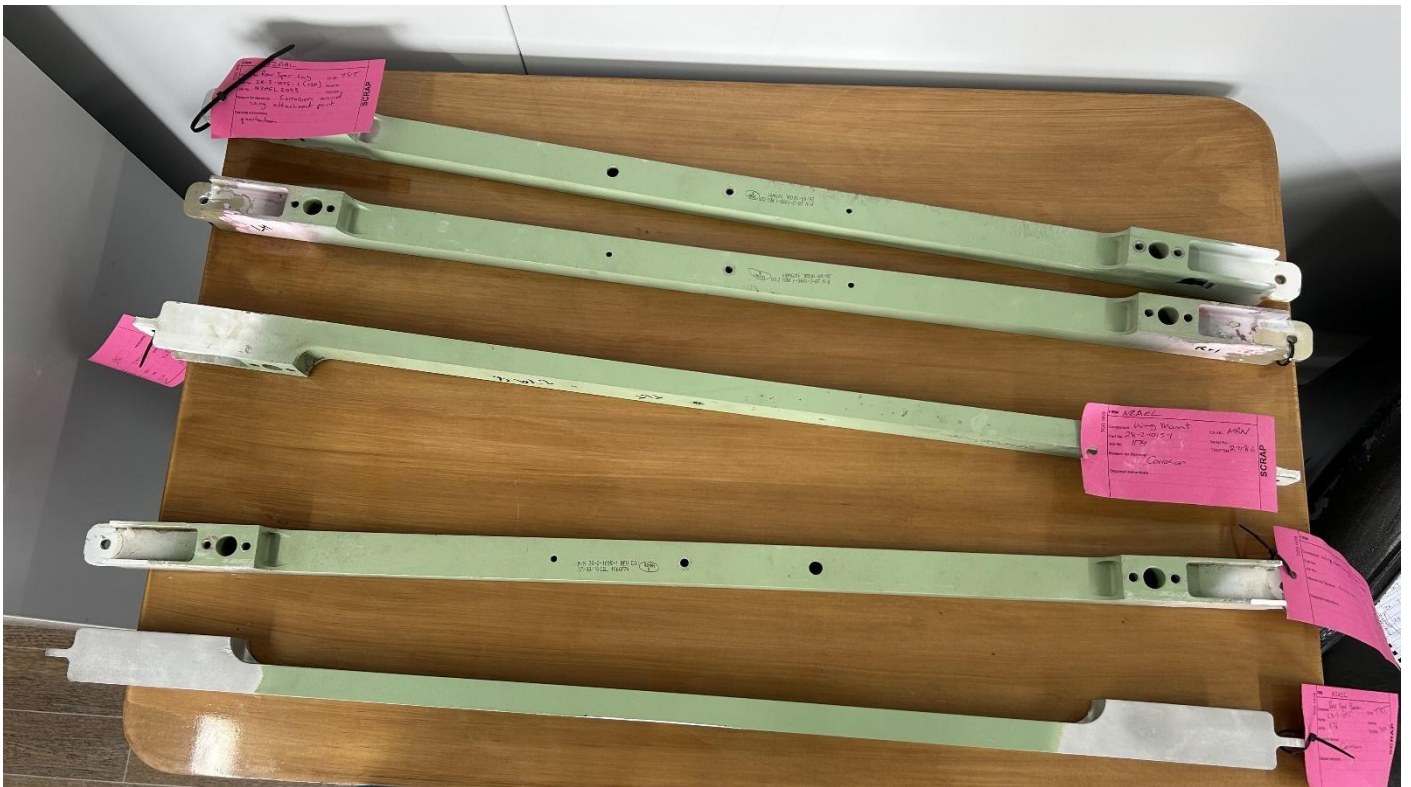
This CAN is prompted by five occurrences reported to the CAA of finding corrosion in the attachment lugs of the fuselage extrusion P/N 28-2-1095-1. The fuselage extrusion attaches both the LH and RH wings aft spars to the fuselage. The corrosion found in the bolt attachment lugs is intergranular, and had advanced significantly to require replacement.

The corrosion was found during wing removal for an unrelated issue. The corrosion appears to have occurred in areas where the protection paint finish was not damaged and also not in areas of dissimilar metal contact (e.g. from the attachment bolts).

Five fittings. Fuselage aft wing attachment

Operators should follow manufacturers recommendations for corrosion control applicable to operation in high salt/high humidity environments. In the case of Tecnam aircraft, the manufacturer recommends applying anti-corrosive to wing attachments every 12 months.

The CAA strongly recommends that operators and maintainers of Tecnam P2008 aircraft inspect the attachment lugs of fuselage extrusion P/N 28-2-1095-1 for defects and corrosion.

If any defects are found accomplish appropriate corrective actions before further flight.
