# Continuing Airworthiness Notice – 57-006

## Tecnam P2002 – Wing Rib Cracks

30 October 2026

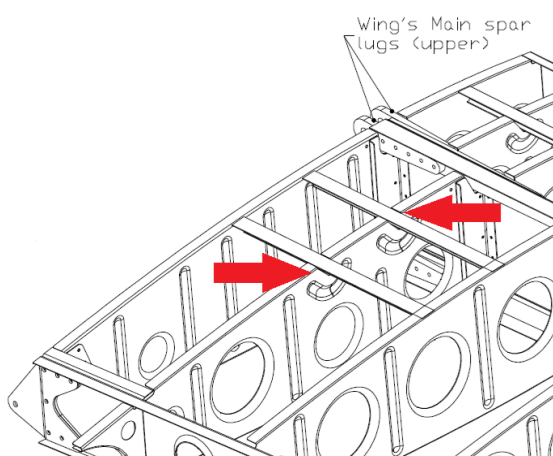
Figure 1 – Reported crack locations #2 wing rib upper.

Operators are advised to pay particular attention to any flexing of the wing surface above wing rib #2 (i.e. in the wing walkway area). Any walkway flexing should be subject to further investigation by a maintenance engineer.

Engineers planning to inspect wing rib #2 with wings installed, are advised that the cracked area as described in this CAN is only visible using additional inspection aids such as a borescope.

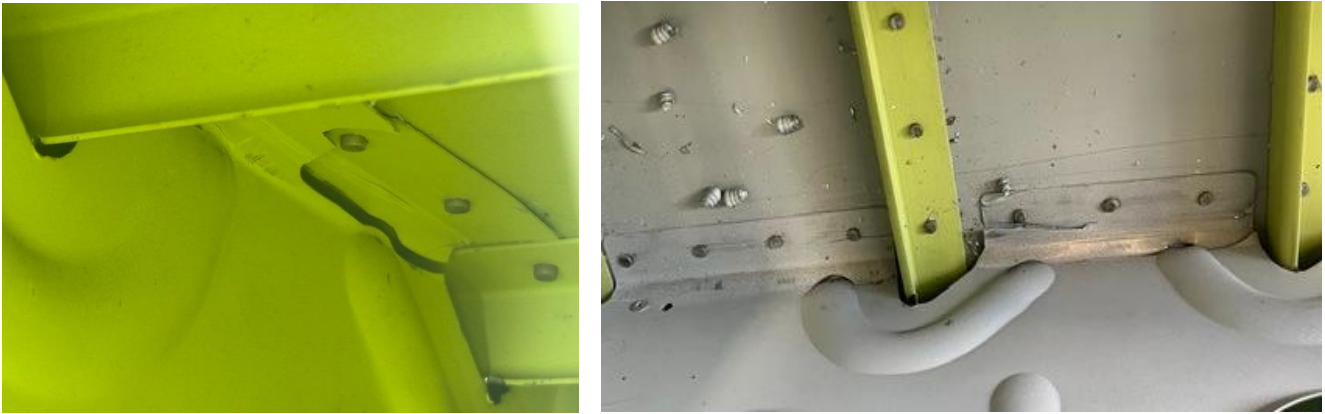
During a scheduled inspection of a Tecnam P2002 aircraft, engineers observed flexing of the wing skin with an associated faint clicking noise in the wing walkway area above wing rib #2 on both LH and RH sides of the aircraft. Further investigation identified significant cracking in both LH and RH wing ribs #2.

Figure 2 – Rib #2 LH and RH cracking 1<sup>st</sup> aircraft.

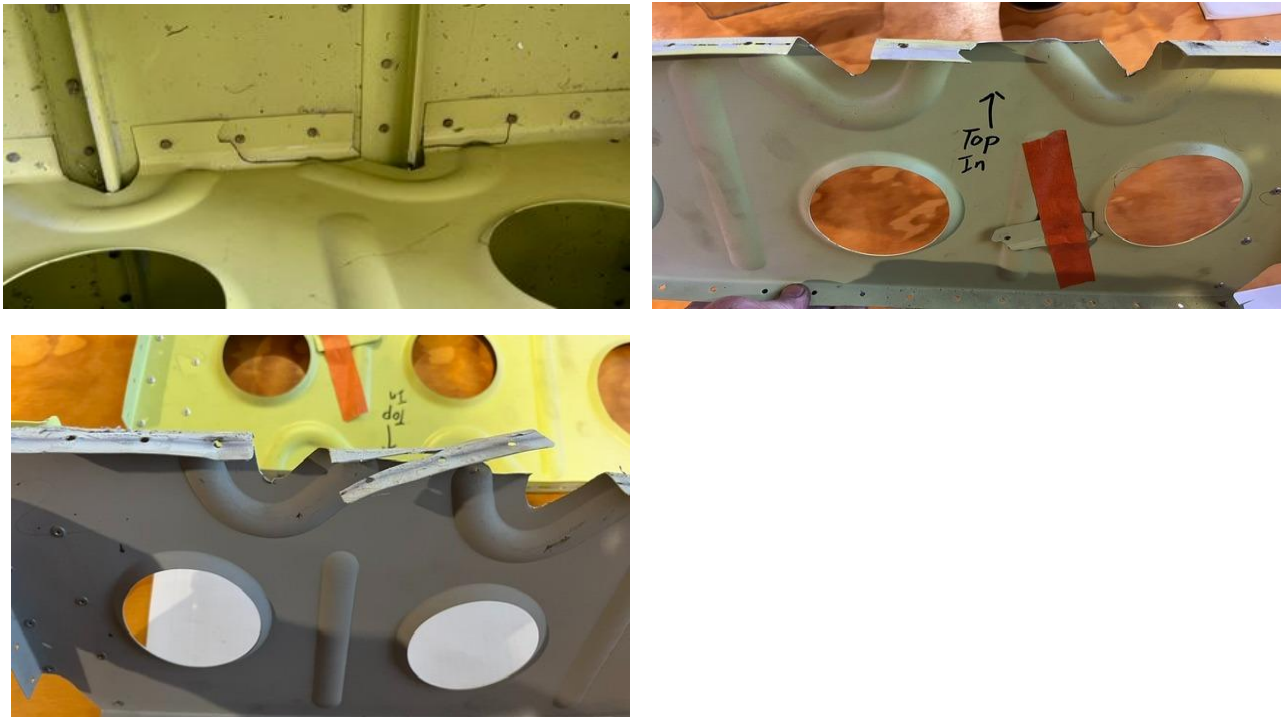
Engineers subsequently inspected another P2002 of the same operator, identifying the same defect.

Figure 3 – Rib #2 LH and RH cracking 2<sup>nd</sup> aircraft.
