# Continuing Airworthiness Notice – 62-005

## MD369 Main rotor blade – Cracking at the root section

19 May 2026

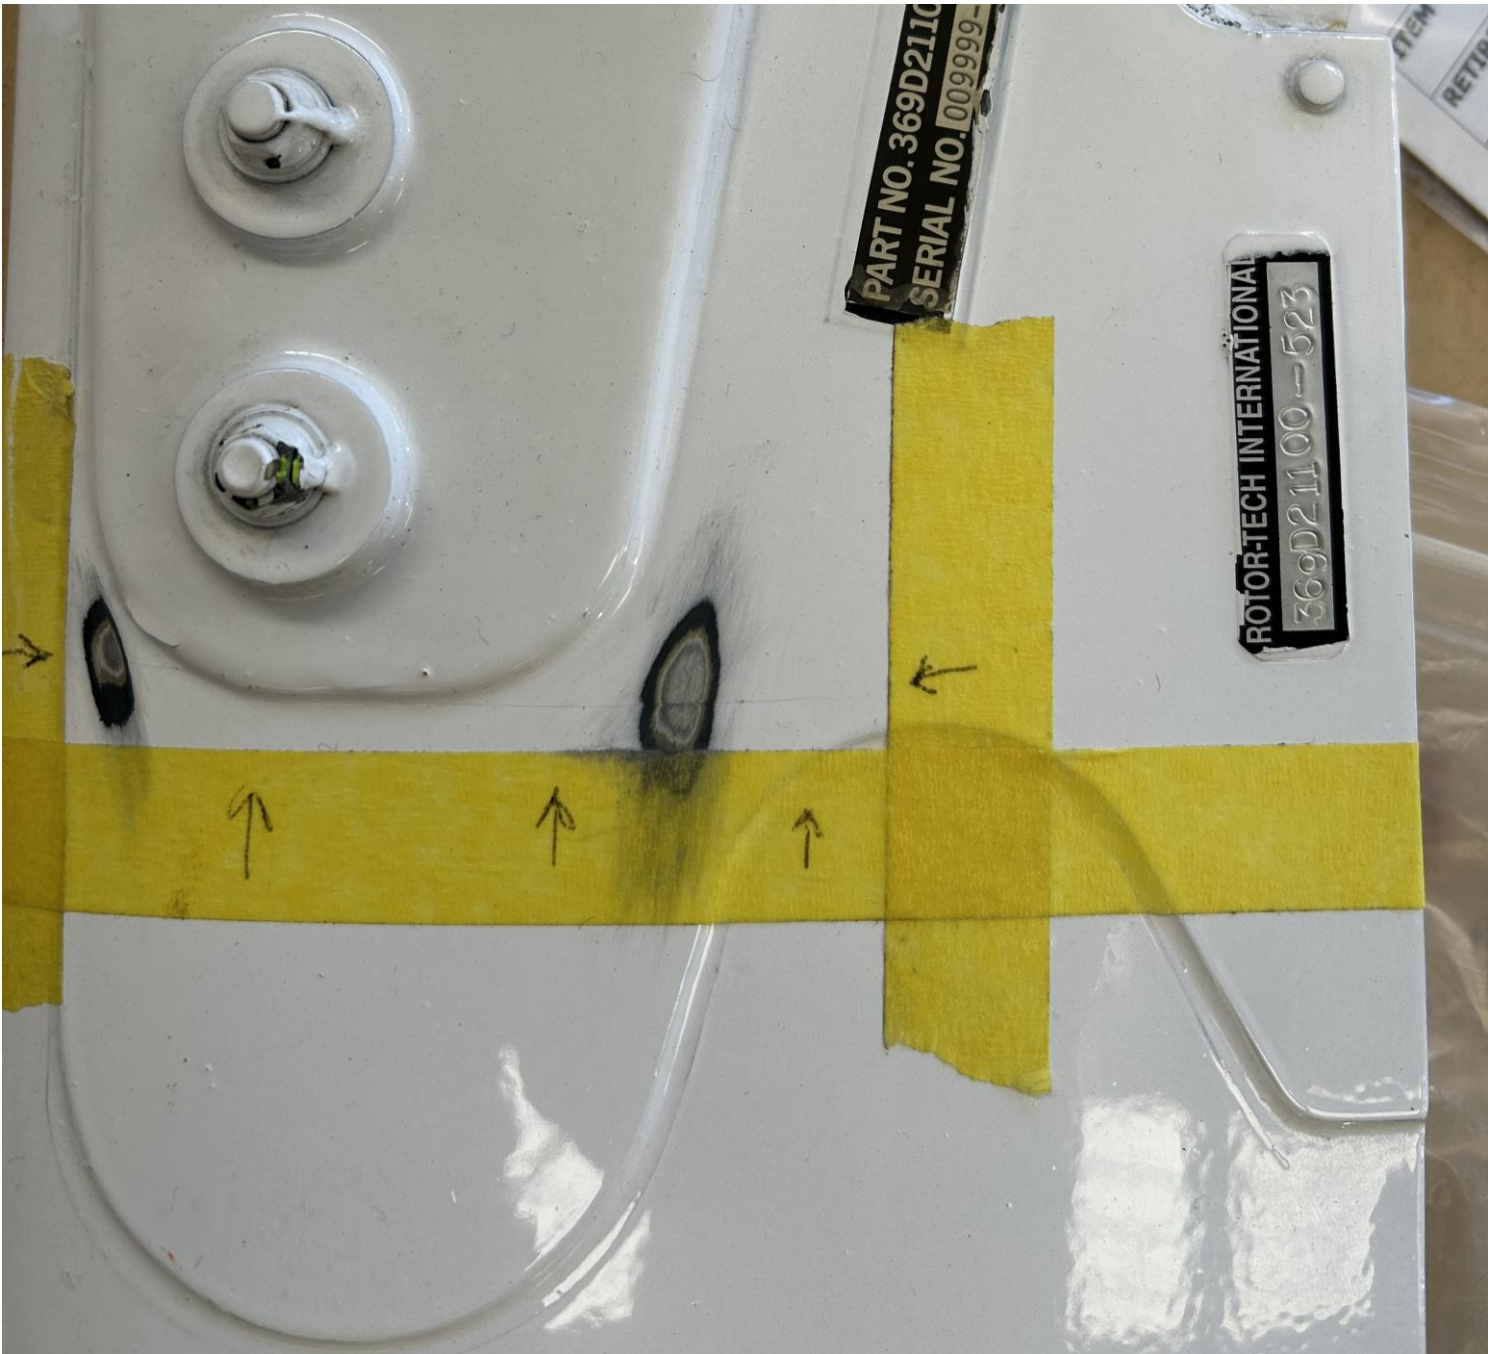
Fig 1 below shows a previously identified MD blade with a crack (confirmed by paint removal) which was identified during a scheduled maintenance inspection.

Figure 1 – MD manufactured blade showing crack indication at the root fitting, confirmed by paint removal.

CAA are advised that the identification of cracks at the blade root fitting (often associated with torque events (TE) requires careful examination, including the use of supplemental lighting and optical magnification.

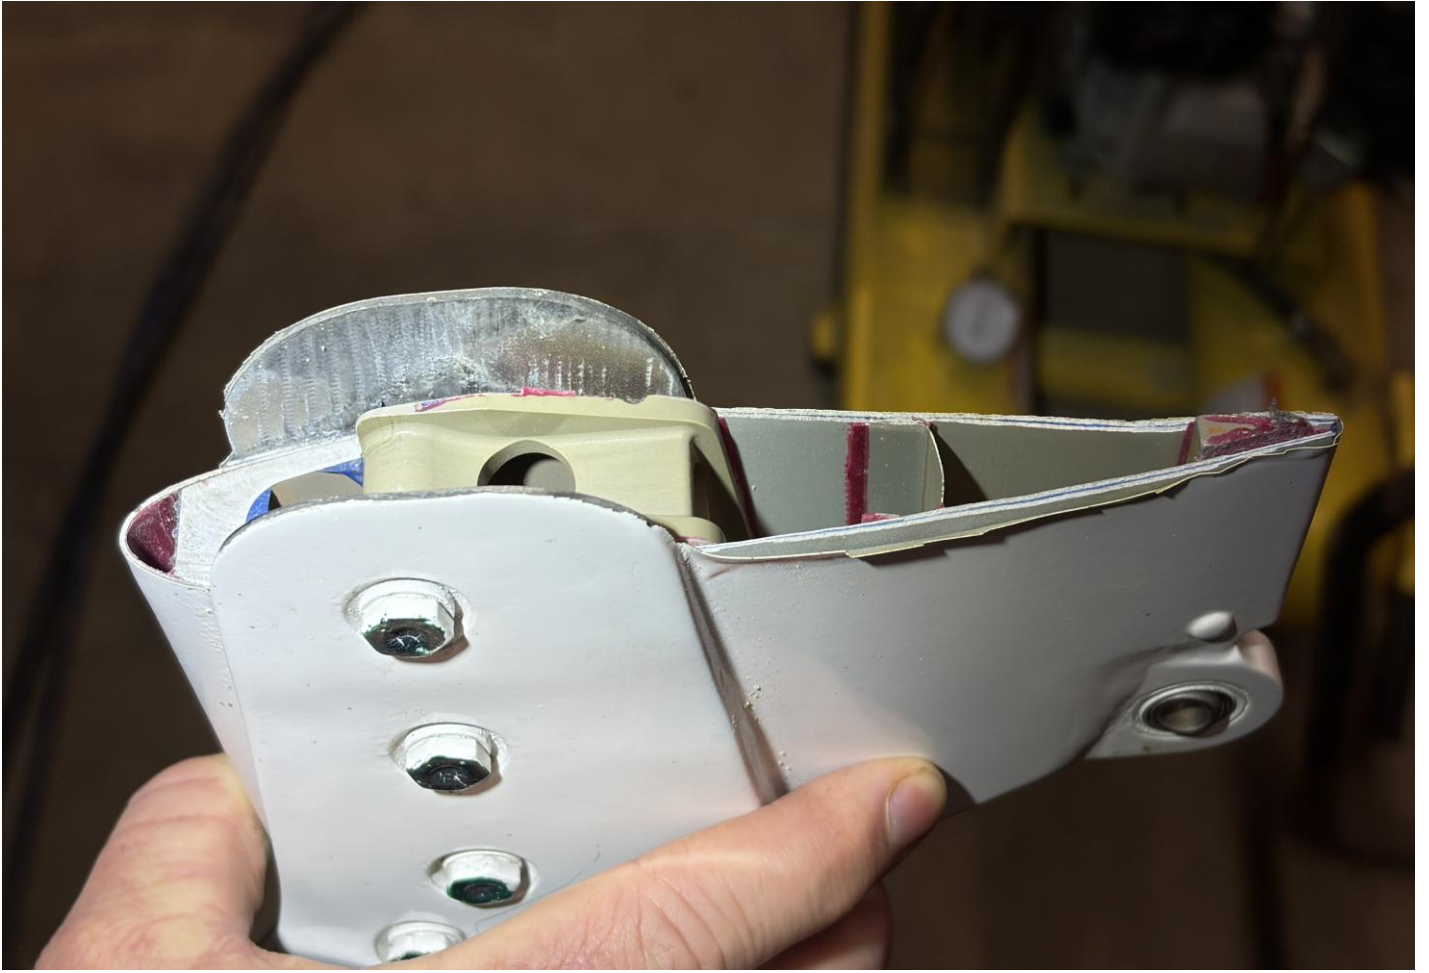
Fig 2 shows the retained section of the failed blade from the recent accident. The crack in this case appears to have initiated beneath the retention doubler.

**Figure 2 – Complete failure of main rotor blade at root fitting (HTC Manufactured Blade).**
