# Continuing Airworthiness Notice – 65-002

## MD Helicopters 369 Series - Tail Rotor Gearbox Casing Crack

29 October 2025

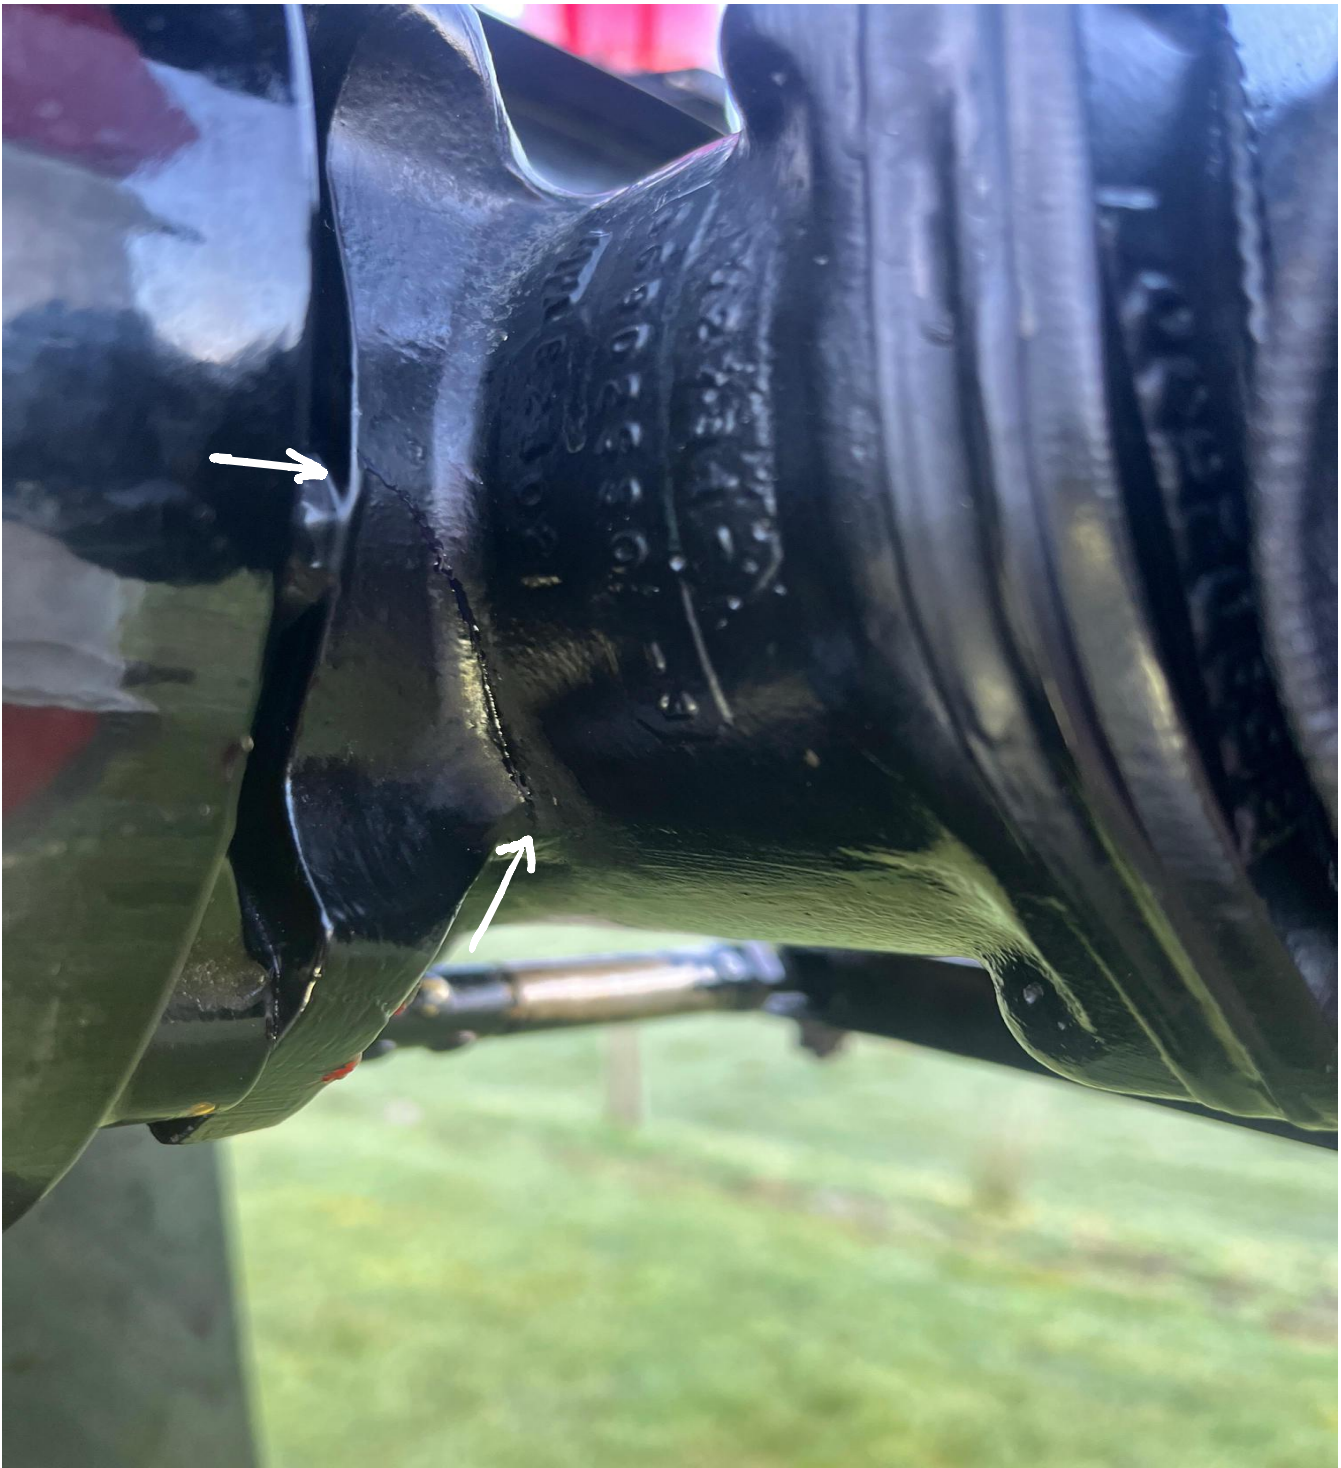
During the pre-flight inspection of a 369D, the pilot found a defect in the tail rotor gearbox housing, which was initially thought to be a paint crack.

**Figure 1 – Tail Rotor Gearbox crack found during the pre-flight inspection. Note the presence of oil residue.**

CAA recommends that operators of 369 series helicopters pay particular attention to exposed gearbox and flight control casings during pre-flight inspections.

Paint defects, or evidence of oil leaks should be thoroughly investigated. If there is any doubt whether a component casing is cracked, or damaged, an engineer should be consulted.

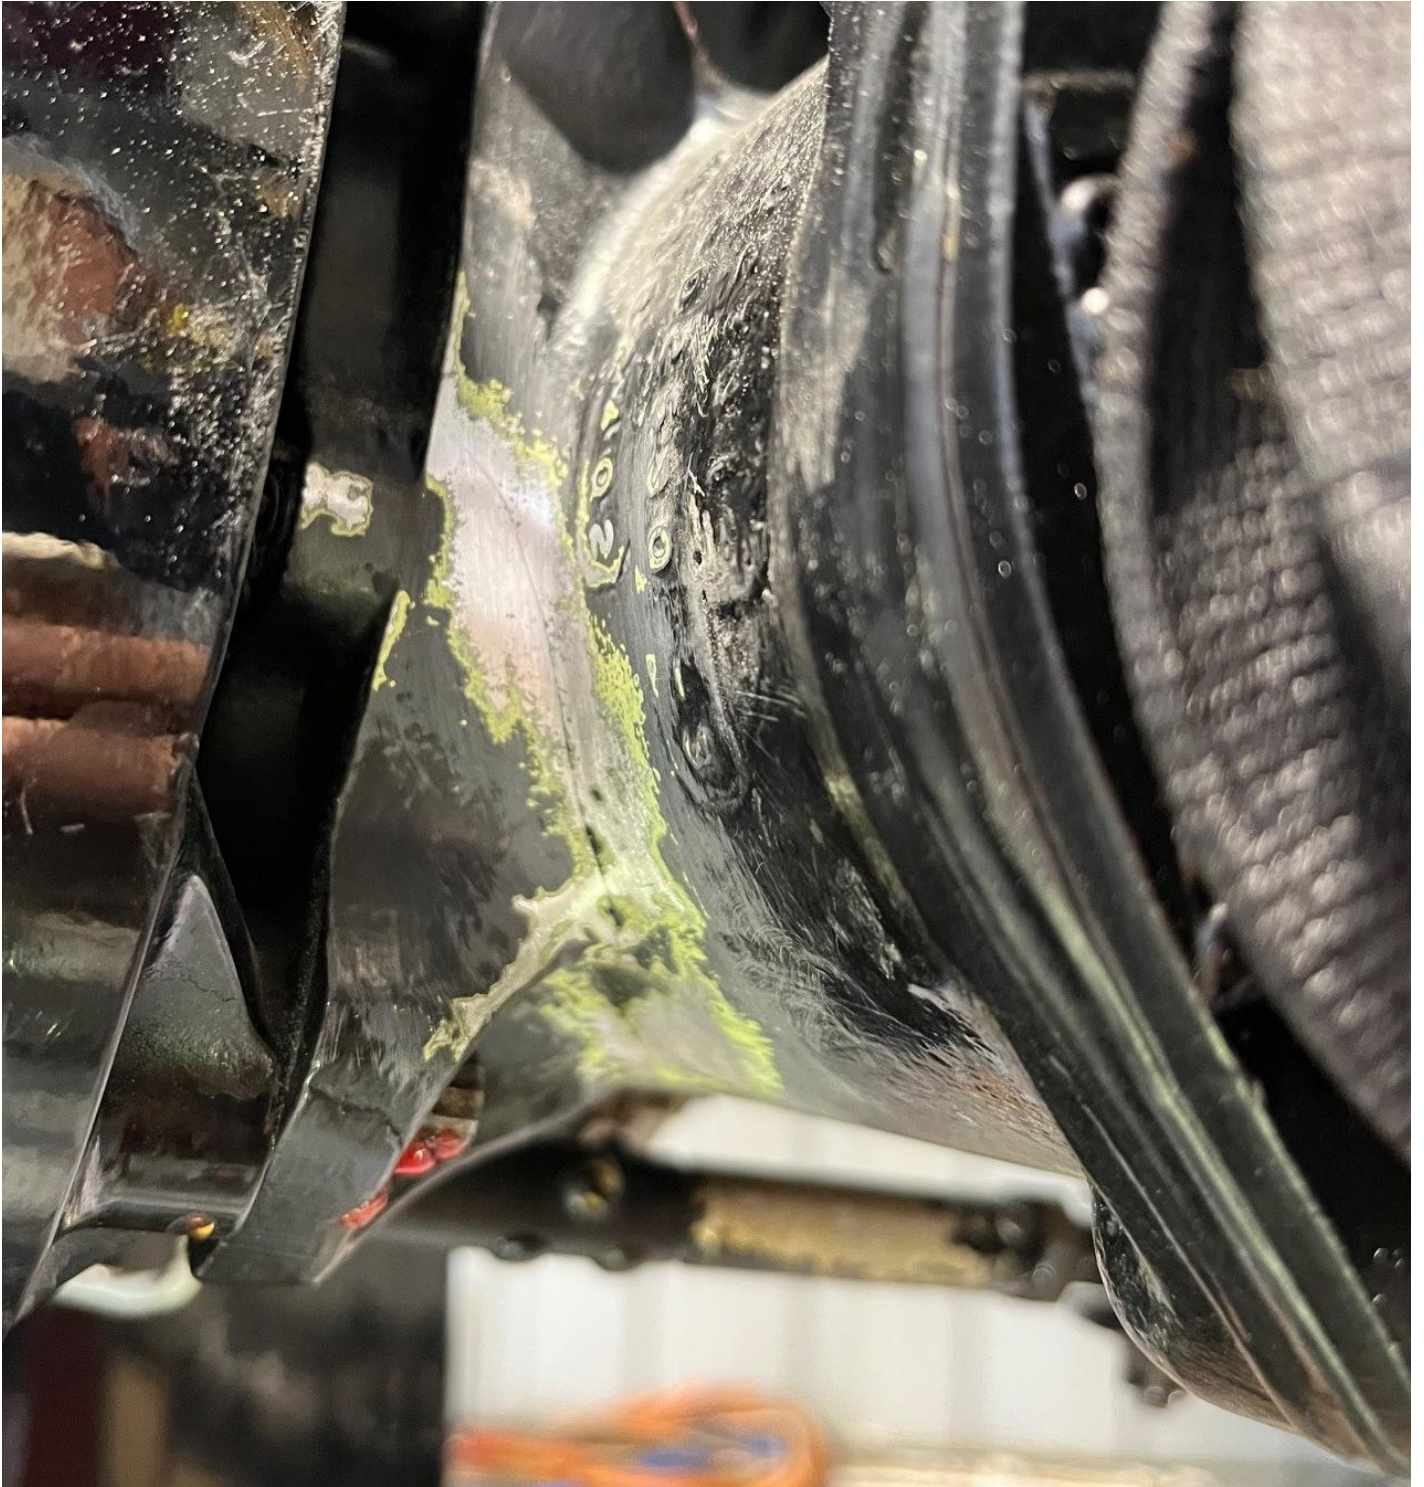
The aircraft was grounded, and during an inspection by an engineer a significant crack was found.

CAA understands that paint was removed from the casing by the engineer to facilitate the inspection (See Figures 1 and 2 below).

**Figure 2 – Crack with paint removed.**

Maintenance providers who are carrying out inspections of 369 tail rotor gearbox casings should consider paint removal if a preliminary inspection identifies a potential crack.

Paint removal and restoration should be carried out in accordance with the relevant aircraft, or component manufacturer instructions.
