# Continuing Airworthiness Notice – 65-003 Rev 1

## MD369 Tail rotor gearbox – Input pinion shaft failure

14 August 2026

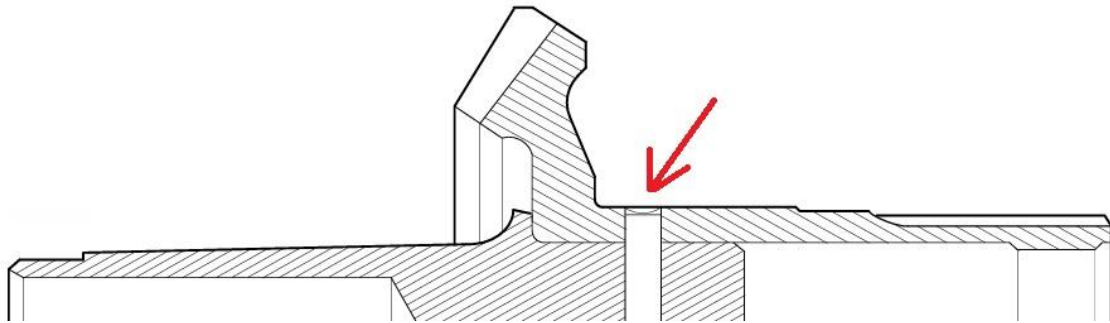
CAA have received two successive reports of excessive axial and radial play in the TGB input pinion shafts of an MD369FF helicopter. In each case, the damaged shaft was identified following a chip light indication in flight. Removal of the gearbox and subsequent teardown revealed the excessive play, but also that the input pinion shafts could be separated by hand into their two component parts (usually press fitted together during manufacture) with the retention pin having failed (see figures below).

**Figure 1** – Sectioned two-piece shaft with retention pin indicated

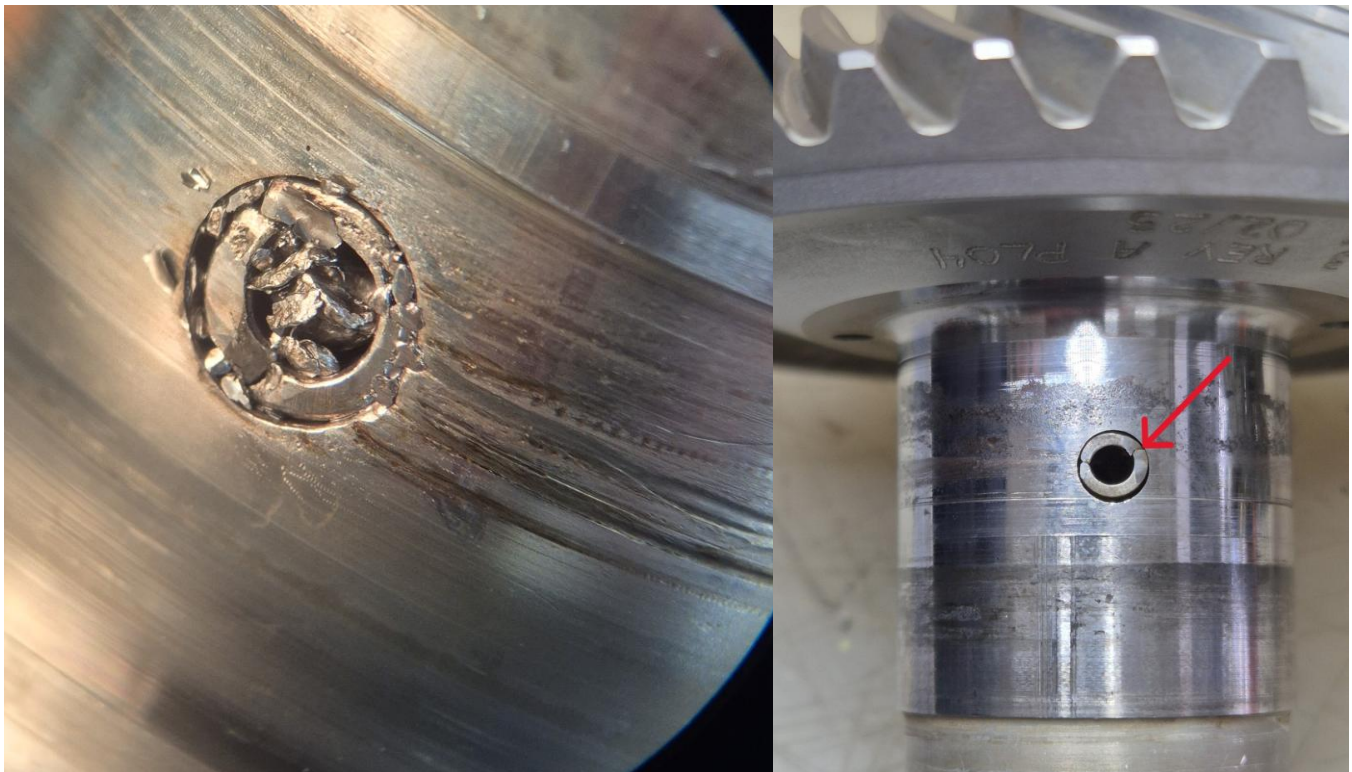
The affected aircraft is understood to have been used for pylon survey work, experiencing consistently high torque with associated increased tail rotor control input.

**Figure 2** – Failed shafts with damaged retention pins

Engineers assessing MD369 aircraft following chip light indication should exercise caution when determining the cause of contamination. CAA are advised that in the incidents described above, the chip plug was coated with a fine metallic sludge, with no fines, chips or swarf present.

CAA requests that operators and maintenance providers report any findings of failed or out of tolerance TGB input shafts via the occurrence reporting process: <https://occurrencereporting.services.aviation.govt.nz>
