Continuing Airworthiness Notice – 73-005

Avstar RSA-10AD1 Fuel Control Units (FCU)

4 May 2021

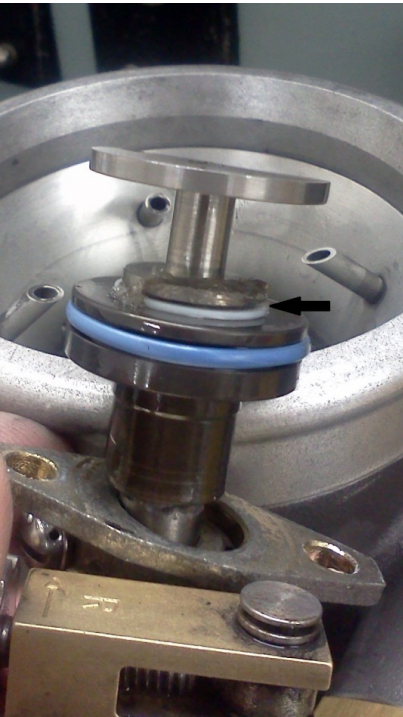
Upon removal of the mixture control valve from the FCU, washer P/N AV367757 was found with broken down material similar to what has been seen on certain FCUs manufactured by Precision Airmotive and predecessors.

Wash P/N AV367757 in situ
on the mixture control valve
shaft.

Anecdotal information suggests that washer P/N AV367757 may be breaking down if the mixture control is stiff, or if reduced engine performance is experienced. An inspection of washer P/N AV367757 cannot be accomplished in situ, or in the field. Disassembly of the FCU is required, which can only be accomplished by an overhaul facility.

The CAA is concerned that washers with P/N AV367757 installed in Avstar RSA-10AD1 FCUs may be breaking down. To assist the CAA in determining if there is a safety concern with P/N AV367757 washers installed in Avstar model RSA-10AD1A FCUs, please report any incidents, or defects found with these FCUs to the CAA by completing a CA005 Defect Report form. Please provide as much engineering detail as possible. The form can be obtained from https://www.aviation.govt.nz/assets/forms/CA005D_Form.pdf. The completed form can be emailed to the CAA at ca005@caa.govt.nz
