Continuing Airworthiness Notice 85-011

Continental CD-135 (TAE 125-01) and CD-155 (TAE 125-02) Engines - Piston Cracking

06 September 2023

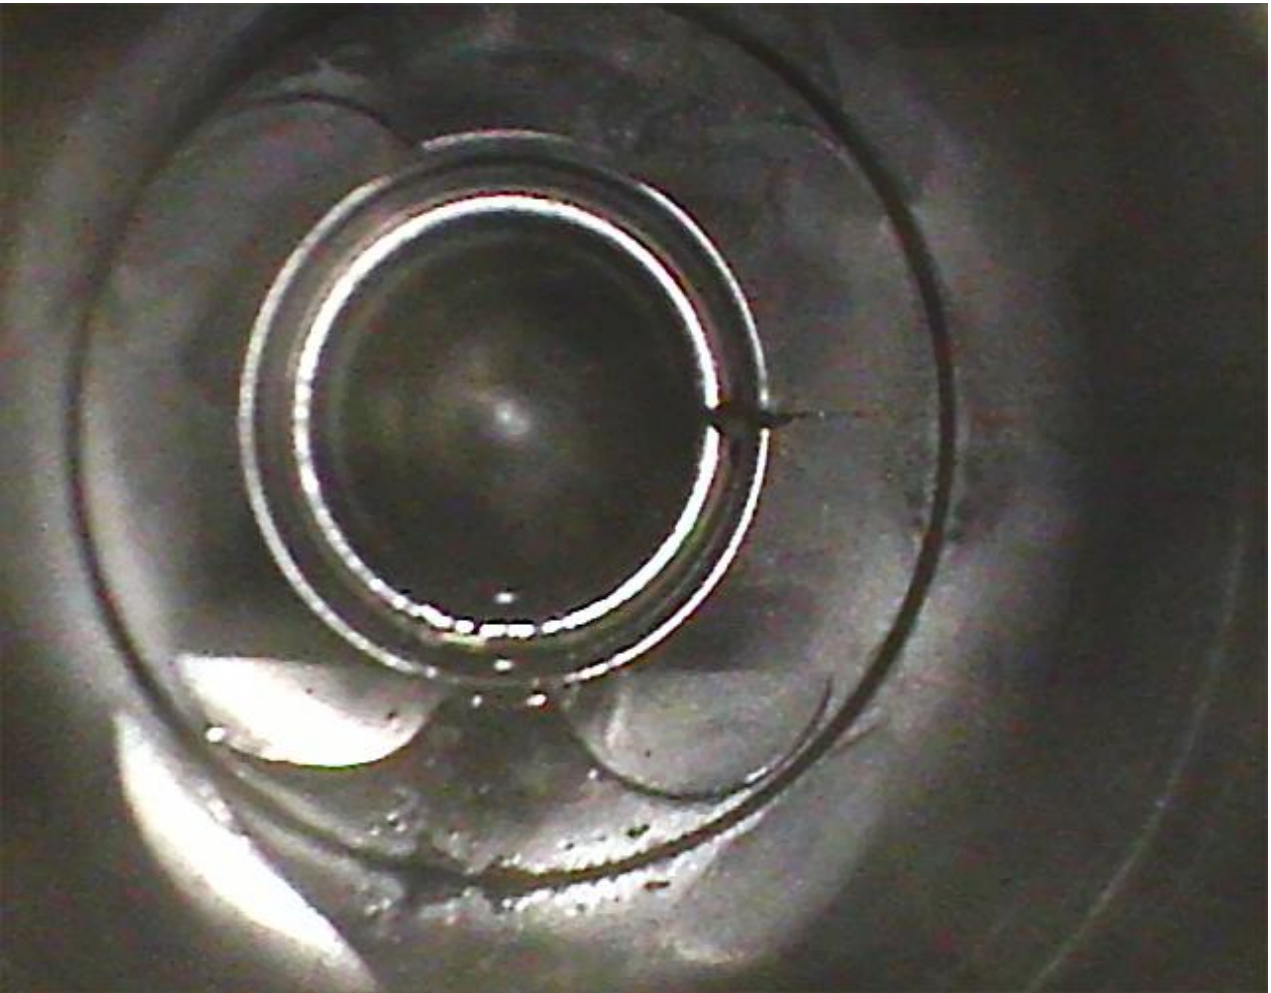
The CAA is aware of six Continental CD-135/CD-155 engines which have been removed from service due to a loss of performance and compression in at least one cylinder.

In every case, further investigation has found a crack in the crown area of the piston (Refer to the photo below of a typical cracked piston).

Operator reports state that the engines perform as expected in flight, up to the point at which they begin to experience vibration, a loss of oil pressure and engine performance.

Early indications of a problem with the engine may be a sudden increase in oil consumption, which may also be accompanied by evidence of oil in or around the engine cowls.

Typical crack found in a piston using borescope equipment.

Pilots, operators, and maintenance providers should take care when checking engine oil levels on aircraft fitted with an affected engine. Any oil uplift should be discussed with the operator's maintenance provider and recorded for reference in the appropriate aircraft records. The appearance of engine oil on the engine cowls, or any apparent oil leak, or smoke from the engine exhaust should also be discussed with the operator's maintenance provider.
