# Continuing Airworthiness Notice – 73-003

## Precision RSA-10AD1 Fuel Control Unit (FCU) – Possible Fuel Flow Restriction

26 June 2014

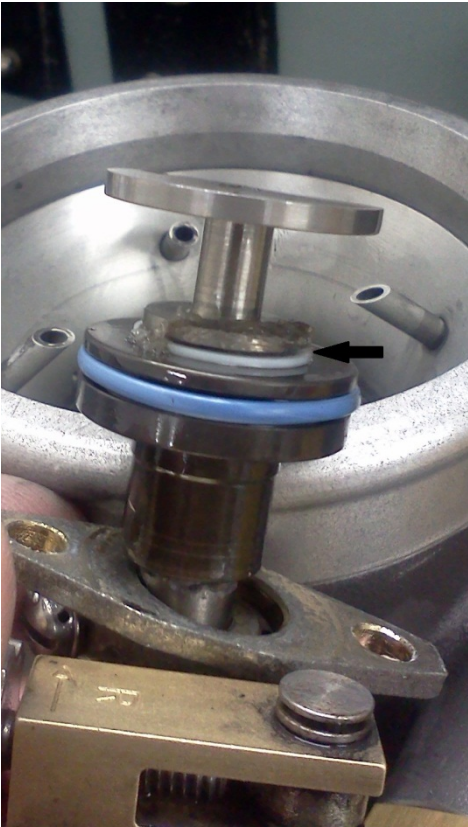
This CAN is prompted by an incident reported to the CAA of a loss of engine power on a Robinson R44 II which resulted in the pilot carrying out a successful auto-rotation landing. A subsequent examination of the FCU revealed delaminated material from washer P/N 367757 which was ingested through the fuel system and resulted in a loss of engine power. The material found was similar in appearance to Polytetrafluoroethylene (PTFE) thread-tape. A laboratory analysis determined that the composition of the material as PTFE, a thermoplastic polymer associated with washer P/N 367757. This washer is fitted to the fuel cylinder injector in the FCU. Refer to the attached photos for more detail.

Washer P/N 367757 in situ on the fuel cylinder injector shaft.

Anecdotal information suggests that washer P/N 367757 may be delaminated if the throttle is stiff, or if reduced engine performance is experienced. An inspection of washer P/N 367757 cannot be accomplished in situ, or in the field. Disassembly of the FCU is required which can only be accomplished by an overhaul facility.

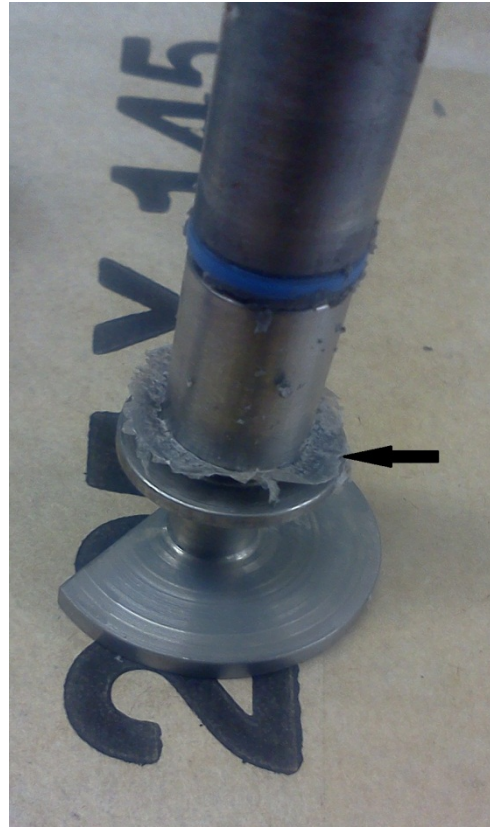
Delaminated material found with washer removed.

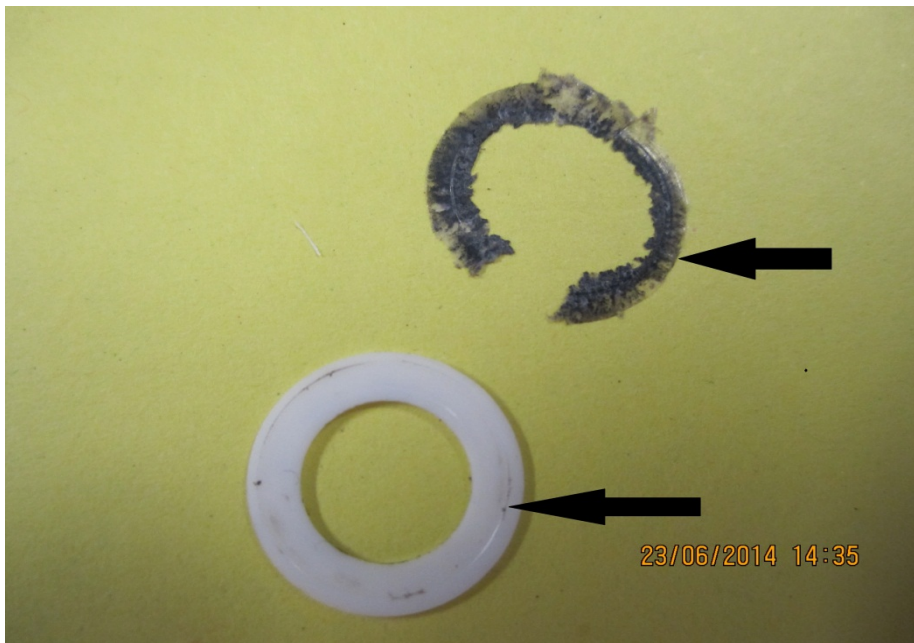
Delaminated material and washer P/N 367757.
