MD Helicopters 369 series, 500N and 600N fitted with Pilot to Co-pilot Tail Rotor Torque Tube P/N 369H7531-XX

10 February 2020

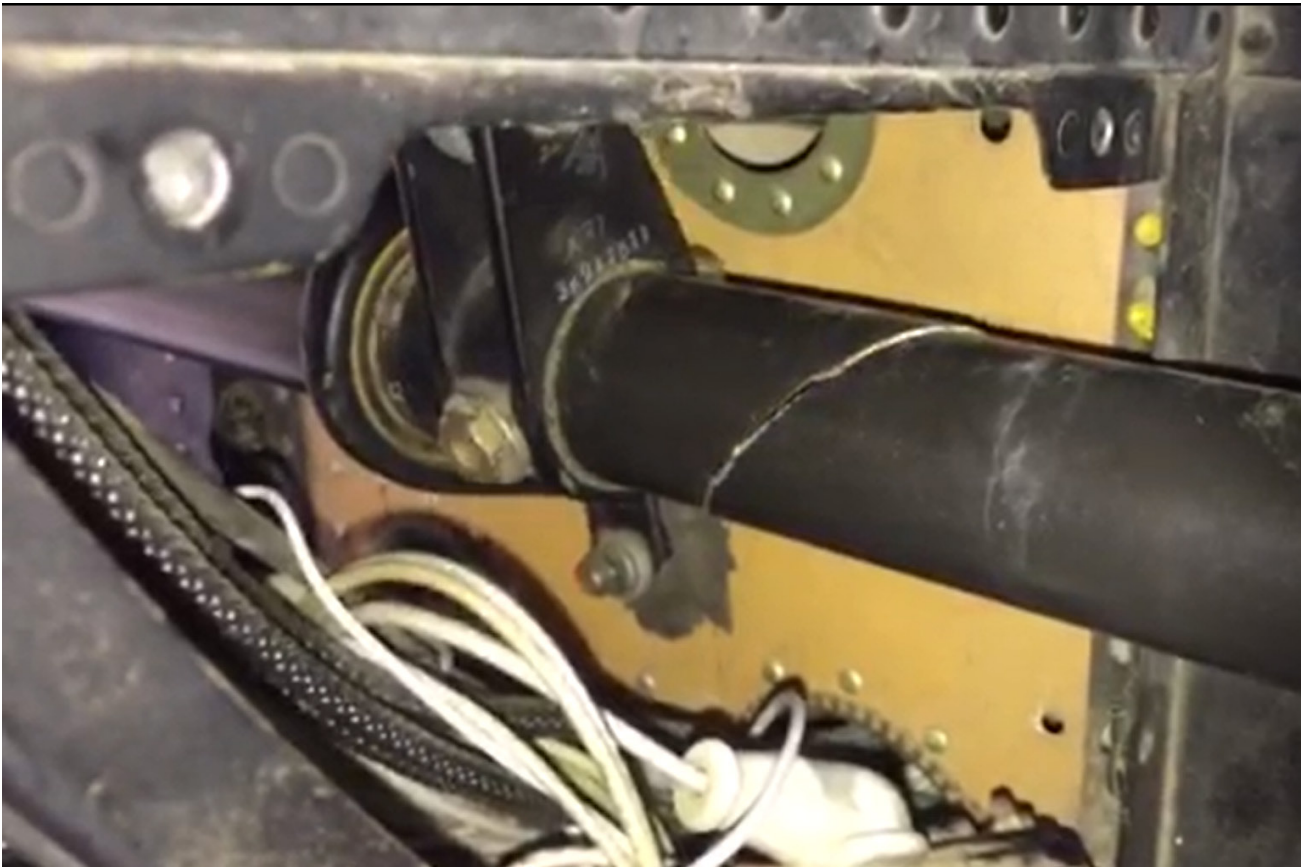
The investigation revealed that the crack initiated from the hole of the control rod fitting (bell crank/push-rod attachment bracket). For further detail refer to the photo on page 2 below.

This CAN is prompted by a defect reported to the CAA of finding a significant crack in the pilot to co-pilot tail rotor torque tube on a MD530FF helicopter. The defect resulted in a significant increase in LH pedal movement to the extent that the pedal was contacting the pedal stop. With full LH pedal applied the pilot could only just maintain heading and continue to a safe landing.

Location of the crack found in Pilot to Co-pilot Tail Rotor Torque Tube P/N 369H7531-11.

The CAA strongly recommends compliance with the instructions in MD Helicopters SB369H-263, SB369E-129, SB500N-066, SB369D-229, SB369F-119 and SB600N-080 (all contained in one document), dated 30 January 2020.
