Airworthiness Directive Schedule

Engines

Honeywell International LTS101 and T53 Series

18 April 2019

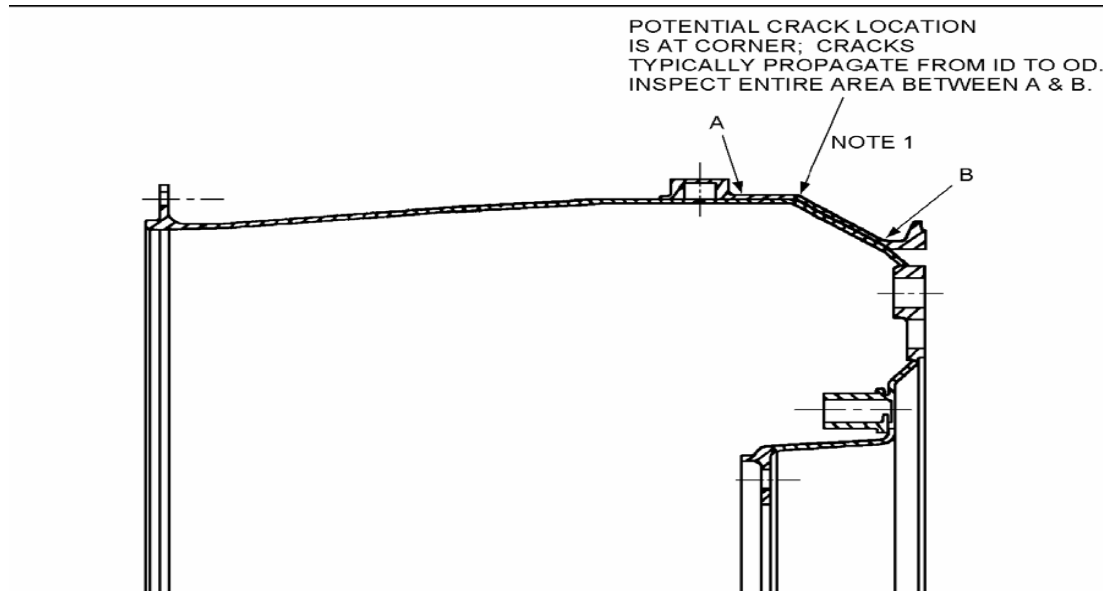
Figure 1: Visual Inspection of Combustion Chamber Housing (CCH)

Inspect the area between points A and B around the entire housing circumference in figure 1 of this AD for weld repairs and cracks.

Note 1: No weld repairs allowed in this area.

If any cracks are found, replace the CCH per Honeywell International ASB T53-A0142 revision 1, dated 14 September 2006 before further flight.

If any weld repairs are found replace the CCH within the next 100 hours TIS after accomplishing the visual inspection per requirement 1 of this AD.
