Airworthiness Directive Schedule

Engines

Continental C-90 Series and O-200 Series

28 May 2020

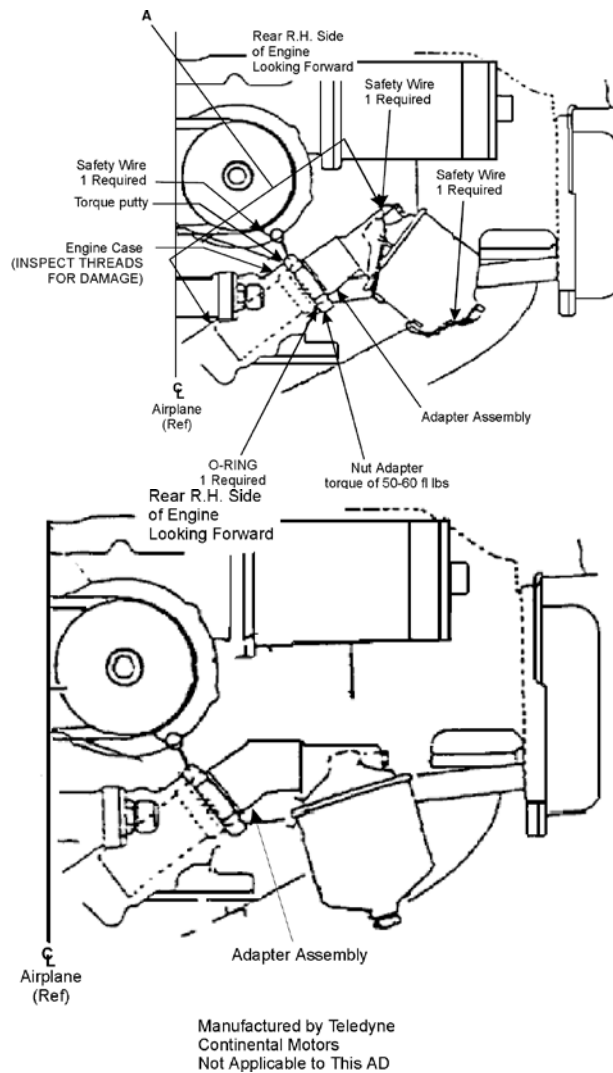
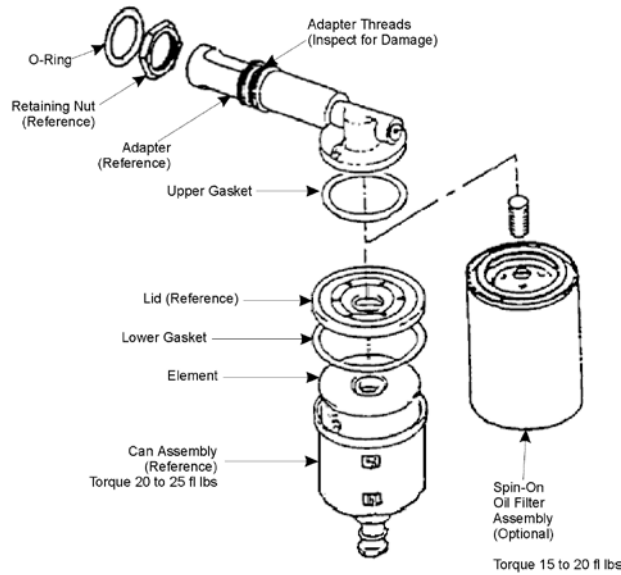
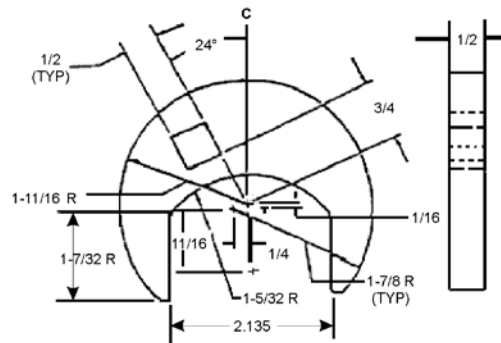
DETAIL A

2. For oil filter adapter assemblies that do have torque putty between the engine filter adapter assembly, nut, and oil pump housing, inspect the torque putty for misalignment, evidence of oil leakage, or cracks.

If any misalignment, evidence of oil leakage, or torque putty cracks are found, prior to further flight, accomplish the requirements specified in paragraph (1) of this AD, including all subparagraphs.

- (i) Inspect the threads of the adapter assembly and engine for signs of damaged or cracked threads; and
- (ii) Replace any adapter assembly and engine oil pump housing (if necessary) that have evidence of thread damage or cracks.
- (d) Apply torque putty between the engine filter adapter assembly, nut, and oil pump housing as specified in the diagram.
- (e) Reassemble the engine oil filter assembly.
