Airworthiness Directive Schedule

Engines

Continental IO-470 Series and O-470 Series

27 August 2020

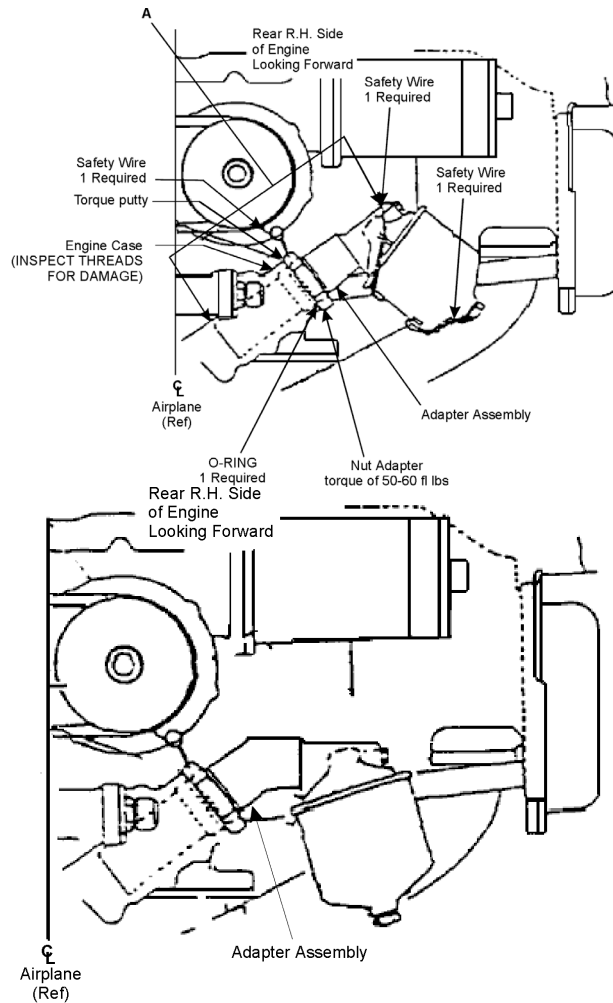
Manufactured by Teledyne
 Continental Motors
 Not Applicable to This AD

- (d) Apply torque putty between the engine filter adapter assembly, nut, and oil pump housing as specified in the diagram.
 - (e) Reassemble the engine oil filter assembly.
