Airworthiness Directive Schedule

Engines

Continental 520 Series

27 August 2020

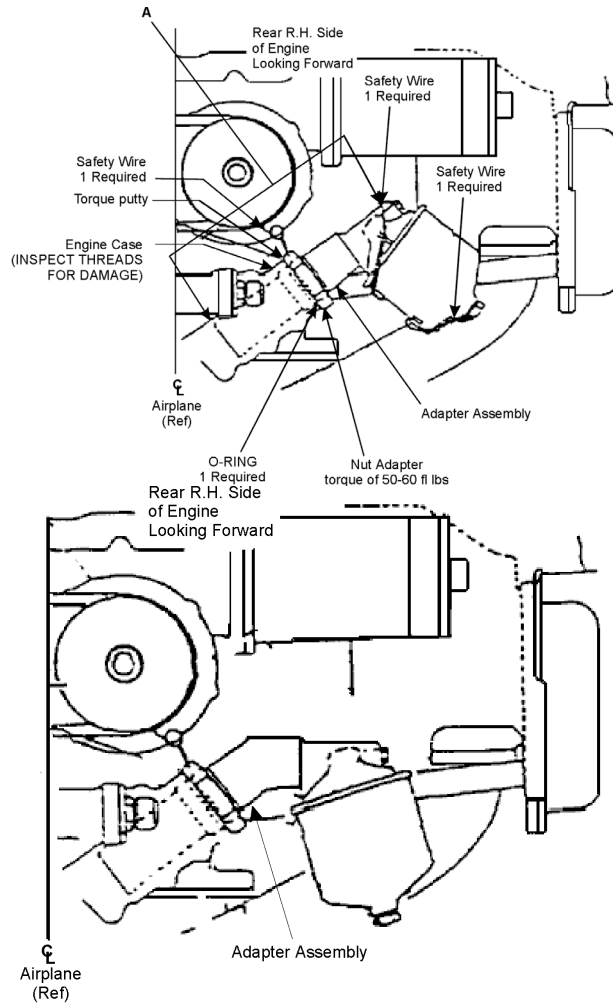
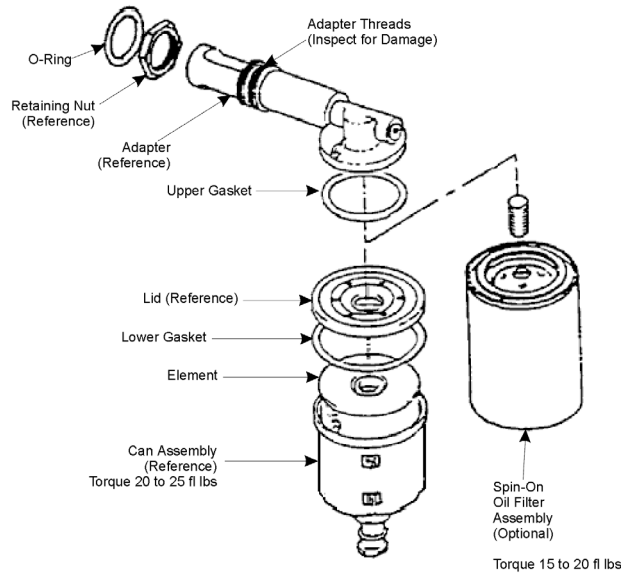
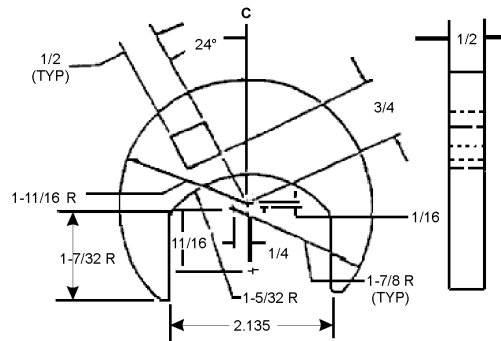
DETAIL A

2. For oil filter adapter assemblies that do have torque putty between the engine filter adapter assembly, nut, and oil pump housing, inspect the torque putty for misalignment, evidence of oil leakage, or cracks.

- If any misalignment, evidence of oil leakage, or torque putty cracks are found, prior to further flight, accomplish the requirements specified in paragraph (1) of this AD, including all subparagraphs.

- (c) If evidence of oil leakage is found or the torque is not within the 50 through 60 foot pound limit, prior to further flight, remove the adapter and filter assembly, and:

- (i) Inspect the threads of the adapter assembly and engine for signs of damaged or cracked threads; and
 - (ii) Replace any adapter assembly and engine oil pump housing (if necessary) that have evidence of thread damage or cracks.
