# Airworthiness Directive Schedule

## Engines

### Lycoming LTIO-540 and TIO-540 Series

26 March 2026

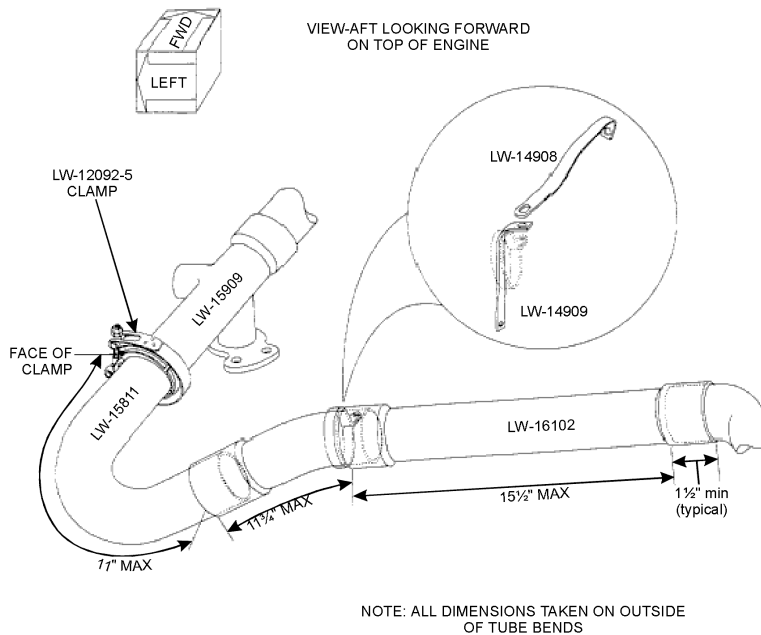
**Requirement:** To prevent exhaust system leaks which may cause engine failure or fire, accomplish the following:

1. Inspect all exhaust system joints, flanges, couplings and brackets for heat damage, distortion, cracks or excessive wear per Textron Lycoming SB 484. Inspect the exhaust system for proper slip joint engagement by measuring distances between pipe end points of LW-16102 (RH) and LW-16103 (LH) per the diagram. If damage is found in the exhaust system or measurements which exceed allowable dimensions, repair or replace damaged parts with serviceable parts as necessary, before further flight.

2. Install new design one-piece exhaust riser kit (05K21503) and manifold retainer kit (05K19650-S) per SB 499C.
