# Airworthiness Directive Schedule

### Merlin

**\* DCA/MER/1      Rocker Arm – Inspection and Replacement**

**Applicability:**      Rolls-Royce Merlin series engines embodied with Modification 9/223/M2623.

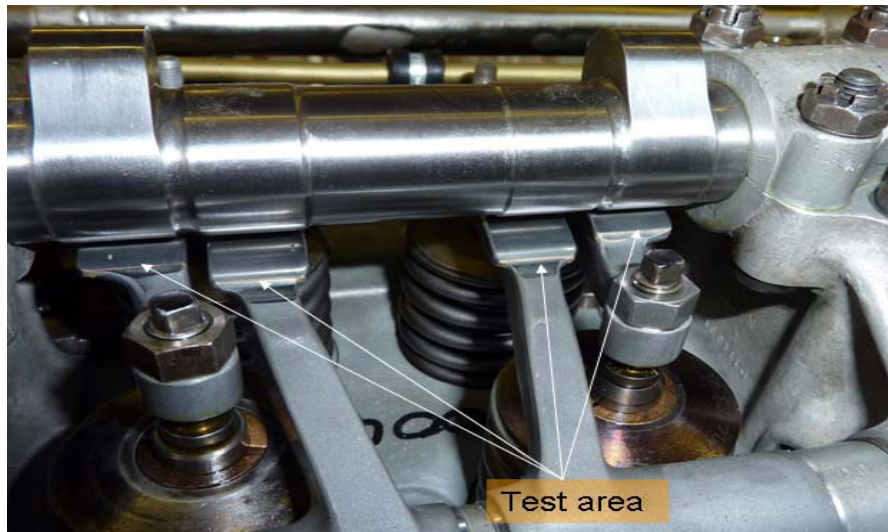
Figure 1:

**Note 1:**              Modification 9/223/M2623 introduces the installation of rocker arm carbide pads. This AD requires repetitive inspections for carbide pad detachment and indications of debonding of the pad from rocker arm. These inspections are an interim requirement as the bond failures are still under investigation.

**Requirement:**      To prevent failure of the rocker arm carbide pads due to possible separation of the pad from the rocker arm which could result in the pad dropping onto the block and migrating, which could result in engine damage and failure, accomplish the following:

For all modified rocker arms with the aid of a X10 magnifying glass inspect the region of the brazed joint between the carbide pad and the rocker arm as shown in figure 1. A stylus of a maximum radius 0.005" may be used if preferred. Inspect for any evidence of movement of the pad on the rocker arm which can be detected by a line or a step on the arm.

If any movement is detected accomplish a comparison with a feeler gauge to measure the size of the step. Any arm which has a step estimated at 0.005" or less, or has a step in excess of 0.005" but less than 0.015" may remain in service subject to accomplishment of the repetitive inspections specified in the compliance of this AD.

Inspect all modified rocker arms for detachment of the carbide pad. Remove rocker arms which have a released pad along with the associated pad and replace with a serviceable rocker arm before further flight.

Any arm which has a step of 0.015" or more must be replaced before further flight.
