Airworthiness Directive Schedule

Engines

Rolls-Royce 250 Series Turbine Engines

26 March 2020

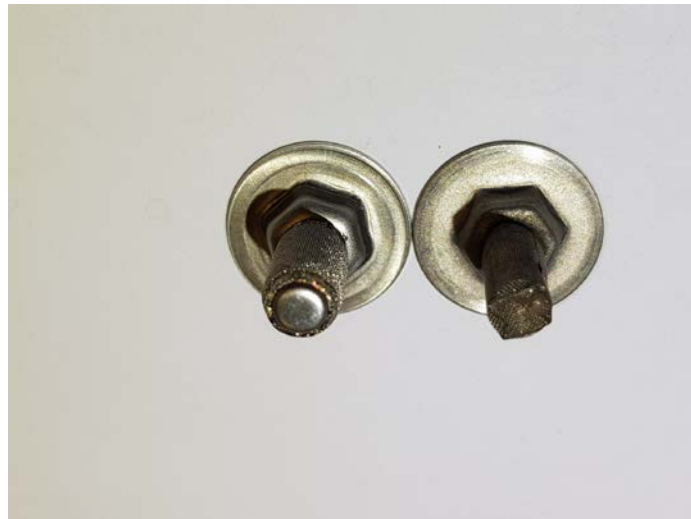
Note: New design fuel nozzle assemblies have a screen filter with a solid metal disk at the aft end of the screen filter. New design fuel nozzles have a screen filter with P/N 139968.

The screen filter on the left of the photo is the new design screen filter, which has a solid metal disc at the aft end of the screen filter.

The screen filter on the right of the photo is the old design screen filter, which is completely constructed of gauze mesh, including the aft end of the screen – Replace before further flight.

If the aft end of the screen filter is constructed of gauze mesh, then replace the fuel nozzle before further flight.
