# Airworthiness Directive Schedule

## Engines

### Continental

27 June 2019

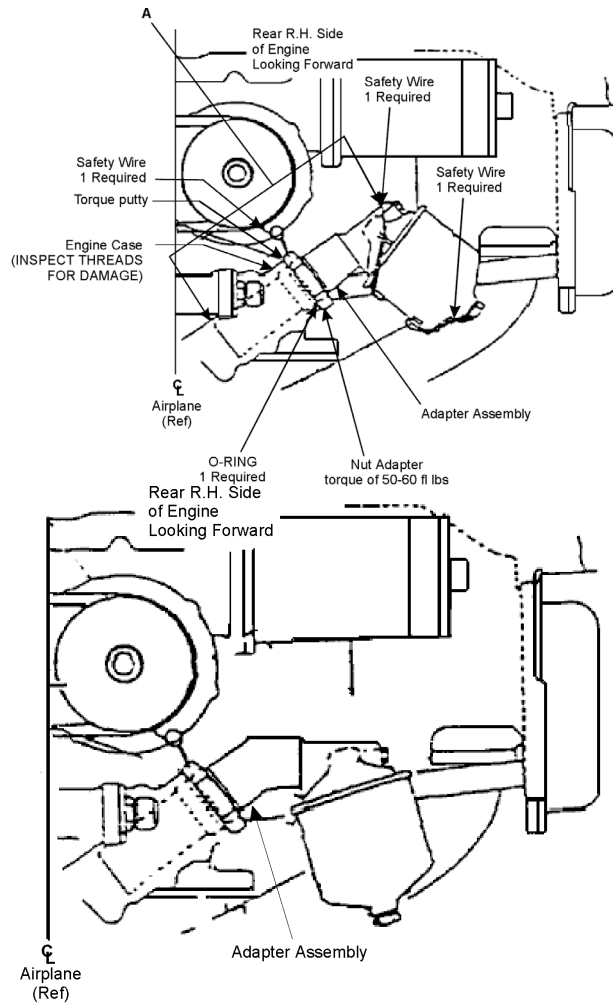
Manufactured by Teledyne  
Continental Motors  
Not Applicable to This AD

- (a) Inspect the adapter locking nut installation for evidence of oil leakage.
- (b) Check the torque of the adapter nut installation and ensure that the torque value is within the limits of 50 through 60 foot pounds.
- (c) If evidence of oil leakage is found or the torque is not within the 50 through 60 foot pound limit, prior to further flight, remove the adapter and filter assembly, and:
  - (i) Inspect the threads of the adapter assembly and engine for signs of damaged or cracked threads; and
  - (ii) Replace any adapter assembly and engine oil pump housing (if necessary) that have evidence of thread damage or cracks.
- (d) Apply torque putty between the engine filter adapter assembly, nut, and oil pump housing as specified in the diagram.
- (e) Reassemble the engine oil filter assembly.
