# Airworthiness Directive Schedule

## Helicopters

### Airbus Helicopters AS 350 Series

26 March 2020

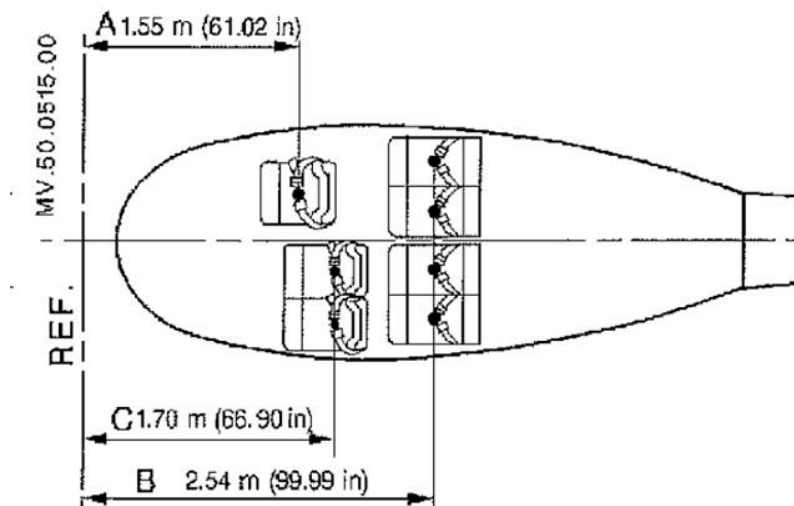
**Requirement:** To prevent a reduction of flight safety from that provided by the manufacturer, accomplish the following:

**Figure:** Airbus Helicopters recommended CG position of forward two-place seat

1. Determine the longitudinal moment arm of the forward two-place seat using the center of the seat pan cushion as a measurement reference point.  
Complete and issue a new form CAA 2173 Weight and Balance Data.  
The weight of the seat components must be included in the CG calculations. If a seat adaptor plate is fitted the moment (position and weight) of the plate must also be considered for the CG calculation.  
The lateral CG arm of the helicopter must not be assumed to be zero. The lateral CG must be recorded and be within the limits specified in the AFM.  
Annotate the CAA2173 to include the value of the longitudinal moment arm of the forward two-place seat used.
2. Remove CAA Limitations Section, (1 page), dated 14 December 2015 and insert 1 page dated 30 June 2016.
