Airworthiness Directive Schedule

Helicopters

Airbus Helicopters AS 355 Series

26 March 2020

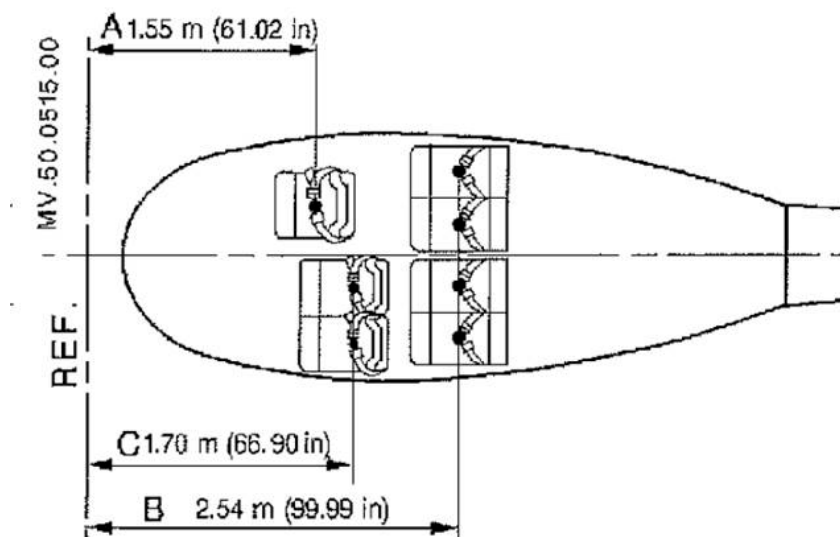
Figure: Airbus Helicopters recommended CG position of forward two-place seat.

Annotate the CAA2173 to include the value of the longitudinal moment arm of the forward two-place seat used.
