# Airworthiness Directive Schedule

## Helicopters

### Airbus Helicopters AS 355 Series

25 July 2024

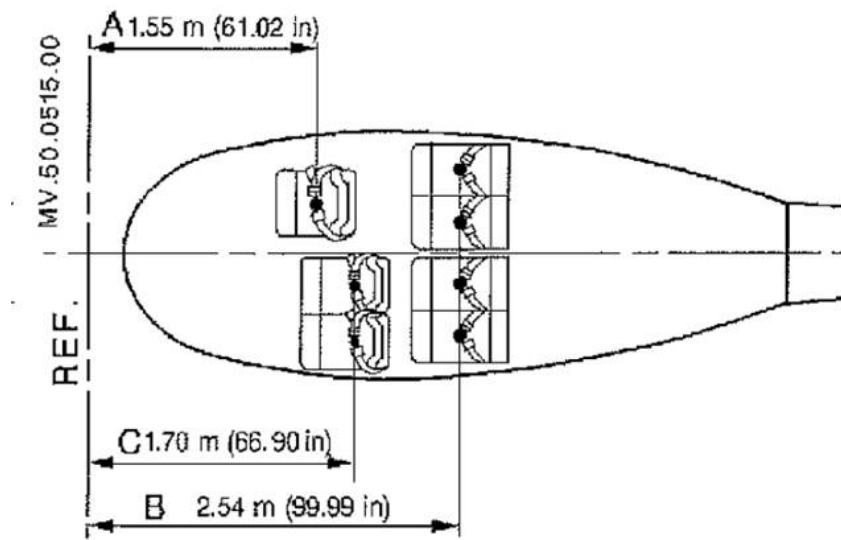
**Requirement:** To prevent a reduction of flight safety from that provided by the manufacturer, accomplish the following:

**Figure: Airbus Helicopters recommended CG position of forward two-place seat.**

1. Determine the longitudinal moment arm of the forward two-place seat using the center of the seat pan cushion as a measurement reference point.  
Complete and issue a new form CAA 2173 Weight and Balance Data.  
The weight of the seat components must be included in the CG calculations. If a seat adaptor plate is fitted the moment (position and weight) of the plate must also be considered for the CG calculation.  
The lateral CG arm of the helicopter must not be assumed to be zero. The lateral CG must be recorded and be within the limits specified in the AFM.  
Annotate the CAA2173 to include the value of the longitudinal moment arm of the forward two-place seat used.
2. Remove CAA Limitations Section, (1 page), dated 14 December 2015 and insert 1 page dated 30 June 2016.
