# Airworthiness Directive Schedule

## Helicopters

### Airbus Helicopters AS 350 Series

31 July 2025

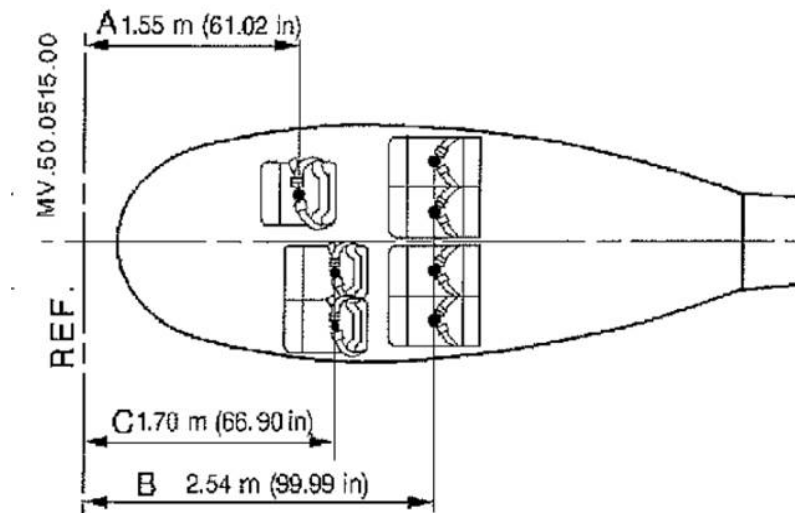
**Figure: Airbus Helicopters recommended CG position of forward two-place seat**

2. Remove CAA Limitations Section, (1 page), dated 14 December 2015 and insert 1 page dated 30 June 2016.

- Compliance:**
1. Before further use of the forward two-place seat, unless previously accomplished.
  2. Before further use of the forward two-place seat.
