Airworthiness Directive Schedule

Helicopters

Bell 412 Series

27 August 2020

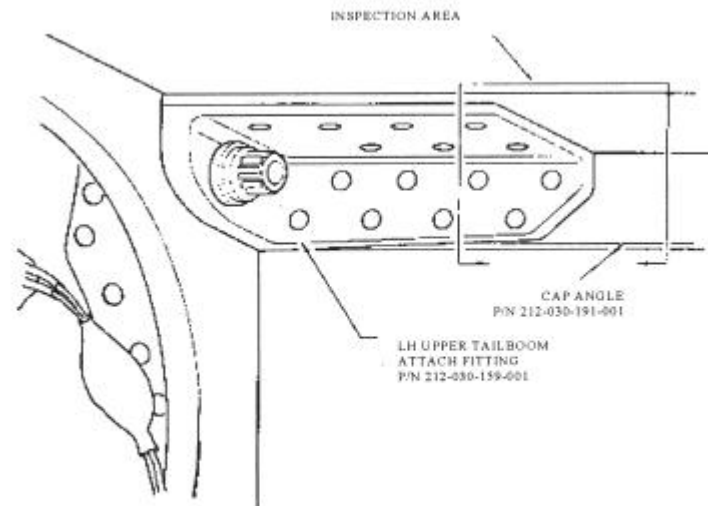
Figure 1 Fuselage tailboom attachment inspection

DCA/BELL412/3 Tailboom Attachment Cap Angle - Inspection

Requirement: To prevent failure of a cap angle, loss of the tailboom, and subsequent loss of control of the helicopter, inspect the cap angle and adjacent structure for a crack in the area shown in figure 1. Use a 10-power or higher magnifying glass. If a crack is found in the cap angle, replace it with an airworthy cap angle before further flight. Repair any crack found in the adjacent structure before further flight.

Compliance: Within 25 hours TIS and thereafter at intervals not to exceed 100 hours TIS.
