Airworthiness Directive Schedule

Helicopters

MD Helicopters 369 Series, 500N and Kawasaki-Hughes 369 Series

26 March 2020

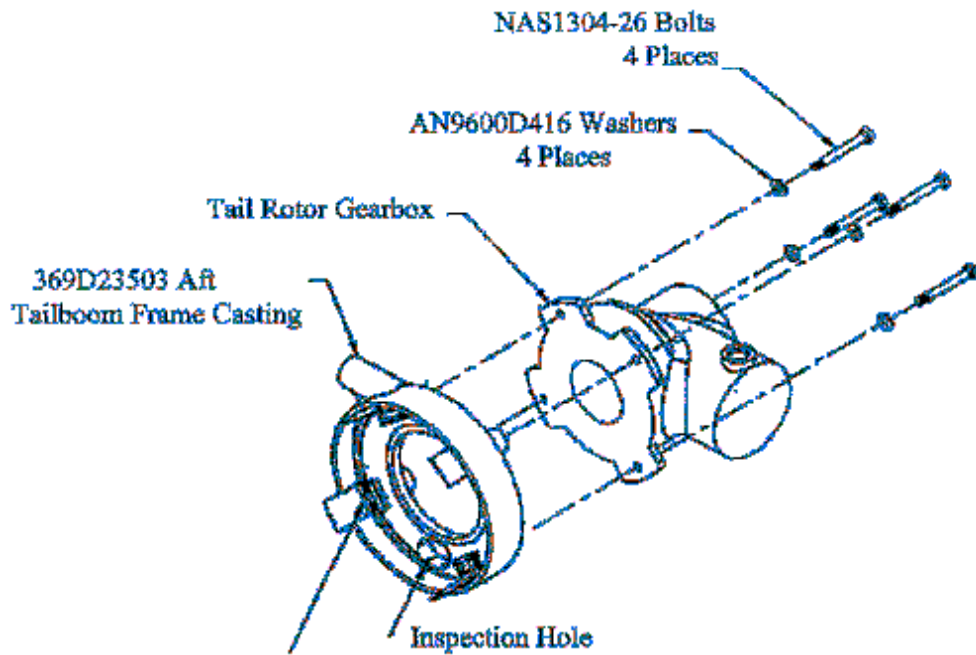
Figure 1 - Inspection Location

2. Remove the tailboom control rod and determine the number of bolt threads protruding from each nutplate on the internal surface of the aft tailboom frame casting, P/N 369D23503, as shown in Figure 1 of this AD. At least one thread must protrude. If more than four threads protrude, add an additional washer, P/N AN960D416, under the bolt head. Torque the bolt to 100-110 in-lbs, and reapply a slippage mark.

**Inspect this area of each bolt.
Bolt must protrude at least one
thread past end of nutplate
4 places.**

1. Determine the P/N of each tail rotor gearbox attaching bolt. If the P/N cannot be determined or if the bolt is not P/N NAS1304-26, replace with bolt, P/N NAS1304-26, before further flight. Torque the bolt to 100-110 in-lbs and apply a slippage mark.
