Airworthiness Directive Schedule

Helicopters

MD Helicopters 369 Series, 500N and Kawasaki-Hughes 369 Series

28 November 2024

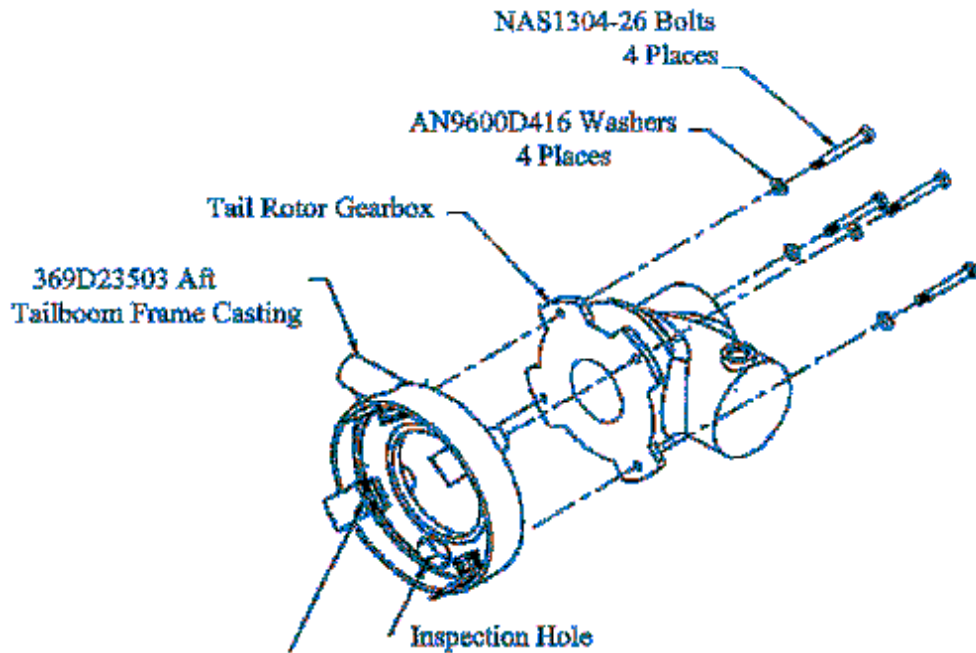
Figure 1 - Inspection Location

Requirement: To prevent loss of the tail rotor gearbox due to attaching bolts of inadequate grip length and subsequent loss of helicopter control, accomplish the following:

Inspect this area of each bolt.
Bolt must protude at least one
thread past end of nutplate
4 places.

1. Determine the P/N of each tail rotor gearbox attaching bolt. If the P/N cannot be determined or if the bolt is not P/N NAS1304-26, replace with bolt, P/N NAS1304-26, before further flight. Torque the bolt to 100-110 in-lbs and apply a slippage mark.
2. Remove the tailboom control rod and determine the number of bolt threads protruding from each nutplate on the internal surface of the aft tailboom frame casting, P/N 369D23503, as shown in Figure 1 of this AD. At least one thread must protrude. If more than four threads protrude, add an additional washer, P/N AN960D416, under the bolt head. Torque the bolt to 100-110 in-lbs, and reapply a slippage mark.
