# Airworthiness Directive Schedule

### MD Helicopters 600N

25 September 2025

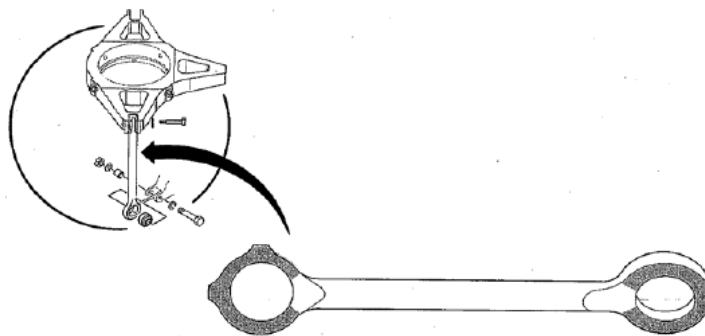
Figure 1

- Applicability:** All model MD600N aircraft fitted with a lateral mixer output link assembly (mixer link), P/N 600N7636-1, -3, -9 or -11.
- Requirement:** To prevent cracks in the mixer link, which could result in failure of the mixer link and subsequent loss of control of the aircraft, accomplish the following:  
Remove each mixer link and visually inspect the shaded areas around the bearing bore for any crack as depicted in figure 1. Use a bright light and a 10x or higher magnifying glass.

Bearings have been removed for clarity.

Accomplish an eddy current inspection on each mixer link in the bearing end areas. Replace cracked mixer links, before further flight. Before installing mixer links held as spares, accomplish an eddy current inspection.
